Model: Model C-C1		Date: 13-Apr-04	No.: RB173001
Subject: Service Manual Correction		Prepared by: A. Ishiyama	
From: 1st Technical Support sec. Service Support Dept.			
Classification:	<input type="checkbox"/> Troubleshooting <input type="checkbox"/> Mechanical <input type="checkbox"/> Paper path <input type="checkbox"/> Other (      )	<input type="checkbox"/> Part information <input type="checkbox"/> Electrical <input type="checkbox"/> Transmit/receive	<input type="checkbox"/> Action required <input checked="" type="checkbox"/> Service manual revision <input type="checkbox"/> Retrofit information

Please apply the following revisions to your Service Manuals. This bulletin contains the revised pages only, which has been posted to the RISSN server along with a separate full-manual version.

Model: Model C-C1		Date: 2-Jul-04	No.: RB173002
Subject: Machine Firmware History		Prepared by: A. Ishiyama	
From: 1st Technical Support Sec. Service Support Dept.			
Classification:	<input type="checkbox"/> Troubleshooting <input type="checkbox"/> Mechanical <input type="checkbox"/> Paper path <input type="checkbox"/> Other (      )	<input type="checkbox"/> Part information <input type="checkbox

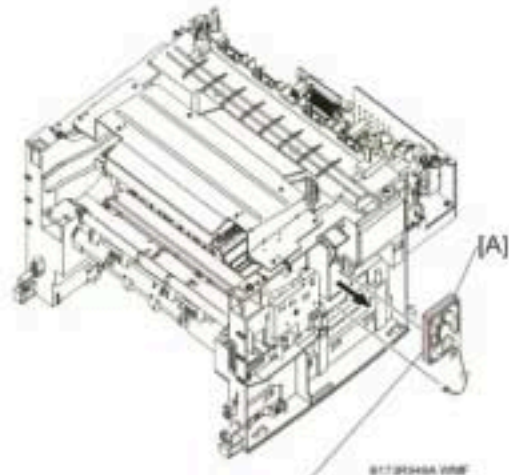
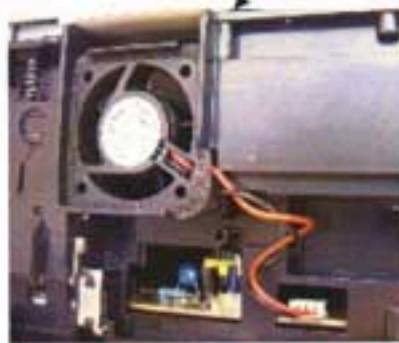
**3.13 FAN**

**CAUTION:** Make sure to set the fan in the correct position.  
The label on the fan must face outward.

1. Before you remove the fan, you must remove these:
  - Rear cover (➡ 3.2)
  - Side covers (➡ 3.3)
2. Disconnect the connector from the SMPS. Then remove the fan [A].

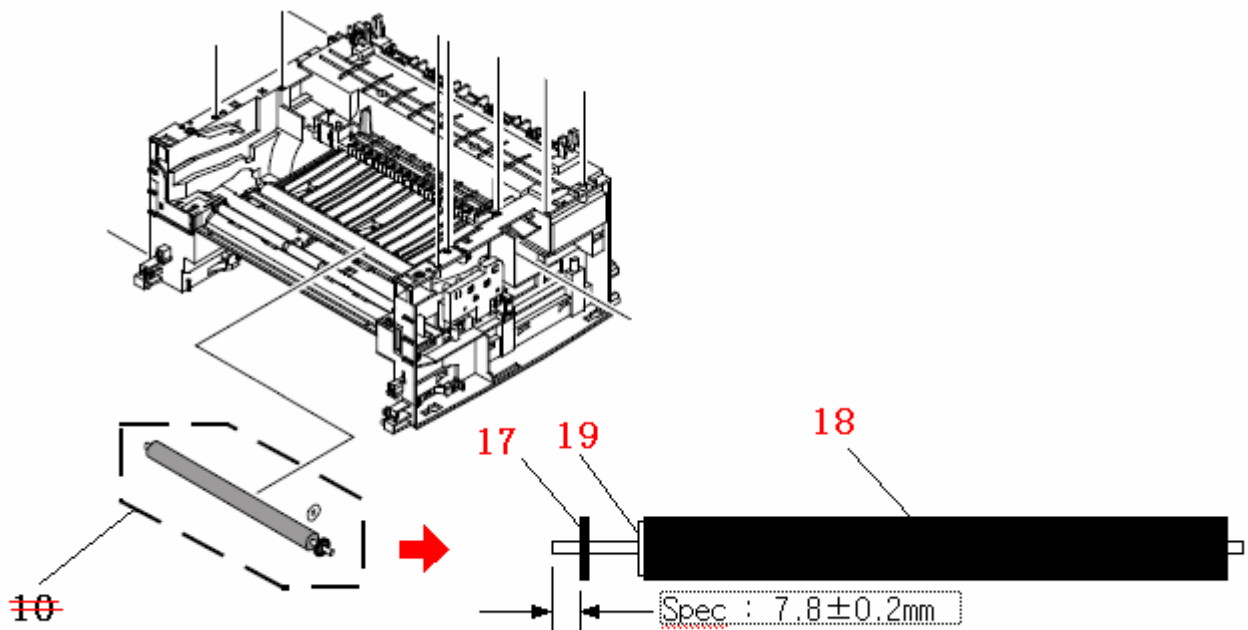
**Change:** P/N B1739513 was divided into three separate parts.

Old Part Number	New Part Number	Description	Q'ty	Int	Page	Index	Note
B1739513	B1739801	GEAR - TRANSFER	1	O/O	3	10→17	
	B1739802	ROLLER - TRANSFER	1			10→18	
	B1739803	SPACER - TRANSFER	1			10→19

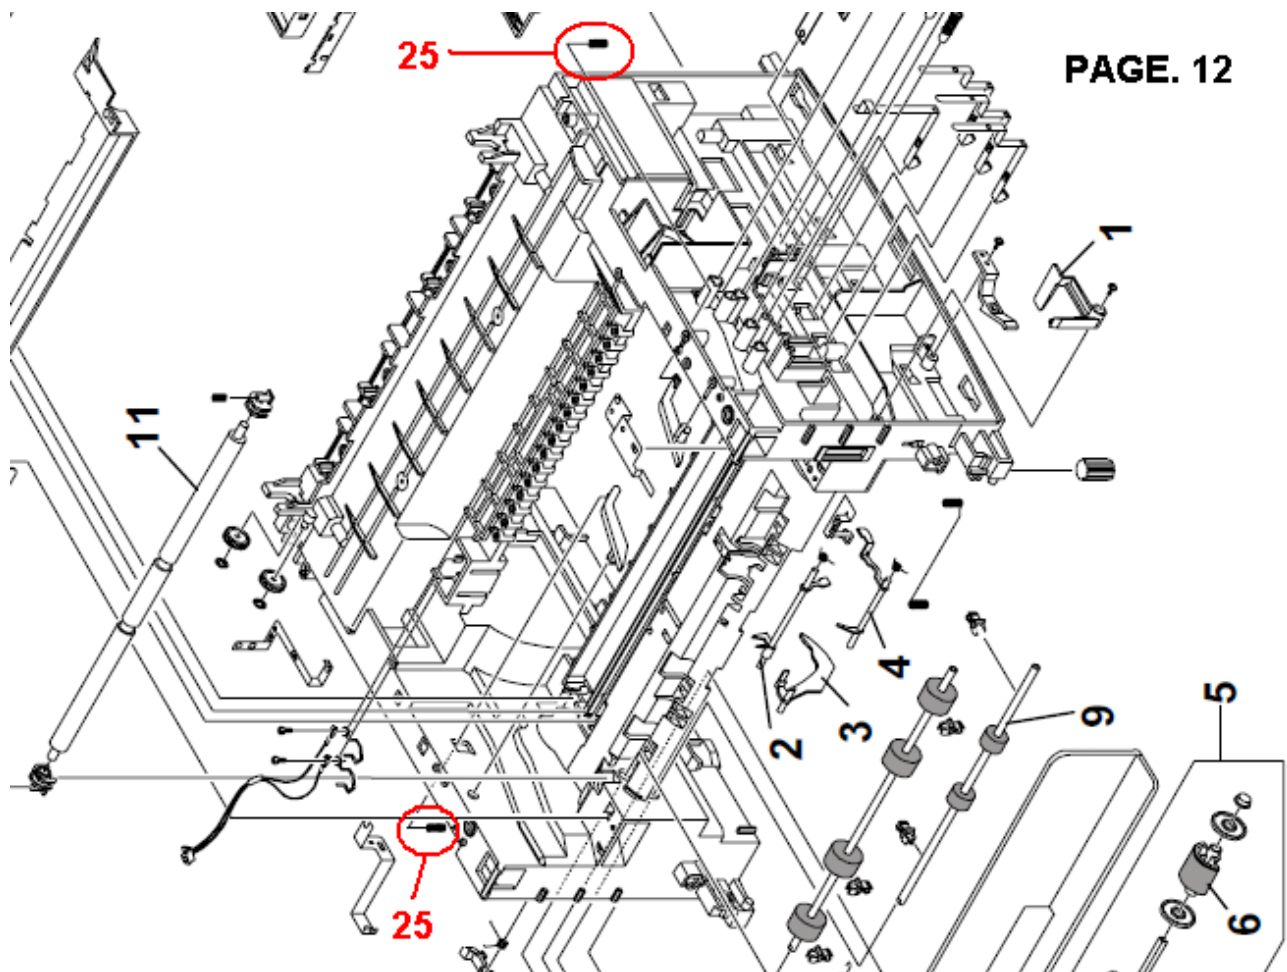
New Part #	Description	Q'ty	Int.	Page	Index	Note
G1861203	SPRING - GUIDE	2	-	13	25

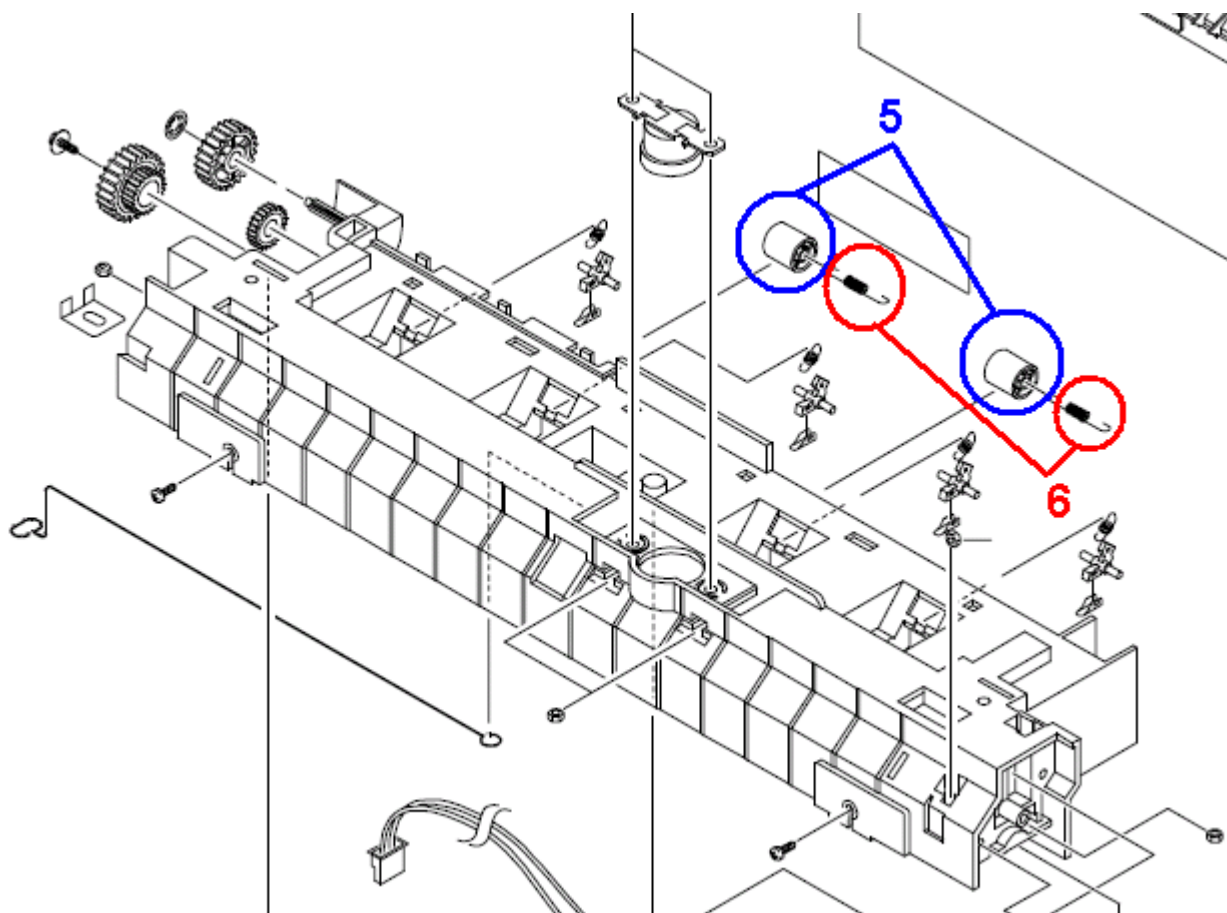
Page 14 of the Parts Catalog

Part Number	Description	Q'ty	Page	Index	Note
B1739805	ROLLER EXIT	2	14	5	
B1739806	SPRING FUSER EXIT	2	14	6

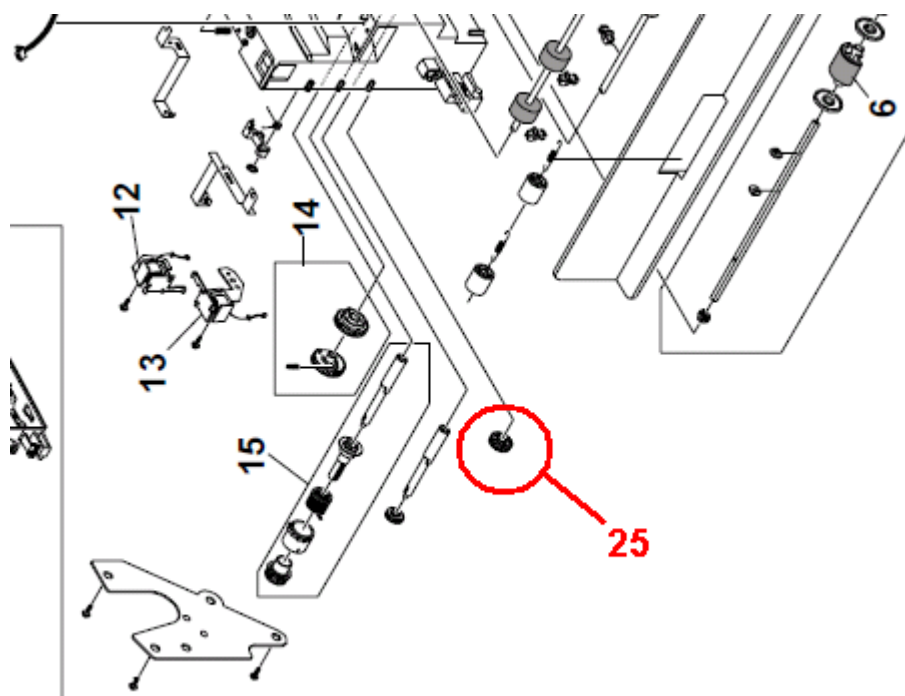
Page 12 of Parts Catalog

New Part #	Description	Q'ty	Page	Index	Note
G9601101	IDEAL GEAR MA ASS'Y (RoHs)	1	13	25
