Model: CM-C1			Dat	e: 12-Jan-06	No.: RB273001a		
RTB Correction The items in bold italics have been corrected or added.							
Subject: Countermeasure for poor image quality Prepared by: T. Shintani					Shintani		
From: 1st Tech. Support Sec. Service Support Dept.							
Classification:		☐ Part info	rmat	tion	n required		
	☐ Mechanical	☐ Electrica	al	☐ Servi	ce manual revision		
	☐ Paper path	☐ Transm	it/rec	eive	fit information		
	☐ Product Safety	Other ()

Model: Model CM-C1			Dat	ate: 1-Feb-06		No.: RB273002
Subject: Limitat	(Prepared	by: T.SI	hintani		
From: 1st Tech. Support Sec. Service Support Dept.						
Classification:	☐ Troubleshooting	☐ Part info	ormat	tion [Action	required
		☐ Electric	al		Servic	e manual revision
	☐ Paper path	☐ Transm	it/rec	eive [Retrof	it information
	⊠ Other ()

Model: Model CM-C1		Date: 6-Nov-06)6	No.: RB273006	
Subject: Light copy image		Prepared by: T.Shintani		hintani		
From: 1st Tech. Support Sec. Service Support Dept.						
Classification:	assification: Troubleshooting Part inform Mechanical Electrical			tion		required ce manual revision
	☐ Paper path ☐ Other ()	☐ Transm	it/rec	eive	Retrot	fit information

Subject: Machine stall problem		Prep

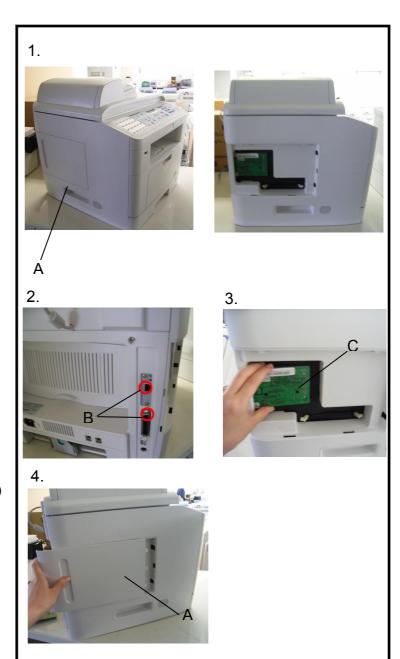
3.19 Network Board

Add the replacement procedure for the network board.

Open the side cover (Cover – Memory)
[A].

- 2. Remove the 2 screws [B].
- 3. Remove the network board [C].

4. Close the side cover (Cover – Memory) [A].

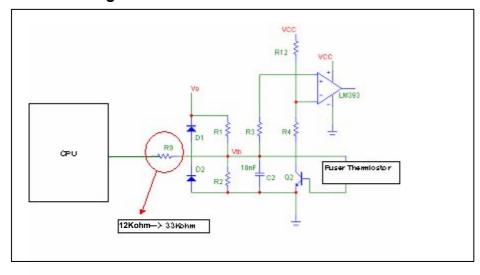
Pressure roller melts to the hot roller at installation or during usage.

If the machine receives abnormal electrical noise (which can be generated by surges or static electricity), it may cause the fusing unit to malfunction.

- 1. Abnormal noise causes the CPU to lock up, and once it's locked up, it cannot control the temperature of the fusing lamp.
- 2. Electronic noise due to electrostatic charge on the paper could potentially interfere at the input point of fusing unit controller.

The following schematic shows the resistor that must be changed.

1. Change the R9 resistor on ADC port from 12 Kohm to 33 Kohms. The hardware protection temperature is reduced by about 100 degrees.
