This RTB has been issued to announce the firmware release information for the Engine.

Technical Bulletin

| Model: Campari-MF1L | | | Dat | Date: 27-Mar-07 | | No.: RG959002 |
| Subject: Countermeasure for Machine stall problem | | | Prepared | d by: T. S | Shintani | |

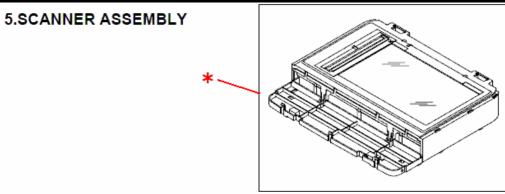
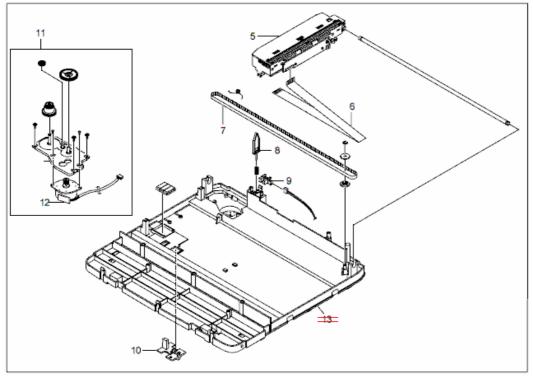
Change: The lower scanner cover was deleted and the scanner unit was newly registered. **Reason:** The parts vendor stopped supplying the cover as an individually replaceable part.

| Old part | New part | Description | Q'ty | Int | Page | Index | Note |
|---|---|---|---|---|---|---|---|
| | B2739810 | Scanner Unit | 1 | - | 15 | * | |
| B2739582 | | Cover - Scanner Lower | 0 | - | 15 | 13 | |

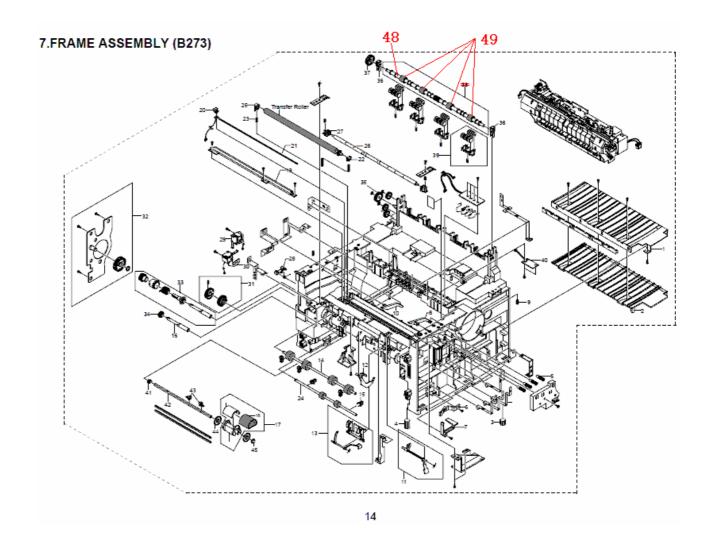
Change: The assembly in the table below (P/N H9149725) was divided into two parts.

Reason: The Parts Catalog was corrected.

| Old Part Number | New Part Number | Description | Q'ty | Int | Page | Index | Note |
|---|---|---|---|---|---|---|---|
| H9149725 | H9149725 | EXIT ROLLER POLE | 1 | 0/0 | 14 | 38→48 | |
| 119149723 | G1449752 | EXIT ROLLER | 4 | . 0/0 | 14 | 38→49 | |

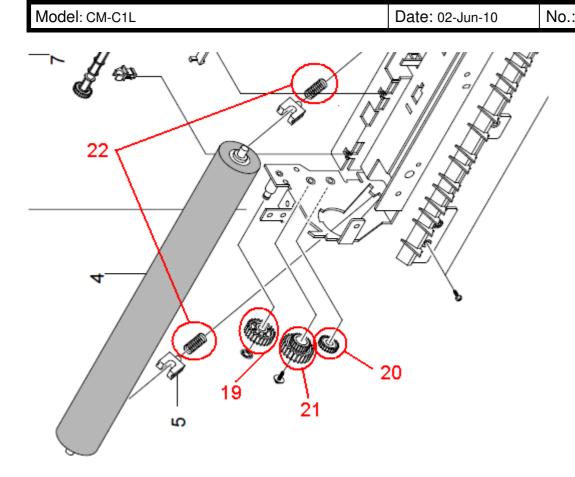
8.FUSING UNIT ASSEMBLY (B273)

Change: The following service parts are added.

Requests from the field.

| New Part # | Description | Q'ty | Page | Index | Note |
|---|---|---|---|---|---|
| G9601101 | IDEAL GEAR MA ASS'Y (RoHs) | 1 | 17 | 19 | |
| B1739804 | GEAR DRIVE16 | 1 | 17 | 20 | |
| G1449609 | GEAR 25/15 | 1 | 17 | 21 | |
| G1449729 | SPRING - BEARING | 2 | 17 | 22 | |
