Model: Stella-C1		Date: 9-Jan-02	No.: RB044001
Subject: PS2 Option		Prepared by: K. Ugaeri	
From: Technical Services Dept., GTS Division			
Classification:	<input checked="" type="checkbox"/> Troubleshooting <input type="checkbox"/> Mechanical <input type="checkbox"/> Paper path <input type="checkbox"/> Other (      )	<input type="checkbox"/> Part information <input type="checkbox"/> Electrical <input type="checkbox"/> Transmit/receive	<input checked="" type="checkbox"/> Action required <input type="checkbox"/> Service manual revision <input checked="" type="checkbox"/> Retrofit information

Model: Stella-C1		Date: 05-Apr-02	No.: RB044004
Subject: Stack Guide		Prepared by: M.Ishihara	
From: Technical Services sec. Service Planning Dept.			
Classification:	<input checked="" type="checkbox"/> Troubleshooting	<input type="checkbox"/> Part information	<input type="checkbox"/> Action required
	<input type="checkbox"/> Mechanical	<input type="checkbox"/> Electrical	<input type="checkbox"/> Service manual revision
	<input type="checkbox"/> Paper path	<input type="checkbox"/> Transmit/receive	<input type="checkbox"/> Retrofit information
	<input type="checkbox"/> Other (      )

Model: Ste

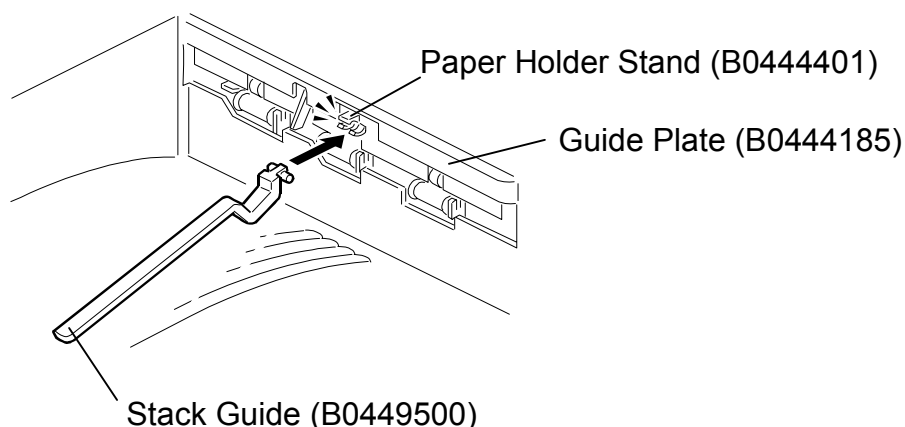
Occasional paper jam at the exit area when using paper that curls easily (e.g. thin paper).

During the copy process, the leading/trailing edges of the paper sometimes curl downward, which can prevent proper stacking and cause a jam.

As shown below, the Stack Guide should be set on the Paper Holder Stand (B0444401), which is attached to the Guide Plate (B0444185) in the paper exit area.

A Stack Guide (P/N **B0449500**) has been registered as a service part, which will allow the paper to stack properly even if it is curled downward.

If returning sheets to the paper stack after removal, be sure to place them under the Stack Guide (otherwise, a paper jam will result).

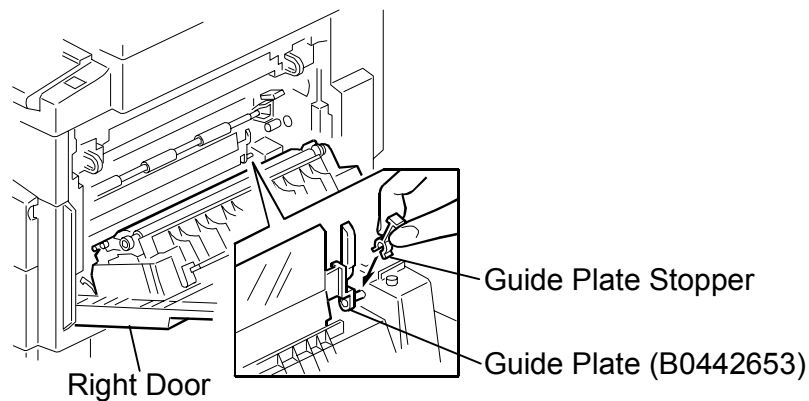
Paper jam

The Paper Feed Guide Plate (B0442653) disconnects from the pivot area.

Attach a Guide Plate Stopper as shown below.

The Guide Plate Stopper was applied to mainframe production from June '02. The cut-in S/N and P/N for the Stopper will be announced as soon as the S/Ns have been confirmed.

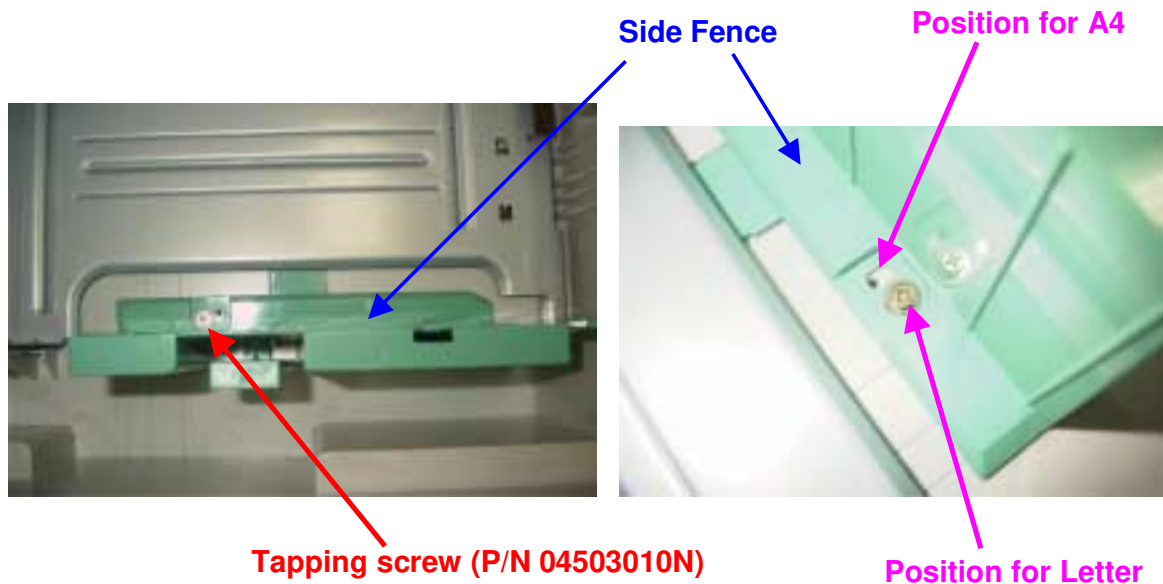
## Fixing the Side Fence in Place

Non-feed jam in the optional paper tray unit.

The side fence can shift inward when the operator loads the paper incorrectly (e.g. not fanning the stack, not placing it in the tray gently), which can then tighten the fence's hold on the paper and make it difficult to feed.

A tapping screw (P/N 04503010N) will be packed together with the optional paper tray unit (B421) for securing the side fence in place at installation.  
Applied from: June 2004 unit production.

After gaining the consent of the customer, please fix the side fence to the base of the cassette using one tapping screw.  
(See the photos on the next page).
