Model: Model S-C2		Date: 25-May-04	No.: RB129001
Subject: When installing the optional paper tray unit (B421)		Prepared by: A. Ishiyama	
From: 1st Tech. Support Sec. Service Support Dept.			
Classification:	<input checked="" type="checkbox"/> Troubleshooting	<input type="checkbox"/> Part information	<input checked="" type="checkbox"/> Action required
	<input type="checkbox"/> Mechanical	<input type="checkbox"/> Electrical	<input type="checkbox"/> Service manual revision
	<input type="checkbox"/> Paper path	<input type="checkbox"/> Transmit/receive	<input type="checkbox"/> Retrofit information
	<input type="checkbox"/> Other ()

Model: Stella-C2		Date: 23-Jul-04	No.: RB129002
Subject: PS3 Option not functioning		Prepared by: M. Ishihara	
From: 1st Tech. Support Sec. Service Support Dept.			
Classification:	<input checked="" type="checkbox"/> Troubleshooting	<input type="checkbox"/> Part information	<input checked="" type="checkbox"/> Action required
	<input type="checkbox"/> Mechanical	<input type="checkbox"/> Electrical	<input type="checkbox"/> Service manual revision
	<input type="checkbox"/> Paper path	<input type="checkbox"/> Transmit/receive	<input type="checkbox"/> Retrofit in

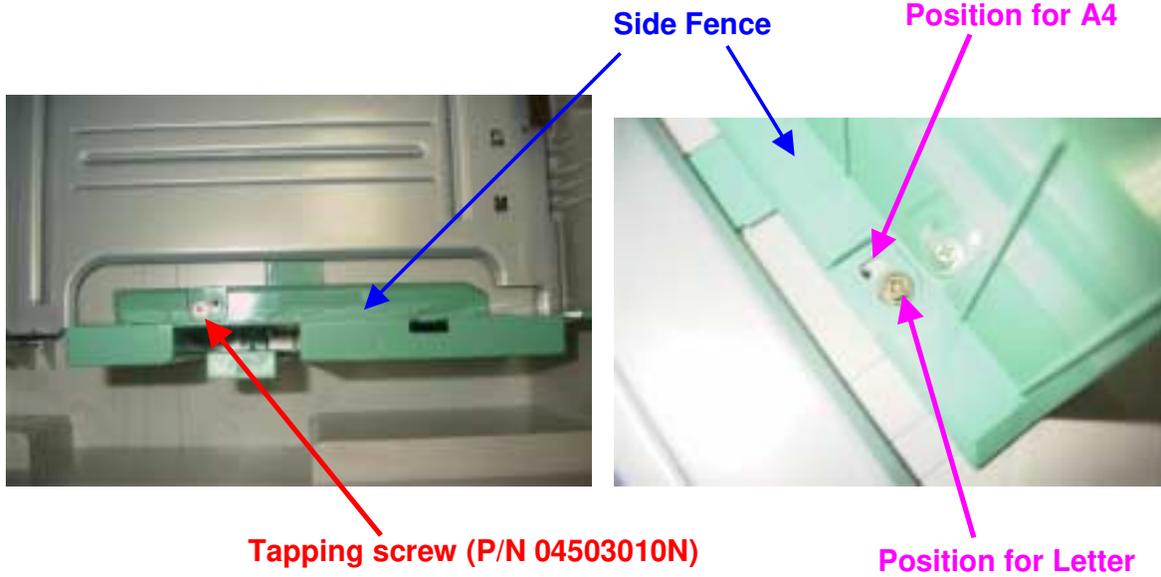
Fixing the Side Fence in Place

Non-feed jam in the optional paper tray unit.

The side fence can shift inward when the operator loads the paper incorrectly (e.g. not fanning the stack, not placing it in the tray gently), which can then tighten the fence's hold on the paper and make it difficult to feed.

A tapping screw (P/N 04503010N) will be packed together with the optional paper tray unit (B421) for securing the side fence in place at installation.
Applied from: June 2004 unit production.

After gaining the consent of the customer, please fix the side fence to the base of the cassette using one tapping screw.
(See the photos on the next page).

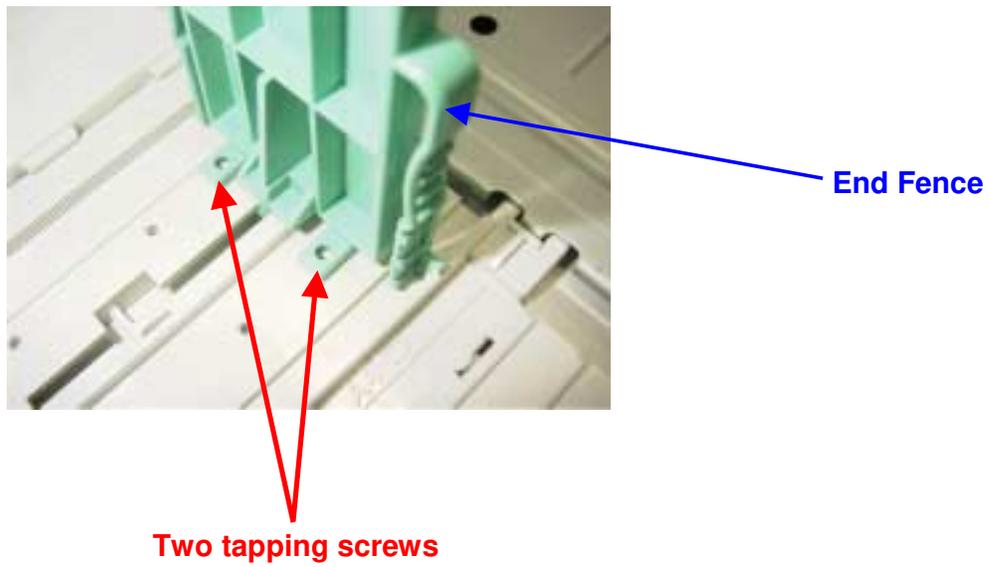
Fixing the End Fence in Place

- Depending on the usage conditions of the customer, it may advantageous to fix the end fence in place as well. This requires two tapping screws, which are not included with the tray unit.
- Please inform the customer that once the side fence is secured in place, 1) the paper size cannot be changed (until the next service visit), and 2) moving the fixed fence by force may damage the fence and/or cassette base.

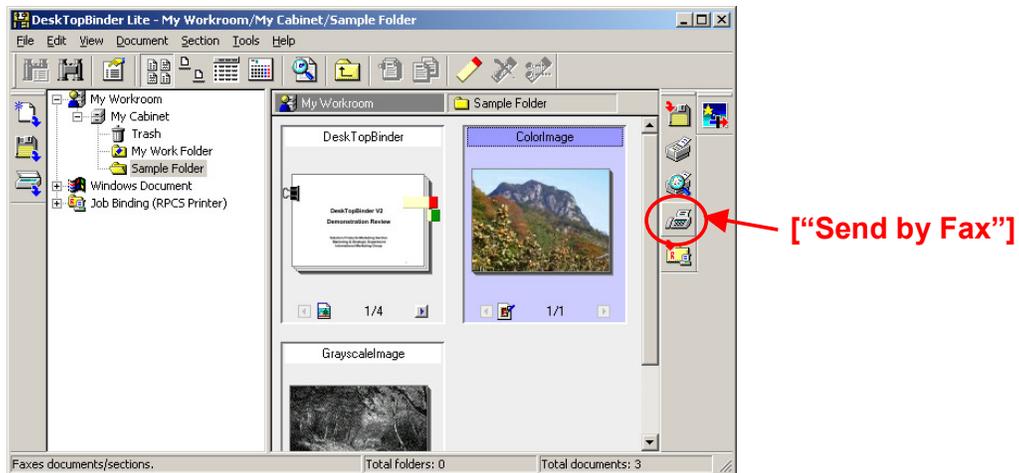
The M5 LAN-Fax Driver is not displayed when it is used as a fax driver within a third-party application. Instead, an error message is displayed (see below).

For example: The driver does not appear when the operator clicks on the “Send by Fax” icon in DeskTopBinder.

The "M5 LAN-Fax driver" was missing from the LAN-Fax driver list bundled with the M5 driver. As a result, the application cannot find the M5 driver.

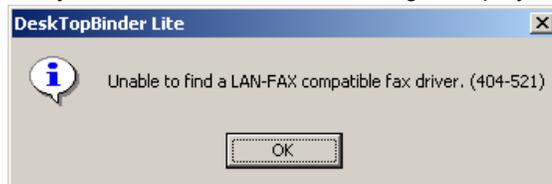
If “Send by Fax” is clicked, this error dialog is displayed:

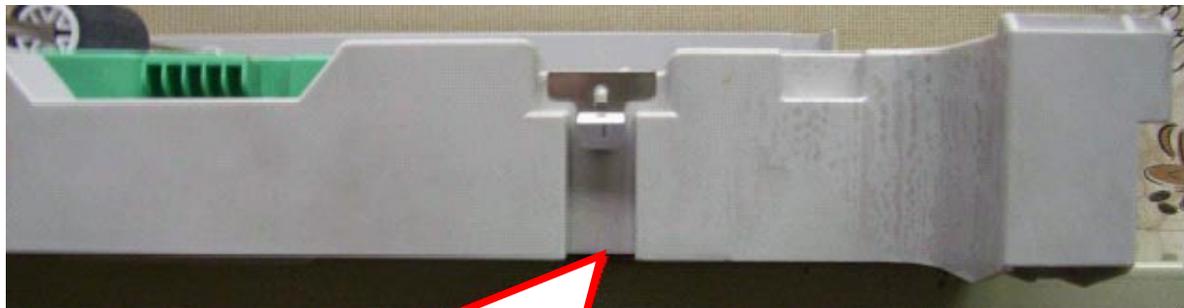
Electrical noise is being generated and it causes image control to function incorrectly. The possible symptoms caused by the electrical noise are SC929s, paper jams, and intermittent digital lines on copies. Static electricity is the source of this electrical noise.

One or both grounding plates on the bottom of the main body paper cassette may not be making proper contact. Reform or replace the grounding plates so that they make proper electrical contact.

B0442709/ B2622709
REAR VIEW OF THE CASSETTE
 Reform the grounding plate out and away from the cassette so it makes proper contact with the main body of the machine. Make sure that the contact on the machine side and this grounding plate are clean and grease free.

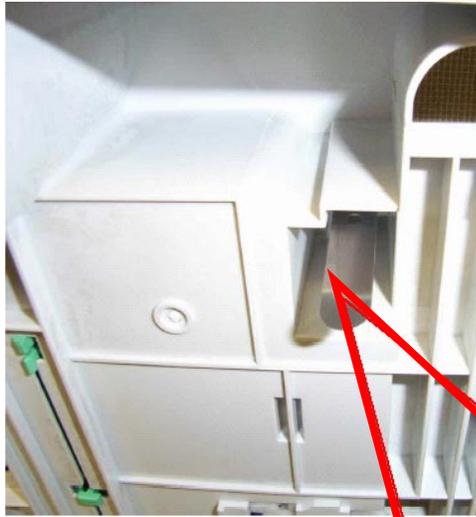
**B0442711/ B2622711****Bottom View of Cassette**

The above photograph is showing the front bottom view of the cassette.

Make sure to form the grounding plate to the rear so that it makes contact with the bottom machine frame.
