Model: Stella-C1		Date: 9-Jan-02	No.: RB044001
Subject: PS2 Option		Prepared by: K. Ugaeri	
From: Technical Services Dept., GTS Division			
Classification:	<input checked="" type="checkbox"/> Troubleshooting <input type="checkbox"/> Mechanical <input type="checkbox"/> Paper path <input type="checkbox"/> Other (      )	<input type="checkbox"/> Part information <input type="checkbox"/> Electrical <input type="checkbox"/> Transmit/receive	<input checked="" type="checkbox"/> Action required <input type="checkbox"/> Service manual revision <input checked="" type="checkbox"/> Retrofit information

Subject: Optional Printer Controller		Prepared by: A. Ishiyama	
From: Technical Services sec. Service Planning Dept.			
Classification:	<input checked="" type="checkbox"/> Troubleshooting	<input type="checkbox"/> Part information	<input checked="" type="checkbox"/> Action required
	<input type="checkbox"/> Mechanical	<input type="checkbox"/> Electrical	<input type="checkbox"/> Service manual revision
	<input type="checkbox"/> Paper path	<input type="checkbox"/> Transmit/receive	<input type="checkbox"/> Retrofit information
	<input type="checkbox"/> Other (       )

Model: Stella-C1		Date: 05-Ap

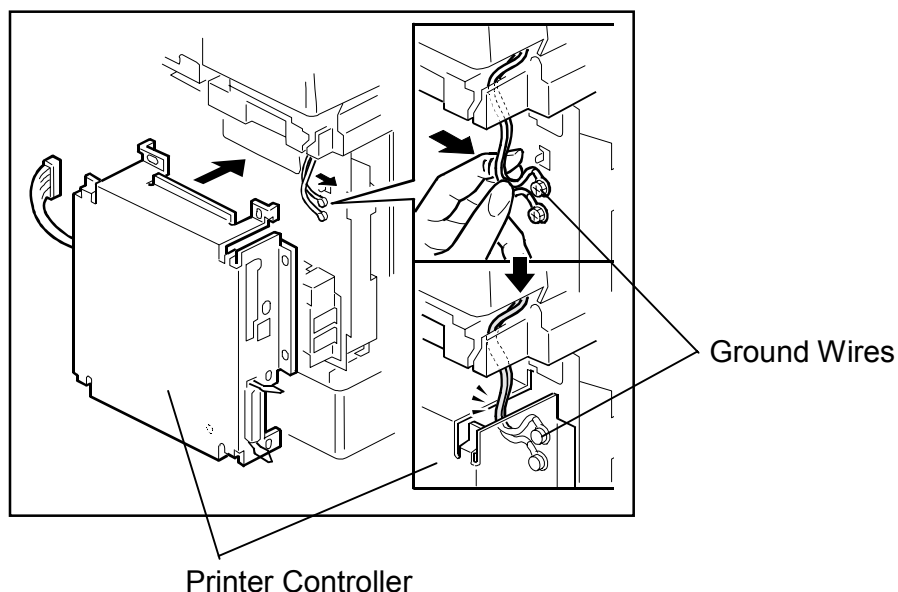
After installing the printer controller in Step 5 of the Installation Procedure, the ADF unit does not open all the way.

When the Controller was installed, the 2 ground wires were not led through the inlet (opening) in the upper right corner of the controller bracket, causing excess tension on the wires.

When installing the Printer Controller, be sure to set the wires into the opening in the upper right part of the bracket as shown below. This will prevent excess tension on the wires and allow the DF to fully open.

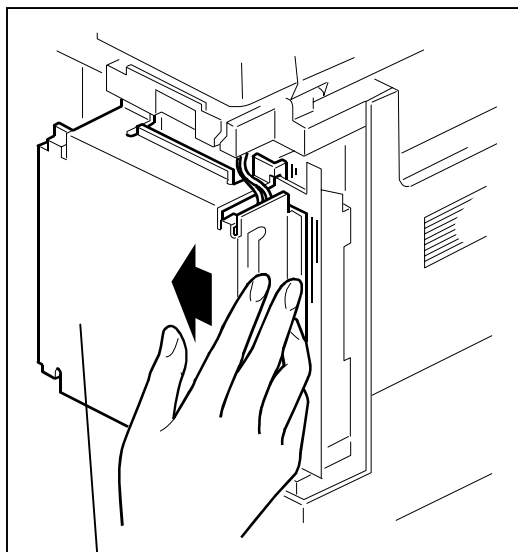
After installing the Printer Controller in Step 5 of the Installation Procedure, the 3 screw holes on the main face of the Rear Cover do not line up with the mainframe holes, making it difficult to reattach the cover.

When the Controller is attached slightly right of center, the width and circular (top) screw holes of the Rear Cover do not provide enough clearance for left/right cover adjustment, and the two contact one another.

When attaching the Controller, hold it flush to the left while tightening the bracket screws as shown in the illustration below.

The shape of the upper screw holes on the main face of the Rear Cover will be changed from circular to elliptical (running change) to allow for any necessary left/right adjustment.

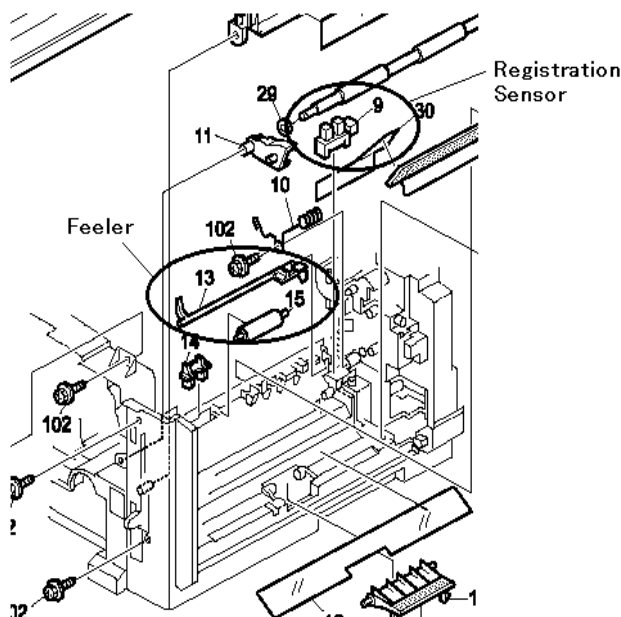
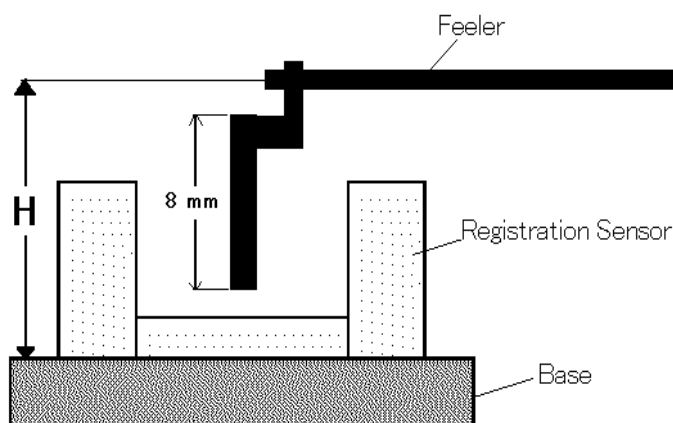
Parts Catalog: Page 8. ~ 4. Paper Registration ~

"Clear misfed paper" is mistakenly displayed. This can occur after printing, when turning on the power, and/or in standby mode.

A misdetection by the registration sensor (#9 in the illustration below) is interpreted by the machine as a paper jam. The misdetection occurs when dimension H below is slightly longer than ideal, preventing the sensor feeler (#13, P/#: B0442603) from shutting correctly. This feeler was located too high because of a fault in the mold used to make the base.

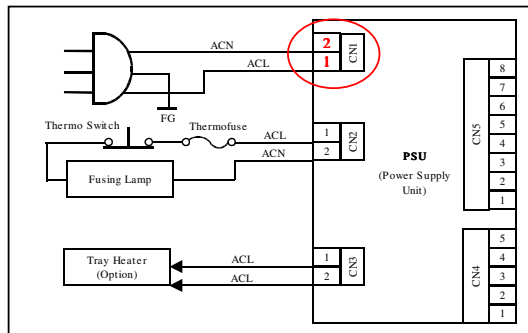
**Up Until October 2004:**  
Wrong Position (reversed wiring)

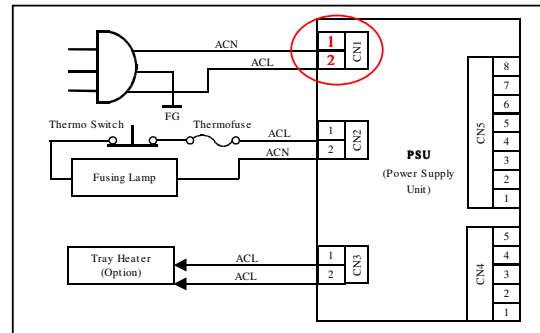
**From November 2004:**  
Correct Position (original wiring)

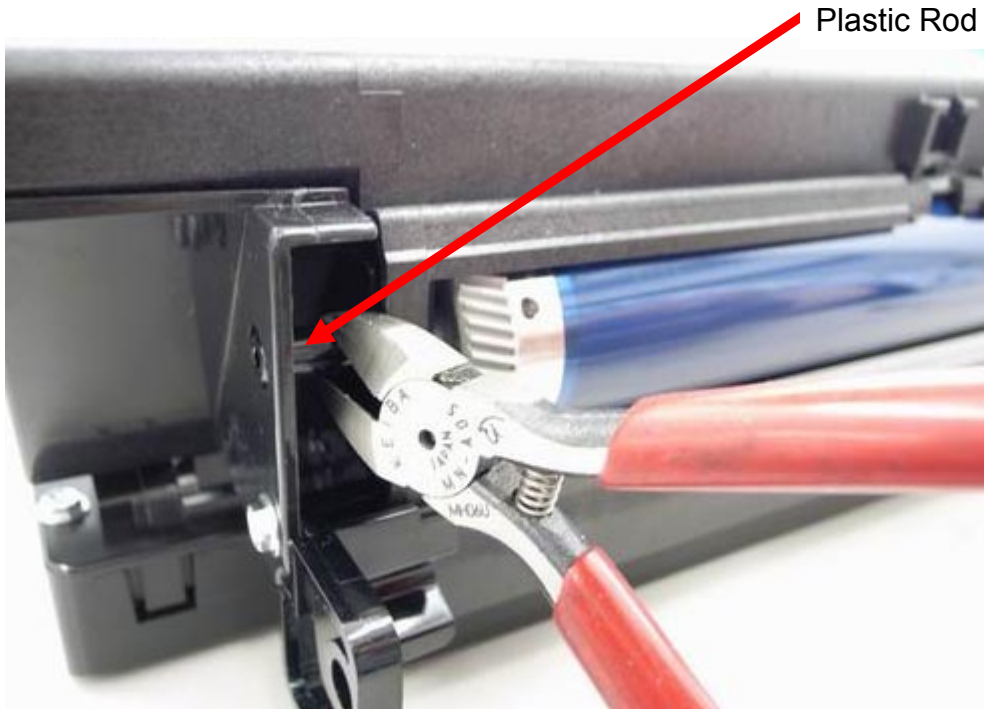
During the installation of a new machine, developer leaks out of the PCU.

1. Cut and remove the plastic rod using a pair of needle-nosed pliers.
