| Model: Model S-F2 | | Date: 30-Jan-03 | No.: RH556001 |
| Subject: Service Manual Correction (Model S-F2) | | Prepared by: M. Mano | |
| From: Technical Service Sec. Service Planning Dept. | | | |

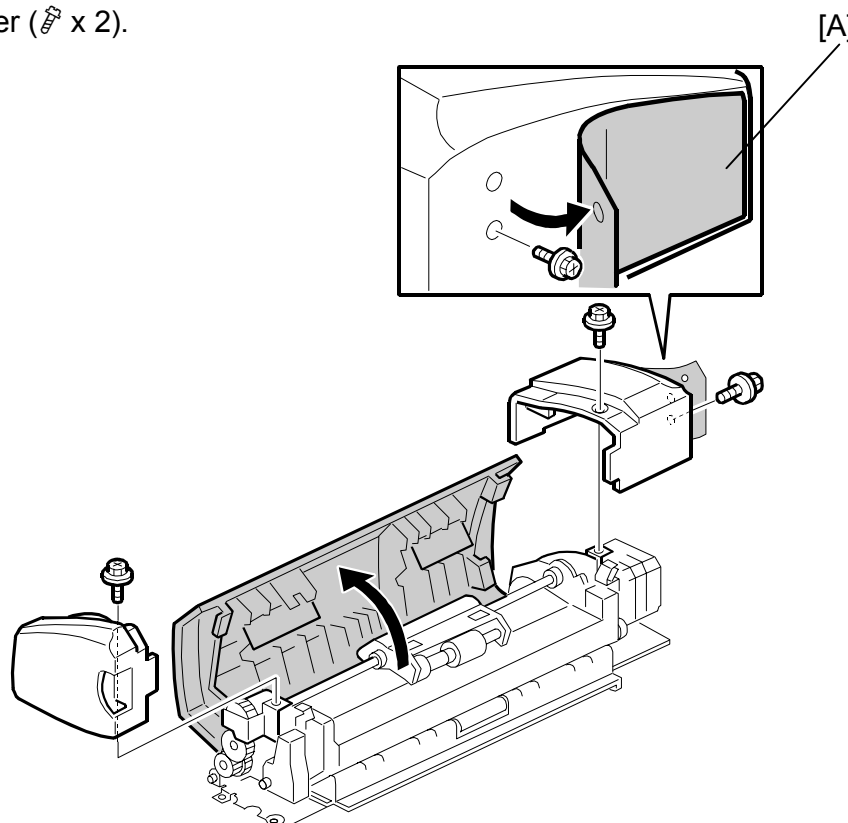
DF Rear Cover

1. Peel off the Mylar [A] as shown.
2. DF rear cover (🔧 x 2).

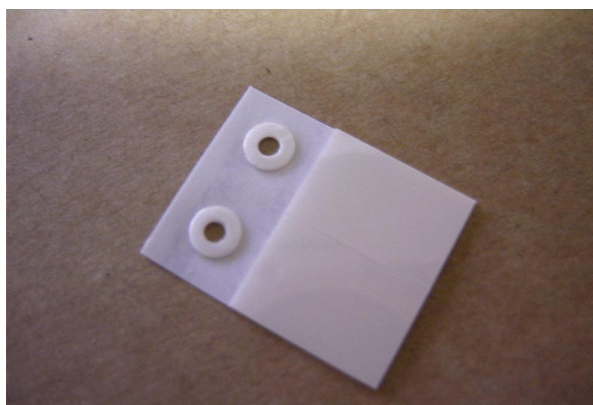
The stamp solenoid can get caught on the edge of the stamp cover opening, preventing the stamp cartridge from returning to home position and triggering an original jam.

The stamp cover opening is small enough so that when the solenoid is off-centered by a wide margin, it can catch on the edge of the opening.

Attach a Stamp Spacer (P/N **H5579900**, qty. 2) if the symptom is reported, or as an extra preventative measure at stamp solenoid or stamp cover replacement.

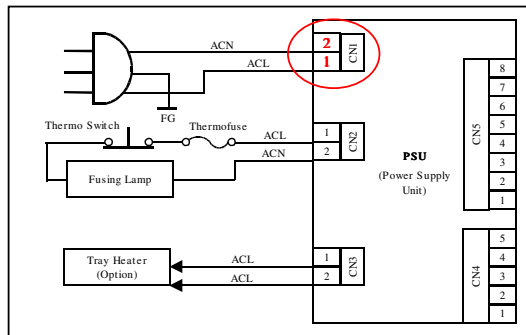
Up Until October 2004:
Wrong Position (reversed wiring)

Even though the hot and neutral wires are reversed, **this will not cause any kind of safety issue**. The machine is completely safe when the operator uses the machine, and when technicians do maintenance.

- P-to-P for machines **up until October**: Should show the hot and neutral lines in the **wrong** position (reversed).
- P-to-P for machines **from November**: Should show the hot and neutral lines in the **correct** position.

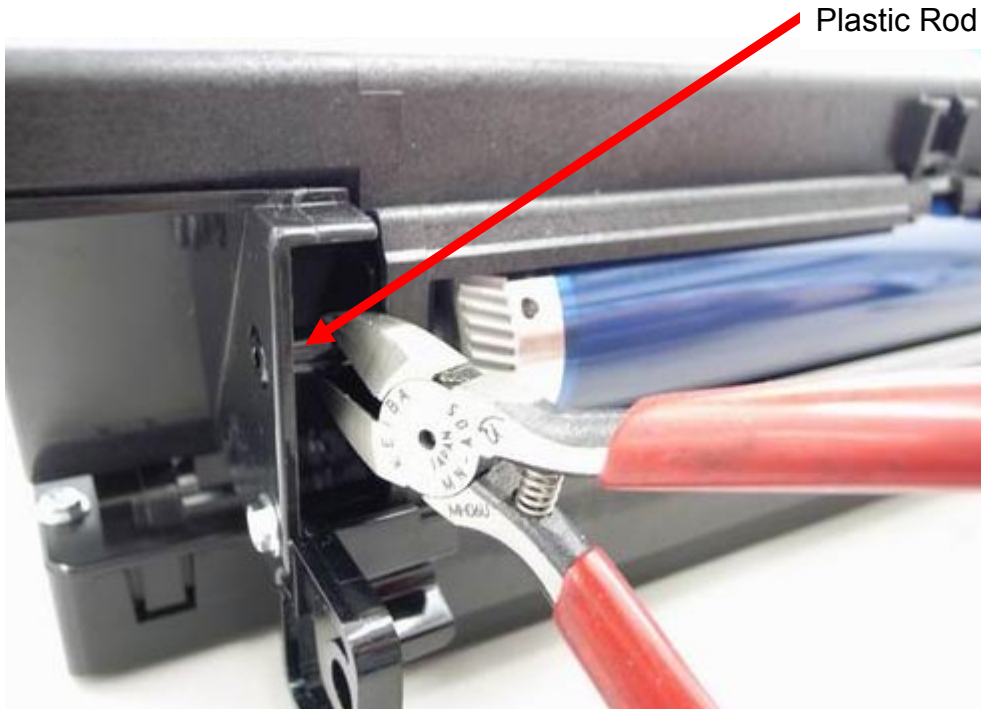
During the installation of a new machine, developer leaks out of the PCU.

1. Cut and remove the plastic rod using a pair of needle-nosed pliers.

Note: There is no side effect created by removing this rod from the PCU (even from a normal PCU).
