Model: Kir-C		Date: 15-May-01	No.: RB040001
Subject: ROM History (Kir-C1 Copy Version)		Prepared by: K. Miura	
From: Technical Services Dept., GTS Division			
Classification:	<input type="checkbox"/> Troubleshooting <input type="checkbox"/> Part information <input type="checkbox"/> Action required <input type="checkbox"/> Mechanical <input type="checkbox"/> Electrical <input type="checkbox"/> Service manual revision <input type="checkbox"/> Paper path <input type="checkbox"/> Transmit/receive <input checked="" type="checkbox"/> Retrofit information <input type="checkbox"/> Other (      )

Firmware history for the Kir-C1

Model: Kir-C		Date: 24-May-01	No.: RB040003
Subject: Note for replacing the Drum Shutter Gear		Prepared by: K. Miura	
From: Technical Services Dept., GTS Division			
Classification:	<input checked="" type="checkbox"/> Troubleshooting <input checked="" type="checkbox"/> Mechanical <input type="checkbox"/> Paper path <input type="checkbox"/> Other (      )	<input type="checkbox"/> Part information <input type="checkbox"/> Electrical <input type="checkbox"/> Transmit/receive	<input type="checkbox"/> Action required <input type="checkbox"/> Service manual revision <inp

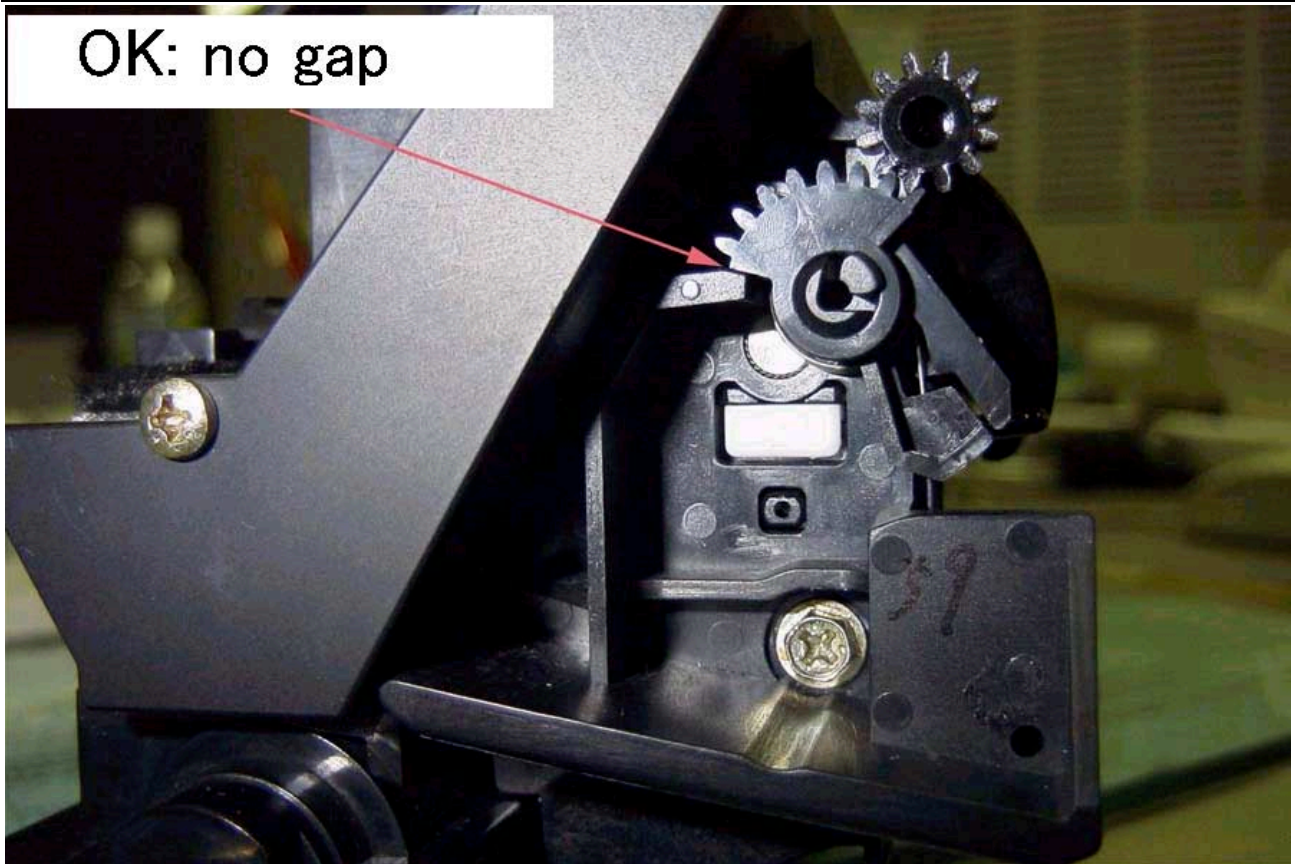
**OK: no gap**

When re-installing the Drum Shutter Gear (B0392362), if there is a gap between the Drum Shutter Gear and Drum Front Side Plate (B0392361), the drum shutter will not open fully. See the photo images on the next page.

The gap causes the Drum Shutter Gear to rotate less.

When re-installing, it is necessary to confirm that there is no gap between the shutter gear and front side plate. A Drum Shutter Stopper (B0392325) has been added from May 2001 production to ensure that the Drum Shutter Gear and Drum Front Side Plate are held flush together with no gap.

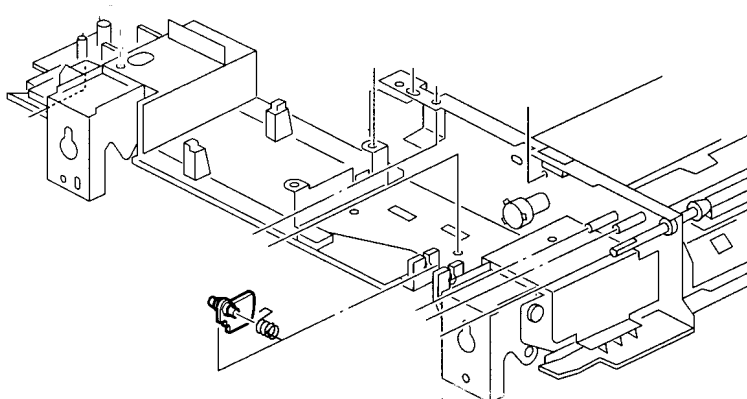
The ADF Paper Size Sensor Feeler (B3871941) sometimes detaches when the ADF is removed from the package.

There are slight variations in shaft width, which can sometimes cause the feeler to detach if the shaft is too thin.

When installing the ADF, check that the Paper Size Sensor Feeler is properly in place. If it comes off, re-set the feeler.

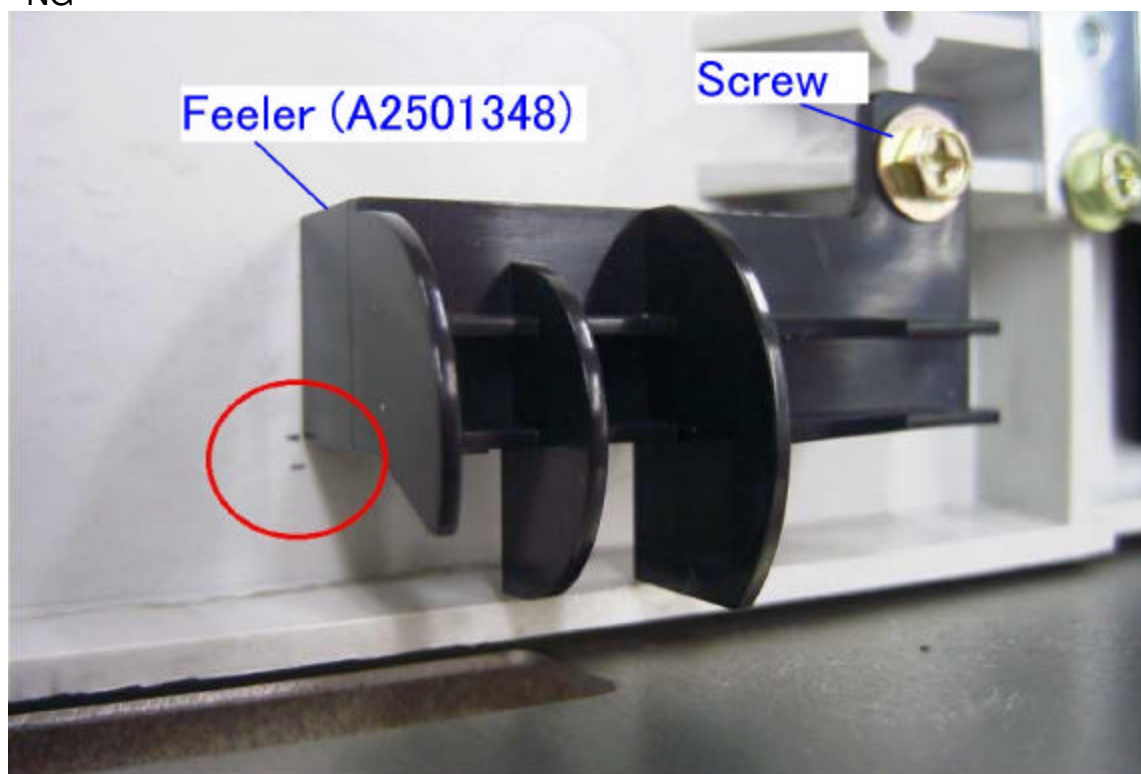
- NG -

When the customer sets an A4 SEF original, the machine incorrectly detects LG instead of A4 SEF.

1. The Platen Cover Feeler (A2501348) is held in place by a screw. However, the screw hole is a little wide and the feeler may not be fixed at the right position. When it is not fixed at the right position, the APS sensor is placed closer to the platen cover than the standard and it detects the platen cover. If the APS sensor detects the platen cover, the machine cannot make the right decision for the document size (see the attached "NG" file and service manual P. 6-11).
2. The APS sensor is closer to the rear of the machine than it was on the previous model. This places the APS sensor closer to the platen cover and causes it to detect the platen cover.

For a temporary solution, adjust the position of the feeler as shown in the attached "OK" picture. For the final solution, we will change the shape of the feeler to determine the paper size at a deeper angle.

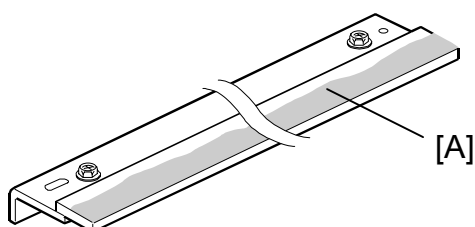
To ensure proper cleaning blade operation, apply toner to the edge of the cleaning blade after replacement. This will also prevent any possible damage to the OPC drum and blade.

1. Remove the old cleaning blade.
2. Install the new blade.
3. With your finger, remove some of the toner that is on the old blade and apply it to the edge [A] of the new blade.

**Note:** Make sure to apply the toner evenly along the full length of the new cleaning blade.

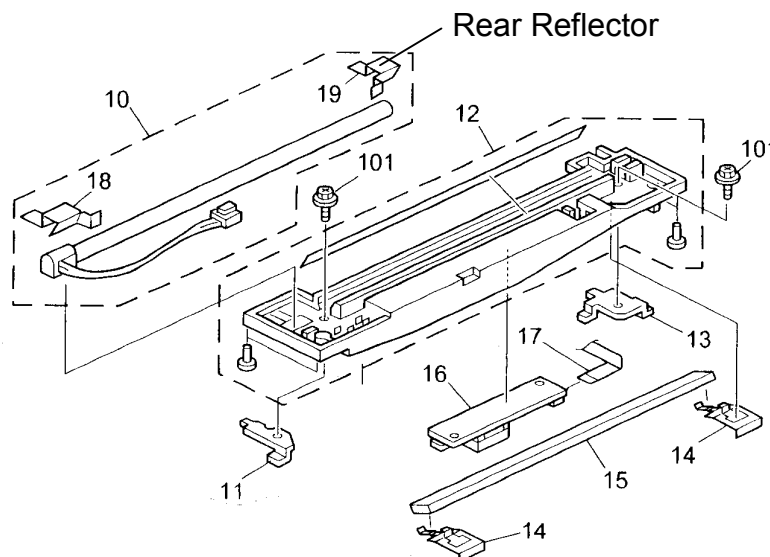
**Note:** The right side has a tendency to peel off if the reflector is not secured properly. Therefore please make sure to firmly attach it using your fingernail to iron out any potentially un-smooth areas.

1. Turn off the main power and remove the exposure glass and top rear cover.
2. Remove the misaligned reflector and replace it with a new one.

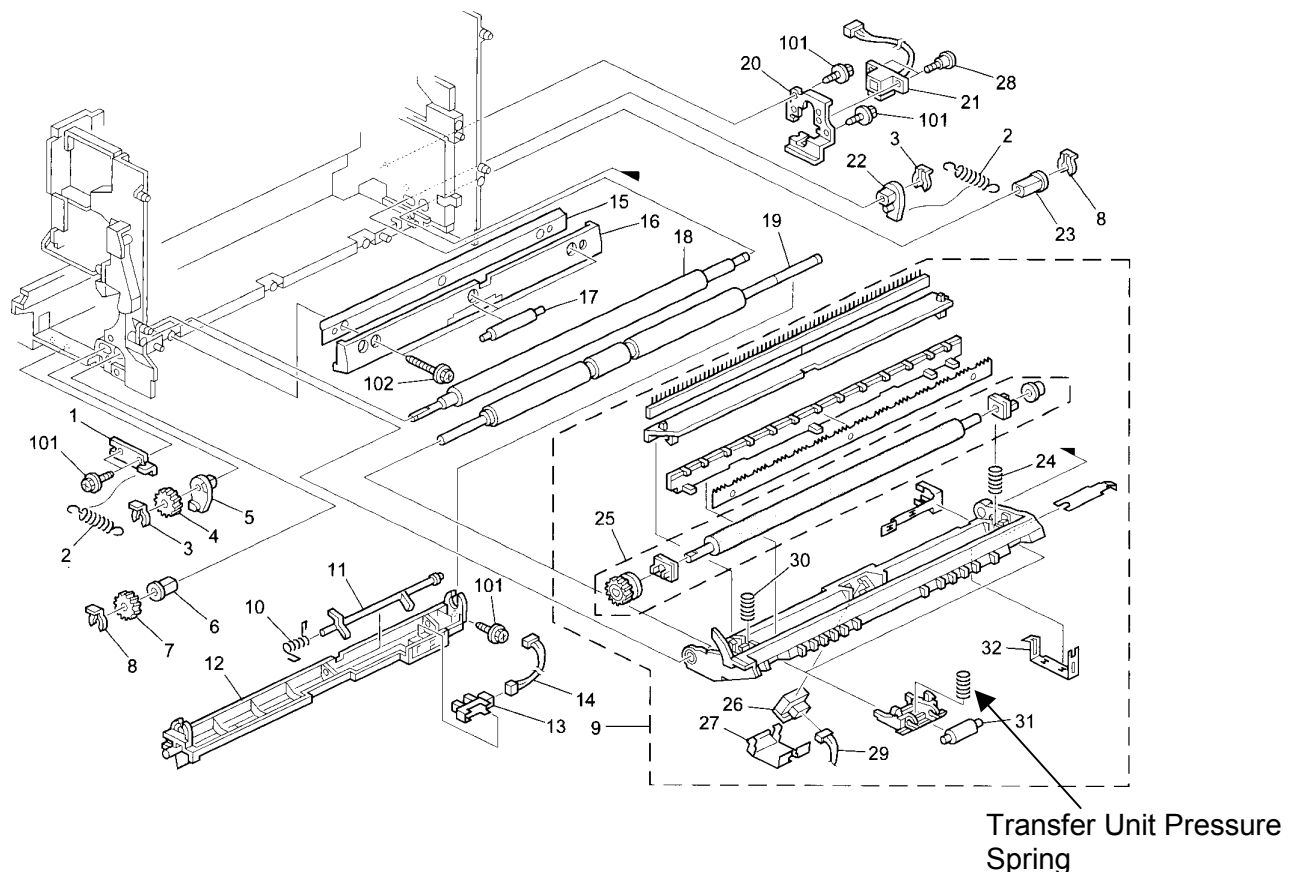
As the paper is transported from the transfer section to the fusing unit, the paper slack becomes unbalanced as the left edge twists toward the back as it passes over the roller. The left edge is then stretched inside the fusing unit ahead of the right, and the resulting stress causes low ID lines on the copy (or creases if the stress is high).

- Decrease the tension of the transfer unit pressure spring to -> 10N.

**Note:** This spring is not an existing service part; please see the illustration below.

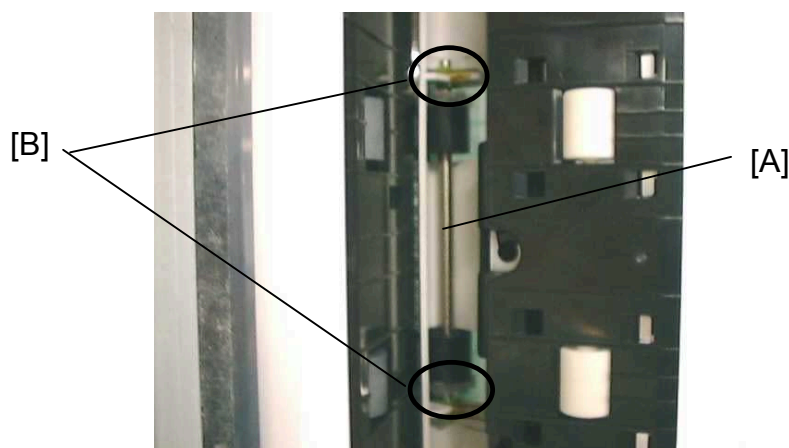
ADF (DF72) Exit Roller detaches, which may cause image skewing or jams if the ADF is used in this condition.

The Exit Roller Springs come off due to impact or excessive shock (e.g. during transport), which can sometimes cause the Bushing and Exit Roller to come off as well.

1. Feed an original to double check whether the Exit Roller has actually detached. If it has detached, the image will show skewing.
2. Turn off the main switch.
3. Open the ADF.
4. Pull open the Exit Guide. Visually confirm that the Exit Roller [A] has come off.  
If the bushing [B] has simply come out of position, push it back into place and go to Step 6. However if it has completely fallen off, continue onto Step 5.

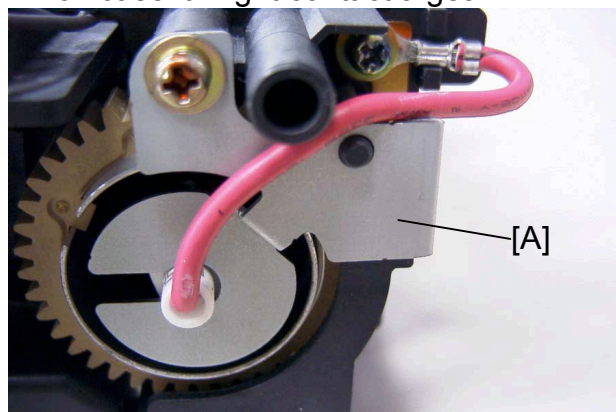
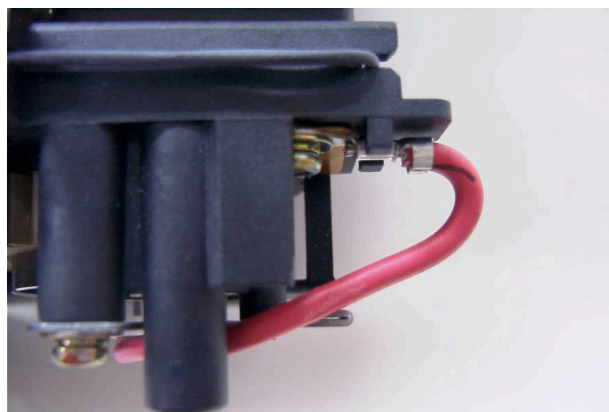
- Before modification -

If the rear holder [A] is removed, the fusing lamp harness is damaged by one of the gears in the gearbox.

The harness lies on the rear holder. It is possible for it to drop in front of the rear holder, in which case it might contact a gear.

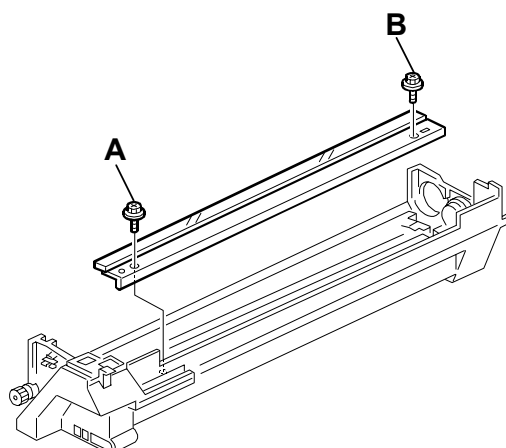
The two cleaning blade fixing screws loosen, or one of the screws (A below) comes loose and falls out.

Tighten both screws (A and B below, visible through the PCU slot before disassembly), and turn the main power Off/On to clear the SC.

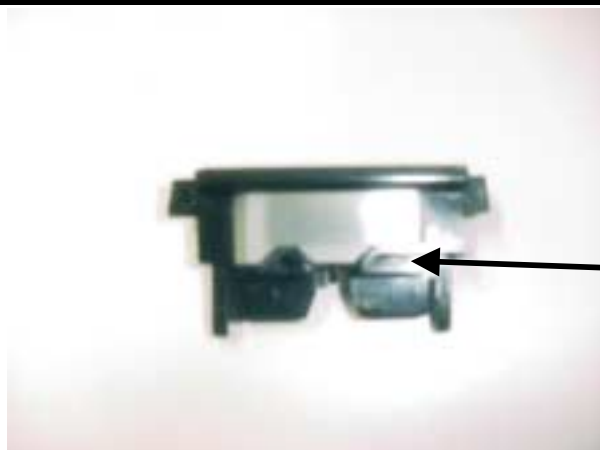
A defect in one of the molds that the manufacturer uses to produce the friction pad left a burr on the pad surface, catching the paper and preventing it from being fed.

Cav number (1 or 2) is visible here.

Cav 1: Normal

**Cav 2: May be defective**

- (1) Replace the friction pad.

**Please use sandpaper to remove the burr for urgent cases in which the replacement part cannot be procured in time.**
