Model: Russian-C2		Date: 24-Oct-01	No.: RB022001
Subject: The fax function does not work		Prepared by: S. Tomoe	
From: Technical Services Dept., GTS Division			
Classification:	<input checked="" type="checkbox"/> Troubleshooting	<input type="checkbox"/> Part information	<input type="checkbox"/> Action required
	<input type="checkbox"/> Mechanical	<input type="checkbox"/> Electrical	<input type="checkbox"/> Service manual revision
	<input type="checkbox"/> Paper path	<input type="checkbox"/> Transmit/receive	<input type="checkbox"/> Retrofit information
	<input type="checkbox"/> Other ()

Model: Russian-C2		Date: 26-Oct-01	No.: RB022002
Subject: Major differences between Russian-C1 and Russian-C2		Prepared by: S. Tomoe	
From: Technical Services Dept., GTS Division			
Classification:	<input type="checkbox"/> Troubleshooting <input type="checkbox"/> Part information <input type="checkbox"/> Action required <input type="checkbox"/> Mechanical <input type="checkbox"/> Electrical <input type="checkbox"/> Service manual revision <input type="checkbox"/> Paper path <input type="checkbox"/> Transmit/receive <input type="checkbox"/> Retrofit information <input checked="" type="checkbox"/> Ot

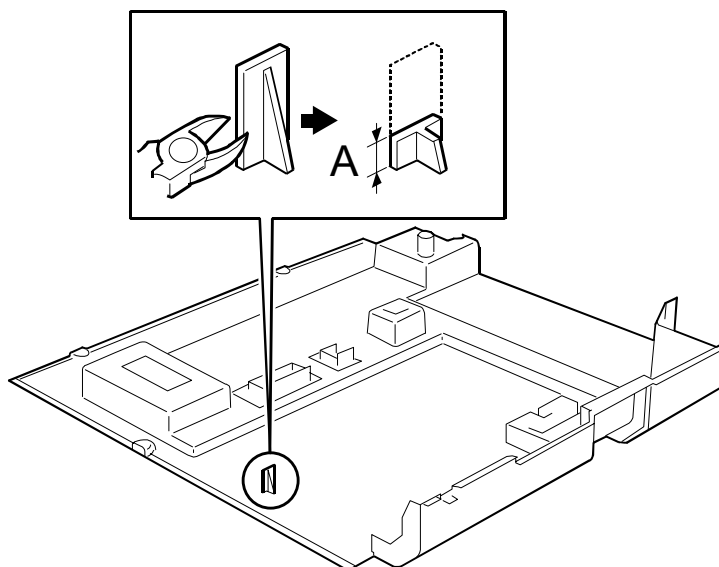
A: 0 – 3 mm

Cause

Permanent: The manufacturer will ensure that the proper molds are used for both covers.

Action in the field: When installing the optional fax unit, please cut the rib off as shown in the illustration below.

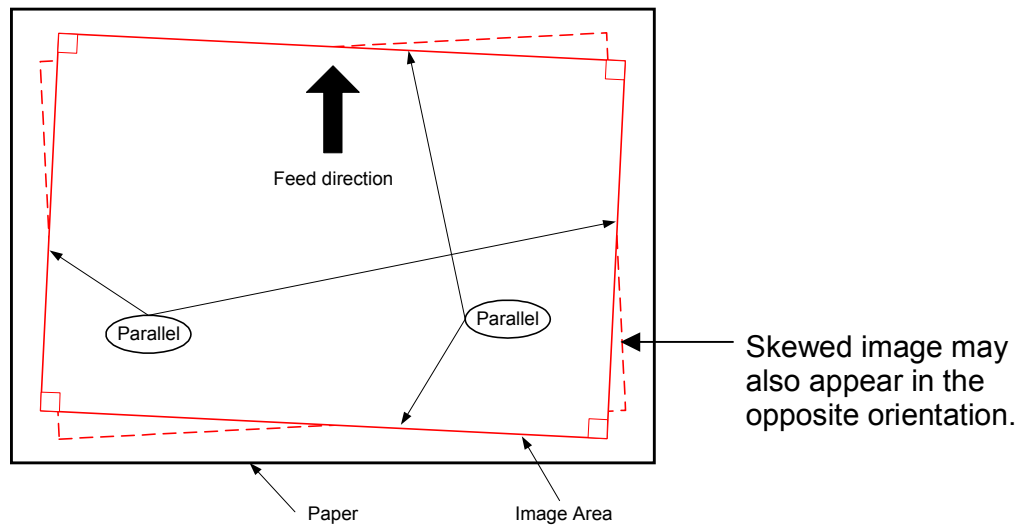
1.1 SKEWED IMAGES

- The image's leading and trailing edges are parallel to one another.
- The image's left and right edges are also parallel.
- However, **all four sides** are slanted with respect to the paper's edge.

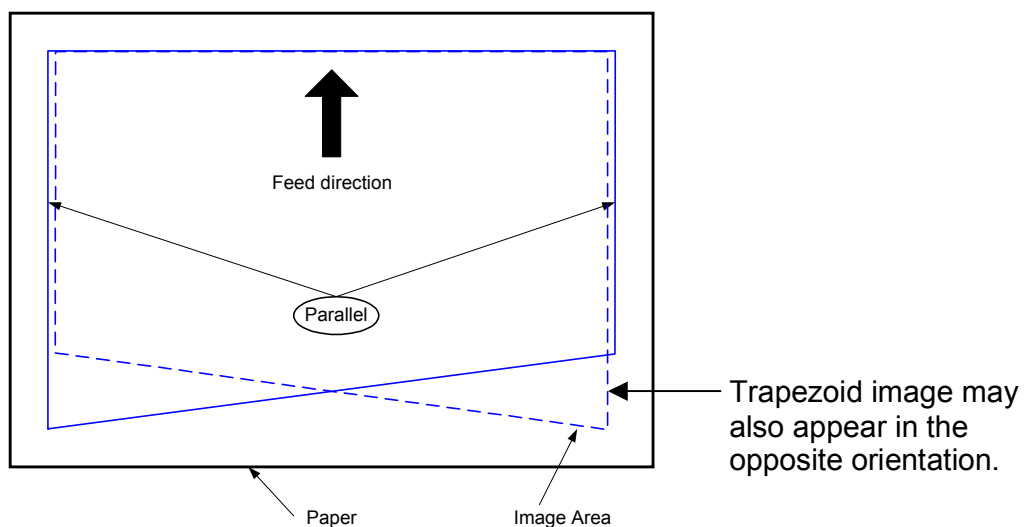
1.2 TRAPEZOID IMAGES

- Only the image's **trailing edge** is slanted with respect to the paper. The remaining 3 sides are parallel to the paper's edges.

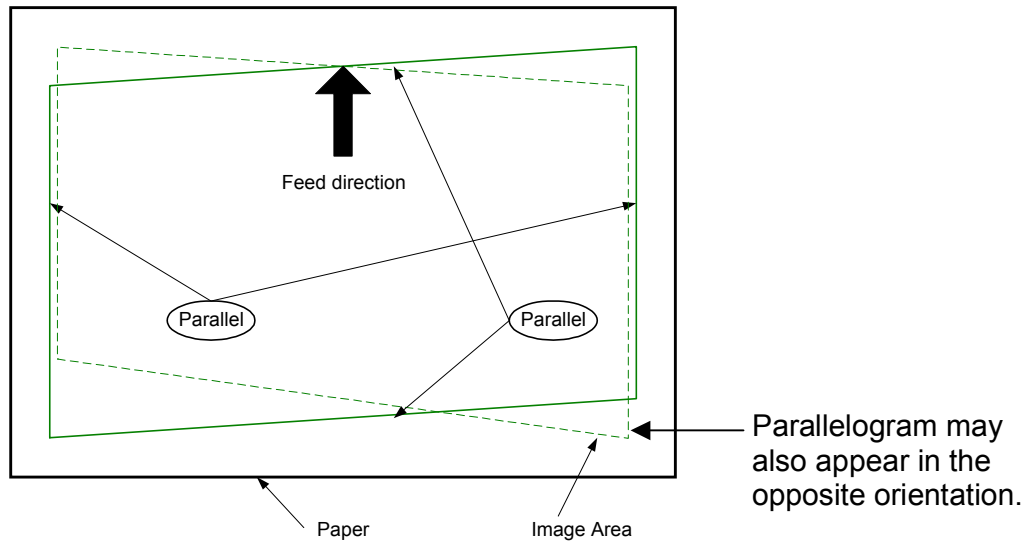
1.3 PARALLELOGRAM IMAGES

- Like skewed images, the leading/trailing edges and left/right edges are parallel to each other, however here, the **leading and trailing edges** are both slanted with respect to the paper's edge.

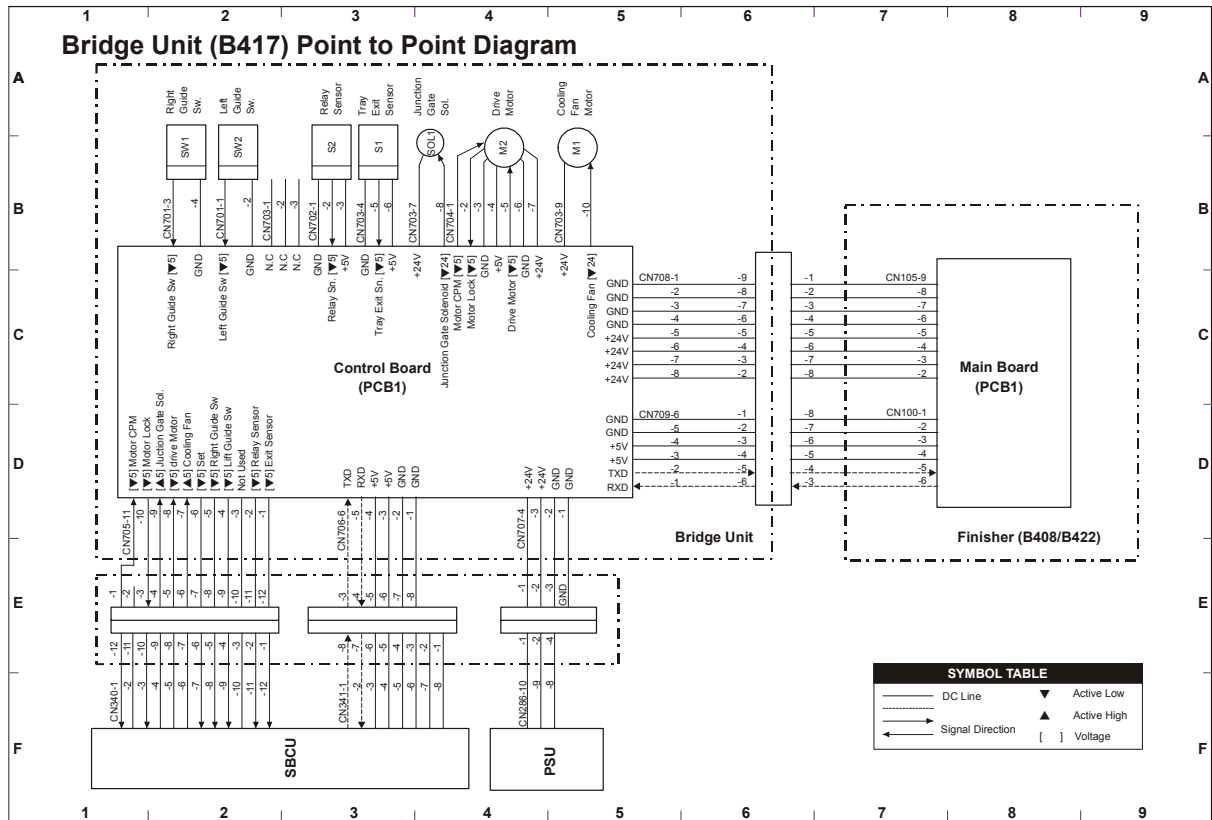
Please correct the connector numbers on the Bridge Unit point-to-point diagram, as shown on the following page.

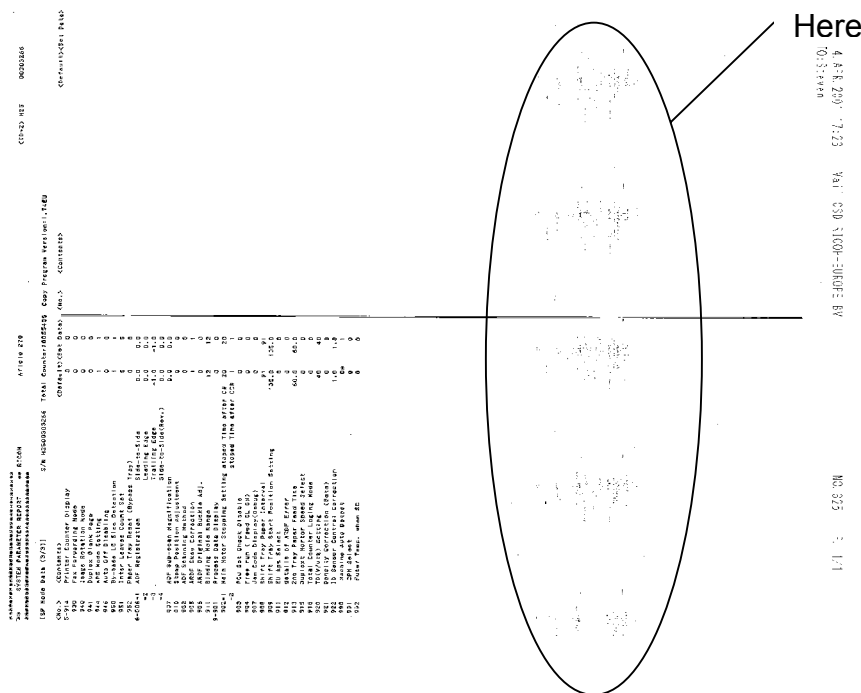
Broken black stripes appear on copies (see below).

The Russian-C1 has toner recycling mechanisms. However there are cases where broken black stripes (see below) can appear on copies when paper dust in this recycled toner builds up on the drum or charge roller surfaces. If the paper dust is on the charge roller surface, the stripe intervals will be at the pitch of the roller. The cleaning mylar, which contacts the registration roller, normally collects paper dust and prevents such copy problems. However, when there is an abnormally large amount of paper dust present, the mylar is not able to collect all of it, which can cause some to get into the PCU.
