Model: Russian-C3			Dat	ate: 28-Nov-03		No.: RB089001
Subject: Firmware Release History (SBCU)			Prepared	d by: Y. C	Ohtani	
From: 1st Tech. S	Support Sec. Service Support D	Dept.				
Classification:	☐ Troubleshooting	☐ Part info	ormat	tion	Action	required
		☐ Electric	al		☐ Service	e manual revision
	☐ Paper path ☐ Transmit/r		it/rec	eive	☐ Retrof	fit information
	⊠ Other ()

Model: Russian-C3		ate: 28-Nov-03		No.: RB089002		
Subject: Firmware Release History (NET)			Prepared b	y: Y.C	Ohtani	
From: 1st Tech. S	Support Sec. Service Support D	Dept.				
Classification:	☐ Troubleshooting	☐ Part info	ormat	tion] Action	required
	☐ Mechanical	☐ Electric	al] Servic	e manual revision
	☐ Paper path ☐ Transmit/re		it/rec	eive \square] Retrof	fit information
	⊠ Other ()

Model: Russian-C3		Dat	e: 28-Nov-0	3	No.: RB089003	
Subject: Firmwar	re Release History (LCDC)			Prepared	by: Y.O	htani
From: 1st Tech. S	Support Sec. Service Support D	Dept.				
Classification:	☐ Troubleshooting	☐ Part inf	ormat	tion	Action	required
		☐ Electric	al		Servic	e manual revision
	☐ Paper path	Transm	it/rec	eive [Retrof	fit information
	⊠ Other ()

Model: Russian-C3			Dat	e: 28-Nov-03		No.: RB089004
Subject: Firm

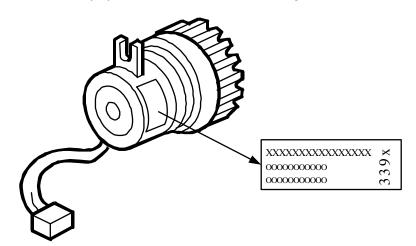
During factory tests in Japan, a non-paper feed jam was observed when feeding thick paper types on a limited number of machines (i.e. only some machines fitted with lot 339 paper feed clutches).

- Lot number labels are attached to the clutch (see illustration below).
- Lot 339 paper feed clutches are no longer in stock at SPC Japan.

If a non-feed jam is reported from the field, replace the paper feed clutch with one from <u>before or after</u> lot 339.

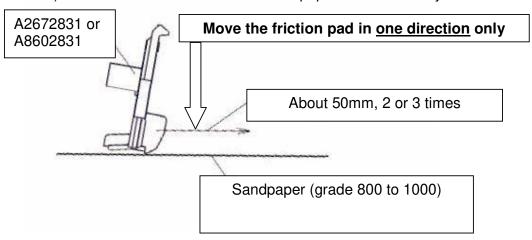
A defect in one of the molds that the manufacturer uses to produce the friction pad left a burr on the pad surface, catching the paper and preventing it from being fed.

- (2) Remove the burr with grade 800 to 1000 sandpaper
- Smoothing the friction pad surface with grade 800-1000 sandpaper:

Rub the friction pad along a 50mm length of the surface of the sandpaper as shown below, two or three times **in one direction only** (do not move the pad back and forth). This is essential to ensure that the paper is fed smoothly.

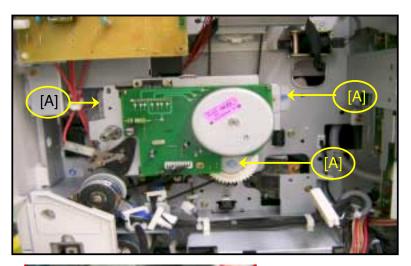
The main motor was not correctly assembled at the factory. The estimate of the failure rate in the field is less than 0.39%.

7. Check the main motor position and secure it with the 3 screws [A].

The main motor bracket must be centered in the opening in the rear side plate.

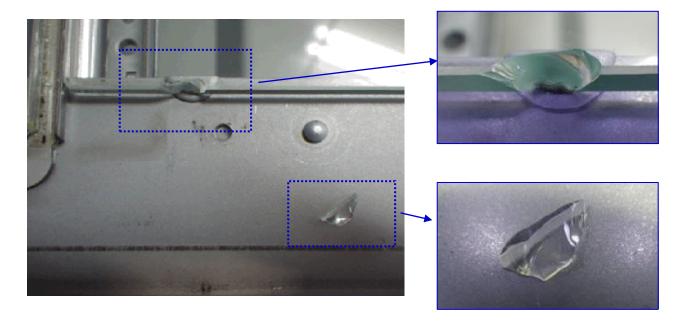
The Exposure Glass is damaged at the front side as shown below.

The shape of the metal frame (on which the exposure glass is mounted) makes the glass more prone to breakage from impact shock.
