Model: Adonis-C2		Date: 23-May-01	No.: RB003001
Subject: Software Release Information		Prepared by: K. Takagi	
From: Technical Services Dept., GTS Division			
Classification:	<input type="checkbox"/> Troubleshooting <input type="checkbox"/> Part information <input type="checkbox"/> Action required <input type="checkbox"/> Mechanical <input type="checkbox"/> Electrical <input type="checkbox"/> Service manual revision <input type="checkbox"/> Paper path <input type="checkbox"/> Transmit/receive <input type="checkbox"/> Retrofit information <input checked="" type="checkbox"/> Other ()

Model: Adonis-C2		Date: 24-Jul-01	No.: RB003009
Subject: Service Card Release History (MFP)		Prepared by: K. Takagi	
From: Technical Services Dept., GTS Division			
Classification:	<input type="checkbox"/> Troubleshooting <input type="checkbox"/> Part information <input type="checkbox"/> Action required <input type="checkbox"/> Mechanical <input type="checkbox"/> Electrical <input type="checkbox"/> Service manual revision <input type="checkbox"/> Paper path <input type="checkbox"/> Transmit/receive <input type="checkbox"/> Retrofit information <input checked="" type="checkbox"/> Other ()

Model: Adonis-

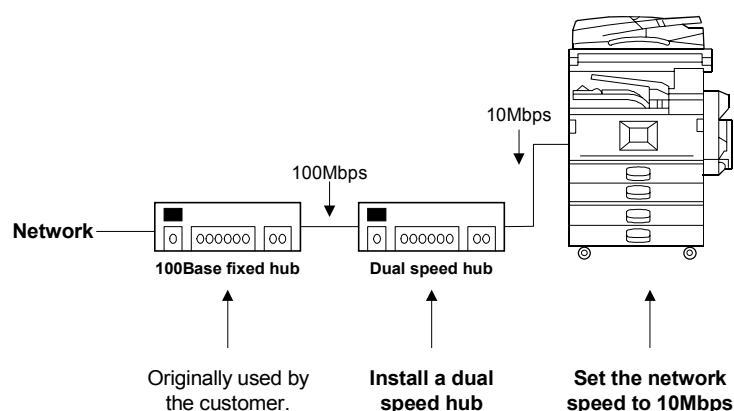
Depending on network conditions, printing from a Macintosh is very slow.

When the data is transferred at 100Mbps, depending on network conditions, the controller ASIC is not able to receive all data packets and a retry procedure occurs. As a result, print jobs from a Macintosh take a long time to print out.

- a) Set the network (ethernet) speed of the machine to 10Mbps.
The default setting of the machine is "Auto." This setting can be changed in the "Network Setup" in the user mode "Host Interface" ("Interface Settings" in the "System Settings" for the Model A-C2).
- b) Install a dual speed hub between the 100Base fixed hub and the machine.

There is almost no effect on actual print time when the machine's network speed setting is changed from 100Mbps to 10Mbps.

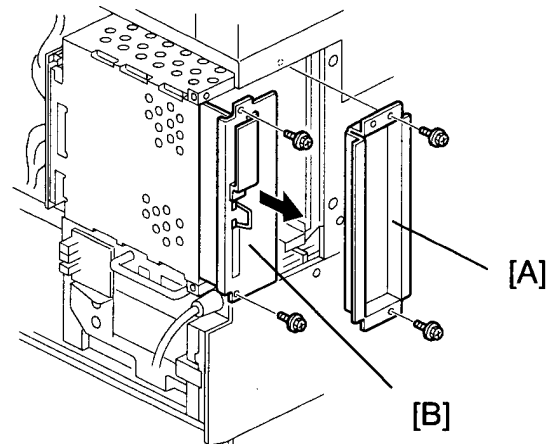
3.20 HARD DISK/CONTROLLER BOARD

A new NVRAM is mounted on all Controller Boards supplied as service parts. However, since it is possible for an error to occur if the new board is installed with the new NVRAM, please add Step 4 below (**bold/italics**), which was missing from the Service Manual.

1. Left rear corner cover (☛ 3.8.1)
2. Expansion spacer [A] (🔩 x2)
3. Controller board [B] (🔩 x2)
NOTE: Use the wire handle to slide the HDD out of the expansion box.
4. ***Remove the NVRAM from the old Controller Board and install it on the new board.***

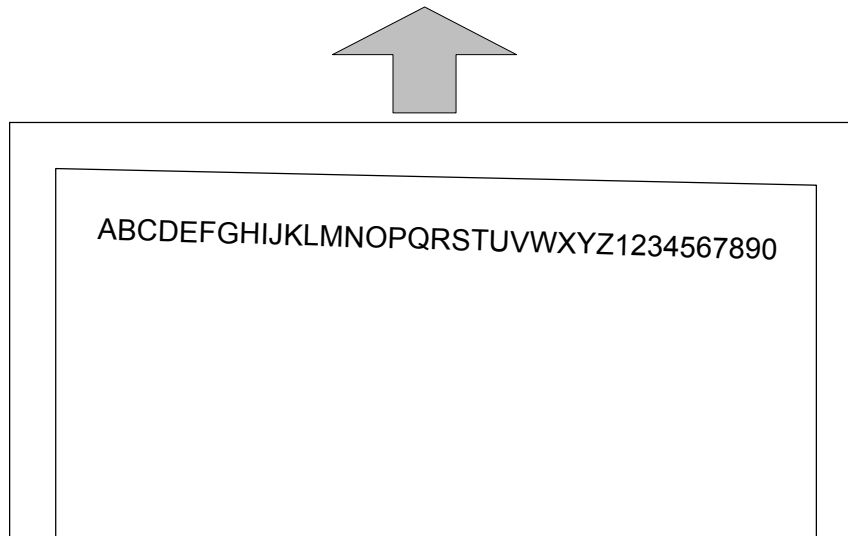
The edges of ADF or platen mode copies are in the shape of a parallelogram.

1. The ADF was not aligned properly when attached, and/or:
2. An excessive load has been placed on the Scanner Stand, causing it to bend.

When the copy image comes out as shown above, please follow the flow chart on the next page and perform the necessary adjustment.
