Model: General RTB	Date: 4-Feb-03	No.: RGene013b
--------------------	----------------	----------------

Subject: Service remarks at installation		Prepared by: T. Itoh	
From: Technical Service Sec. Service Planning Dept.			
Classification:	<input type="checkbox"/> Troubleshooting	<input type="checkbox"/> Part information	<input type="checkbox"/> Action required
	<input type="checkbox"/> Mechanical	<input type="checkbox"/> Electrical	<input type="checkbox"/> Service manual revision
	<input type="checkbox"/> Paper path	<input type="checkbox"/> Transmit/receive	<input type="checkbox"/> Retrofit information
	<input checked="" type="checkbox"/> Other (Specification change)

Model: Adonis-C3	Date: 1-Apr-03	No.: RB082005a
------------------	----------------	----------------

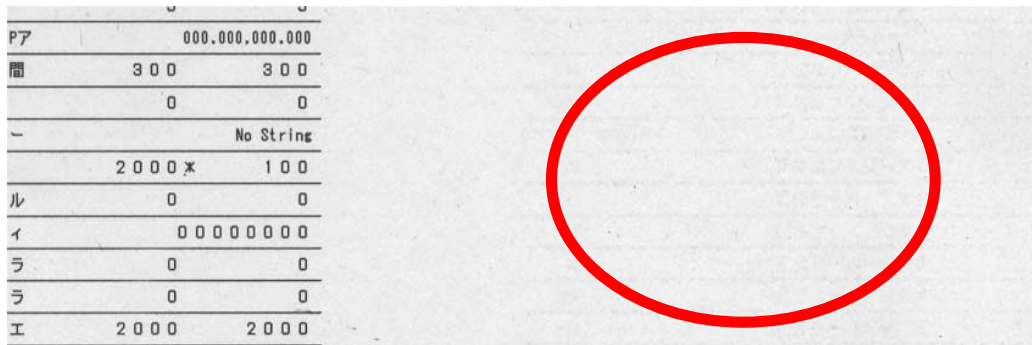
1. Offset from high toner concentration in developer

Lines on the original appear as blurred ghost images, especially along the feed direction on SMC report printouts.

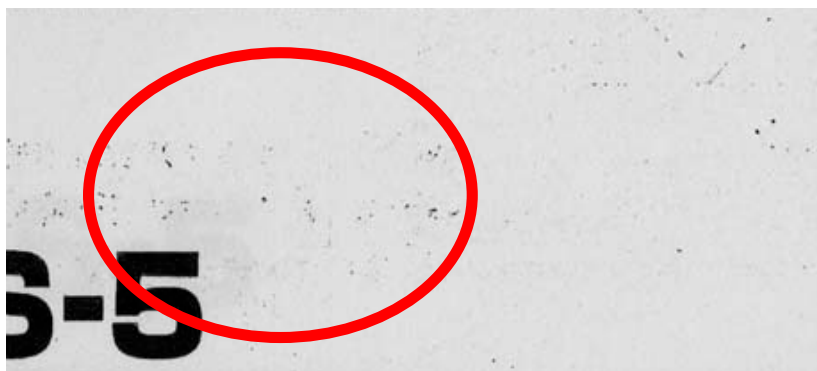
2. Cold offset

Black dots are clearly visible on the image.

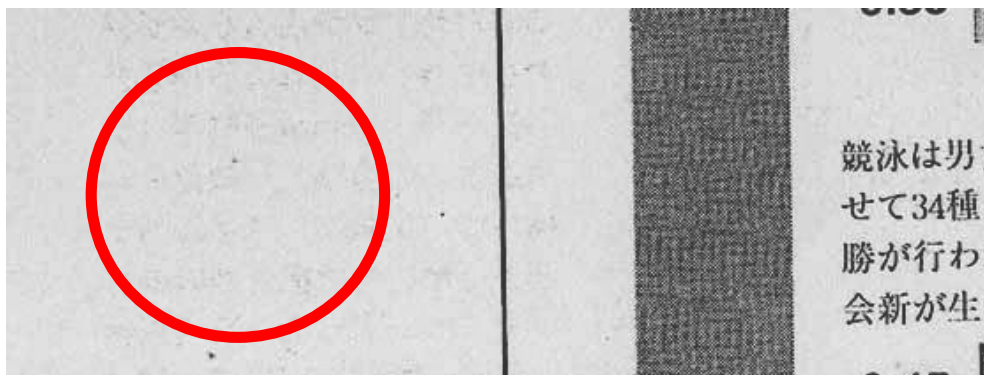
3. Low-charging offset

Most noticeable on the rear side, along the feed direction.

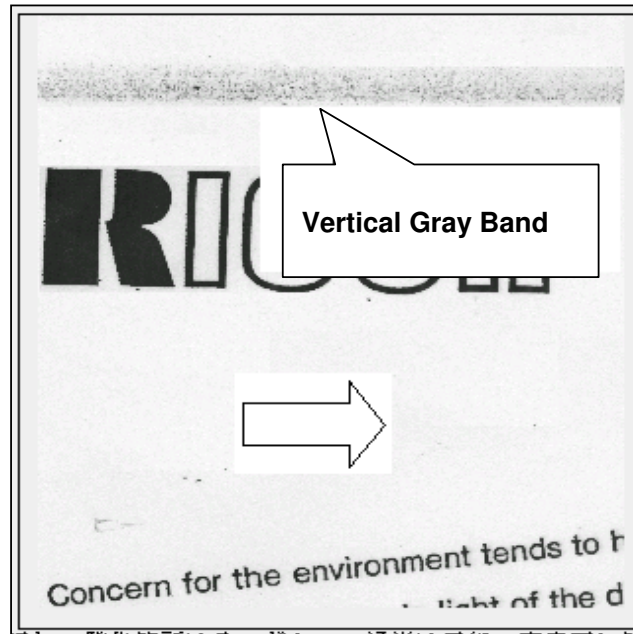
Random **gray band(s)** (both sides) or fusing wrap-around jams due to cleaning roller toner melting, mostly on the 45cpm model.

1. Replace the cleaning roller.
2. If the fusing temperature (SP1105-001, -002) had been set higher than default, return it to its default value.
 - However, if the fusing temperature is being set above default as a solution to cold offset, simply make sure this temperature does not exceed the following:

- ✧ 35cpm: Maximum increase of +10C
 - ✧ 45cpm: Maximum increase of +5C
3. Check the lot number printed on the toner bottle being used in the machine, and replace the bottle if it is older than the following.

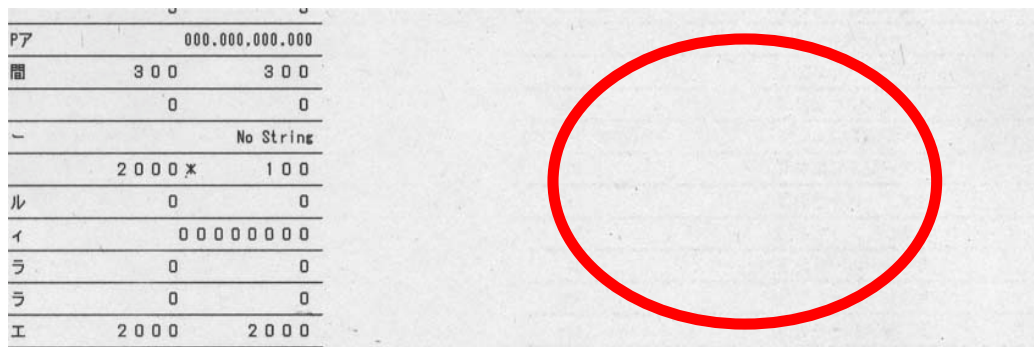
1. Offset from high toner concentration in developer

Lines on the original appear as blurred ghost images, especially along the feed direction on SMC report printouts.

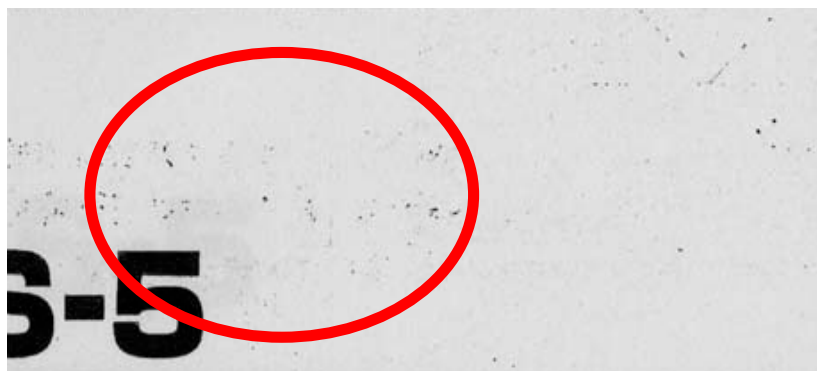
2. Cold offset

Black dots are clearly visible on the image.

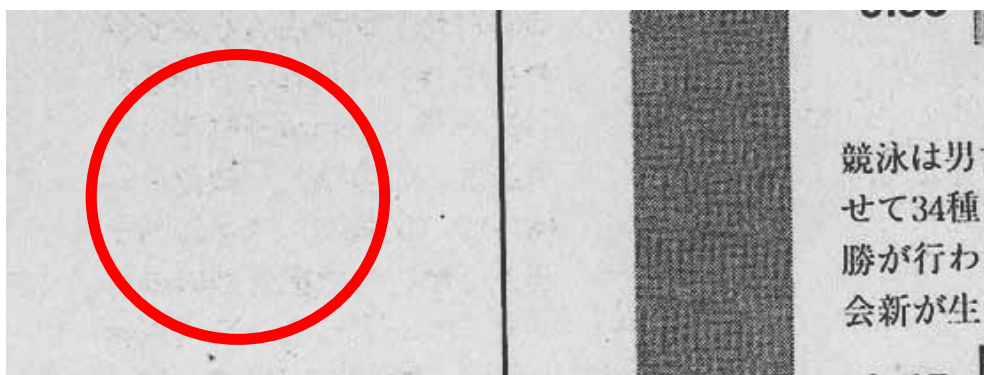
3. Low-charging offset

Most noticeable on the rear side, along the feed direction.

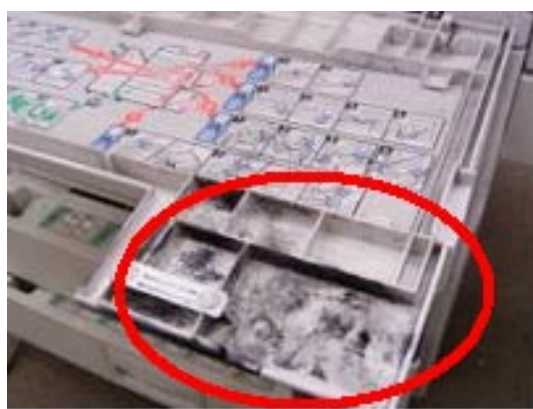
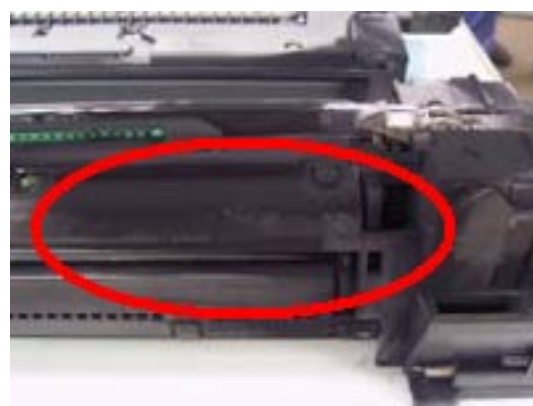
Toner scattering occurs around the PCU and on the inside/outside of the front cover.

The operator pulls down the green lever for the toner hopper unit before they push the toner hopper unit into the machine.

- 1) Re-install the toner hopper unit correctly.
- 2) Clean the inside of the machine.
- 3) Show the customer the correct way to install the toner hopper unit.

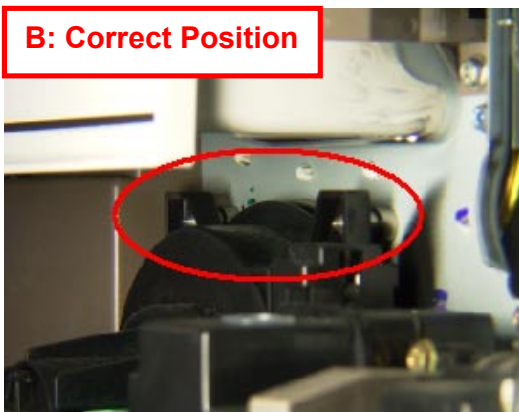
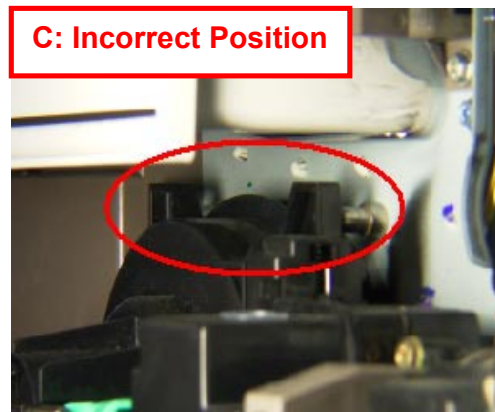
- If the operator makes this error, it looks like the toner hopper unit is set correctly (see photo A). However, the positioning pins in the machine do not go inside the holes in the toner hopper unit.
- As a result, the PCU is not aligned with the toner supply window and the new fusing cooling fan (added from A-C3) scatters the toner inside the machine.
- The correct operation is to: 1) Push the toner hopper unit all the way in, and then 2) Pull down the lever.
