Model: Adonis-C3e/f	Date: 11-Nov-03	No.: RB135001a
---------------------	-----------------	----------------

Subject: Firmware Release History (BICU)		Prepared by: Y.Urushihara	
From: 1st Tech. Support Sec. Service Support Dept.			
Classification:	<input type="checkbox"/> Troubleshooting <input type="checkbox"/> Mechanical <input type="checkbox"/> Paper path <input checked="" type="checkbox"/> Other ()	<input type="checkbox"/> Part information <input type="checkbox"/> Electrical <input type="checkbox"/> Transmit/receive	<input type="checkbox"/> Action required <input type="checkbox"/> Service manual revision <input type="checkbox"/> Retrofit information

This RTB has been issued to announce the firmware release information for the BICU.

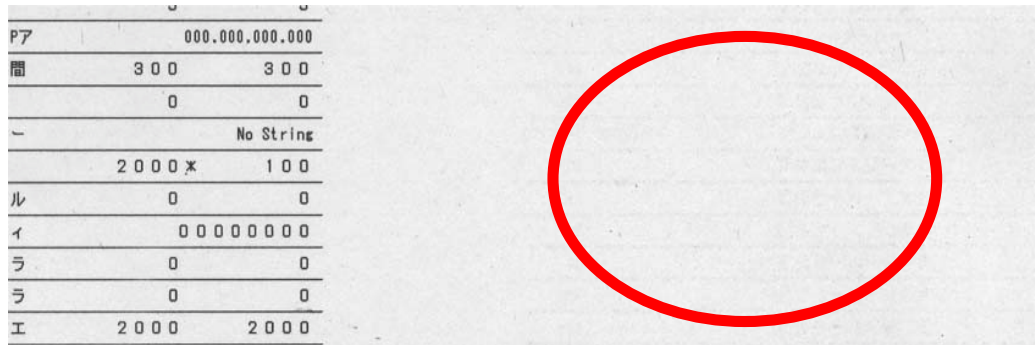
1. Offset from high toner concentration in developer

Lines on the original appear as blurred ghost images, especially along the feed direction on SMC report printouts.

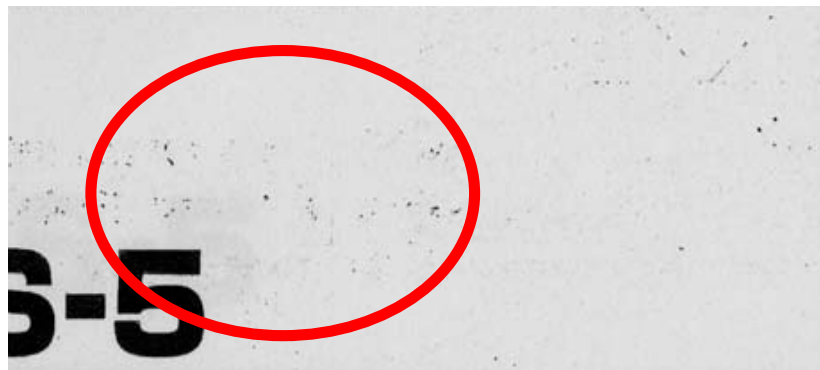
2. Cold offset

Black dots are clearly visible on the image.

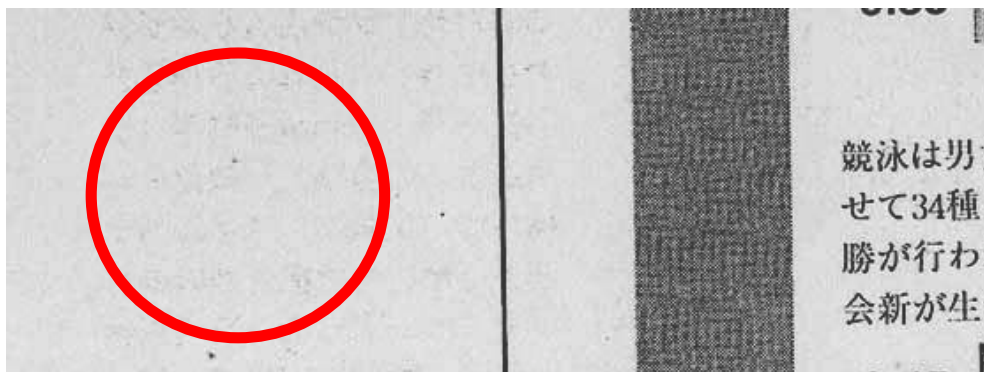
3. Low-charging offset

Most noticeable on the rear side, along the feed direction.

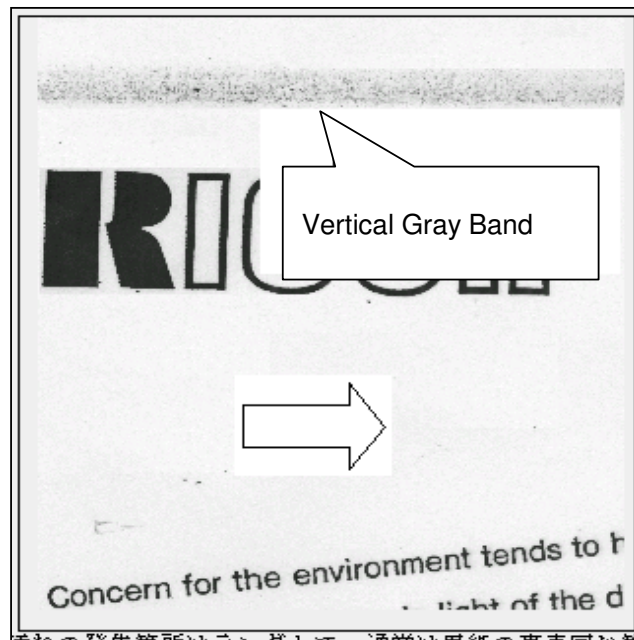
Random gray band(s) (both sides) or fusing wrap-around jams due to cleaning roller toner melting, mostly on the 45cpm model.

The surface temperature of the cleaning roller exceeds the maximum melting point of the toner collected onto the roller, allowing the re-melted toner to be transferred back to the paper via the pressure and hot rollers.

- Since the default fusing temperature is higher on the 45cpm model, the fusing unit internal temperature and therefore cleaning roller temperature is generally higher.
- The fusing temperature on both the 35/45cpm models is sometimes set higher as part of a solution for cold offset.
- The internal temperature rises when high-volume, continuous duplex jobs of 1-to-15 or more are performed on high-ACV machines.

1. Replace the cleaning roller.
2. If the fusing temperature (SP1105-001, -002) had been set higher than the default, return it to its default value.
 - However, if the fusing temperature is being set above default as a solution to cold offset, simply make sure this temperature does not exceed the following:

- ✧ 35cpm: Maximum increase of +10C
 - ✧ 45cpm: Maximum increase of +5C
3. Check the lot number printed on the toner bottle being used in the machine, and replace the bottle if it is older than the following.

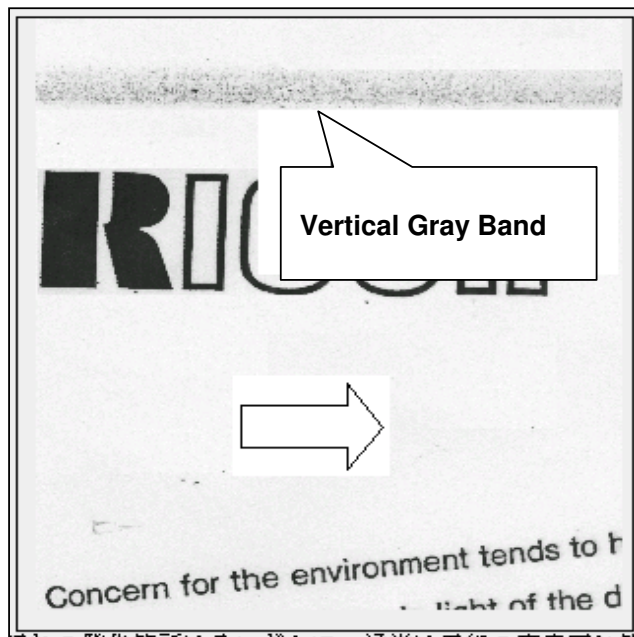
Random ***gray band(s)*** (both sides) or fusing wrap-around jams due to cleaning roller toner melting, mostly on the 45cpm model.

- Since the default fusing temperature is higher on the 45cpm model, the fusing unit internal temperature and therefore cleaning roller temperature is generally higher.
- The fusing temperature on both the 35/45cpm models is sometimes set higher as part of a solution for cold offset.
- The internal temperature rises when high-volume, continuous duplex jobs of 1-to-15 or more are performed on high-ACV machines.

2. Replace the fusing cleaning roller with AE042070

Check the lot number printed on the toner bottle being used in the machine, and replace the bottle if it is older than the following.

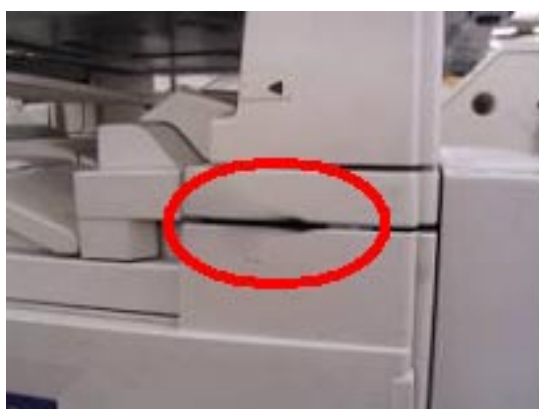
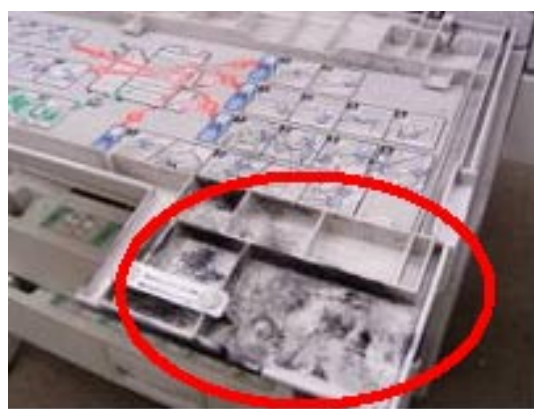
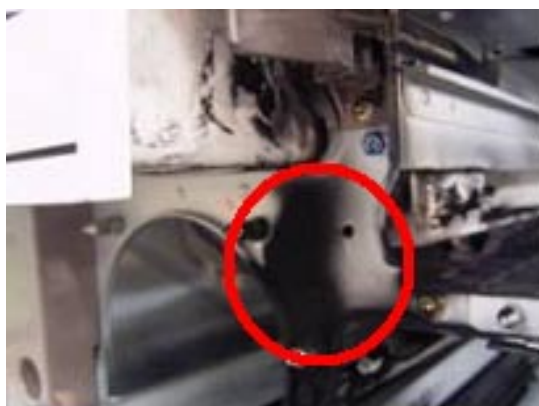
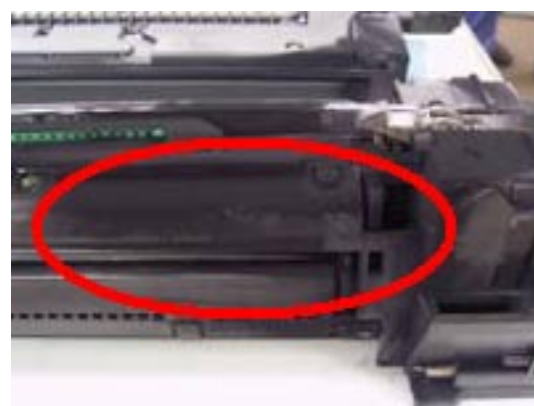
Toner scattering occurs around the PCU and on the inside/outside of the front cover.

The operator pulls down the green lever for the toner hopper unit before they push the toner hopper unit into the machine.

- 1) Re-install the toner hopper unit correctly.
- 2) Clean the inside of the machine.
- 3) Show the customer the correct way to install the toner hopper unit.

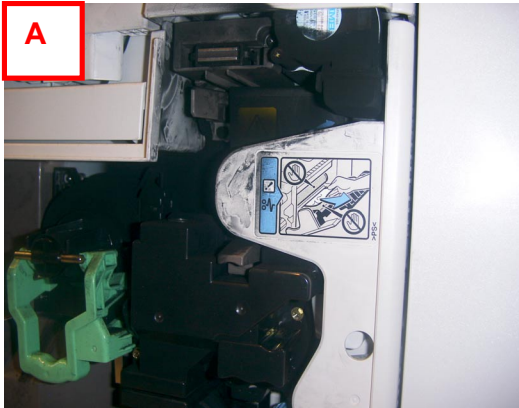
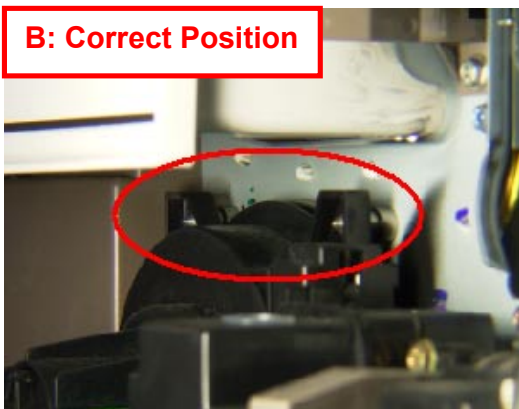
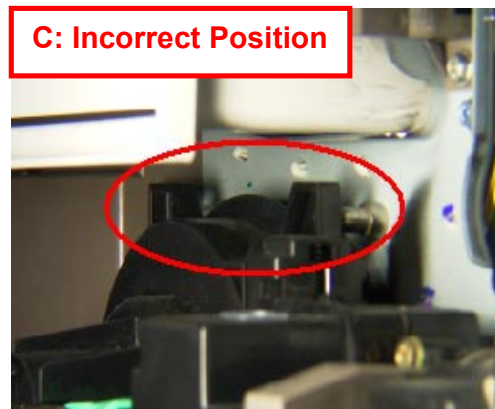
- If the operator makes this error, it looks like the toner hopper unit is set correctly (see photo A). However, the positioning pins in the machine do not go inside the holes in the toner hopper unit.
- As a result, the PCU is not aligned with the toner supply window and the new fusing cooling fan (added from A-C3) scatters the toner inside the machine.
- The correct operation is to: 1) Push the toner hopper unit all the way in, and then 2) Pull down the lever.

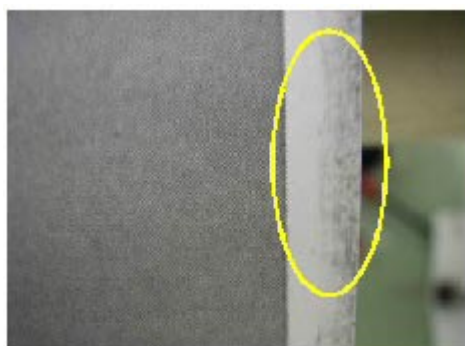
Toner dirtying appears on both sides of the printout just after a new PCU is installed.

Too much grease was applied to the drum or charge roller during factory assembly. As a result, some of the grease moved to the image area of the drum or roller and attracted toner.

3. Take 10 more all-white copies (A3/DLT).
4. If the symptom still occurs, measure the distance between each dirty image.
 - If the distance is about **180mm**: Remove the **drum** and clean the drum surface (dry cloth +alcohol).
 - If the distance is about **44mm**: Remove the **charge roller** and clean the roller surface (dry cloth +alcohol).
5. Reinstall the same part you removed in step 4 (drum or charge roller).
6. Take 5 all-white copies (A3/DLT).
7. If the symptom still occurs:
 - If the distance is about **180mm**: Replace the **drum**.
 - If the distance is about **44mm**: Replace the **charge roller**.

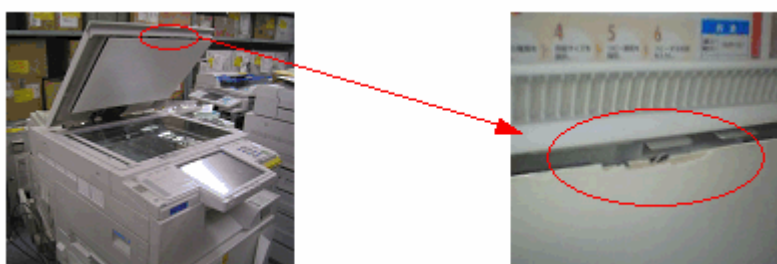
A small area on the lower front edge of the platen cover sheet is damaged. This may have a potential safety risk, depending on the amount of damage.

The platen cover is opened/closed repeatedly over a long period of time, and each time, the operator touches the platen cover sheet. As a result, this area of the platen cover sheet is gradually worn down.

Check the condition of the platen cover sheet at the next service visit.

- Remove the platen cover sheet and reattach it in the reverse orientation (turn it 180 degrees so that the damaged edge is at the rear side).
- Cover the damaged area of the platen cover sheet with transparent tape.

- Replace the platen cover sheet with the modified part:
