| Model: Martini-P2 | Date: 10-Aug-06 | No.: RG148001b |

| Subject: Firmware Release History (Engine) | | Prepared by: S. Watanabe | |

| Subject: Thread-cutting error on the LCT Connection Unit | | Prepared by: S. Watanabe | |

| Model: General | | Date: 12-Mar-08 | No.: RGene027 |

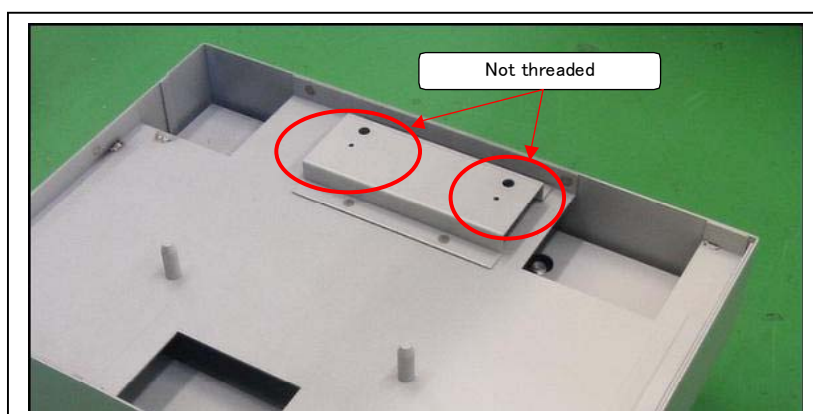
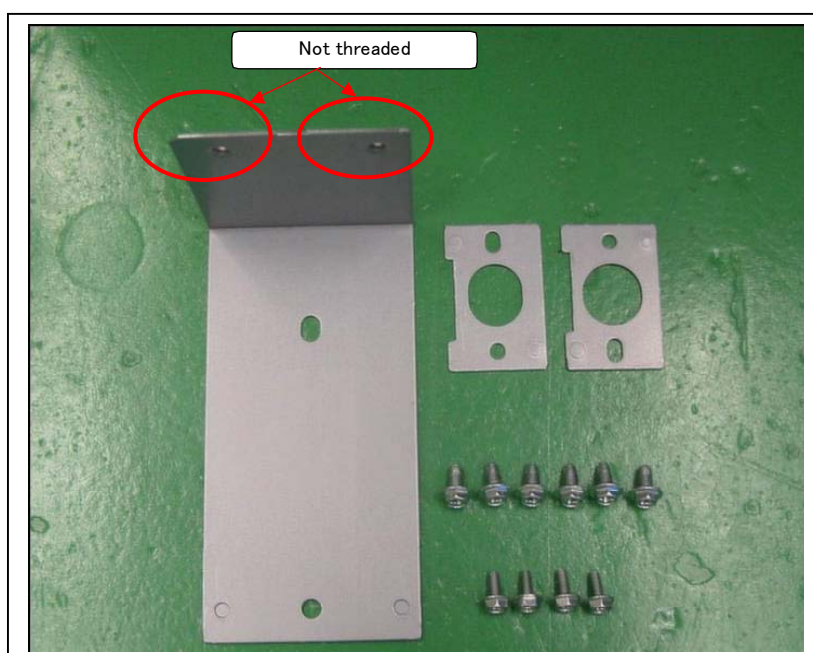
The LCT Connection Unit Type A (G845) cannot be connected to the LCT RT43 (B473).

**Note:** This only occurs with units from July and August production.

The holes shown in the photograph below were not threaded at the factory.

Use tapping screws for the holes that are not threaded (P/N 04514008N or similar M4 tapping screw).

The holes are threaded from lot number 200609.

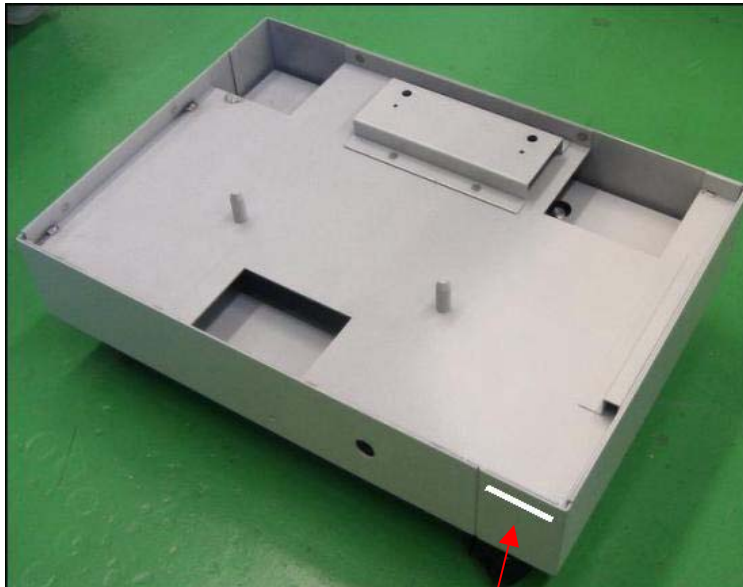
Lot Number

**Note:** You can check this lot number in the location shown in the photo.
