Model: Martini-C1		Date: 13-Sep-02	No.: RB064001
Subject: ROM History (Martini-C1 LCDC/Language)		Prepared by: K. Miura	
From: Technical Services sec. Service Planning Dept.			
Classification:	<input type="checkbox"/> Troubleshooting <input type="checkbox"/> Part information <input type="checkbox"/> Action required <input type="checkbox"/> Mechanical <input type="checkbox"/> Electrical <input type="checkbox"/> Service manual revision <input type="checkbox"/> Paper path <input type="checkbox"/> Transmit/receive <input checked="" type="checkbox"/> Retrofit information <input type="checkbox"/> Other ()

Model: Martini-C1		Date: 13-Sep-02	No.: RB064002
Subject: Service Manual Revision		Prepared by: K.Miura	
From: Technical Services sec. Service Planning Dept.			
Classification:	<input type="checkbox"/> Troubleshooting <input type="checkbox"/> Part information <input type="checkbox"/> Action required <input type="checkbox"/> Mechanical <input type="checkbox"/> Electrical <input checked="" type="checkbox"/> Service manual revision <input type="checkbox"/> Paper path <input type="checkbox"/> Transmit/receive <input type="checkbox"/> Retrofit information <input type="checkbox"/> Other ()

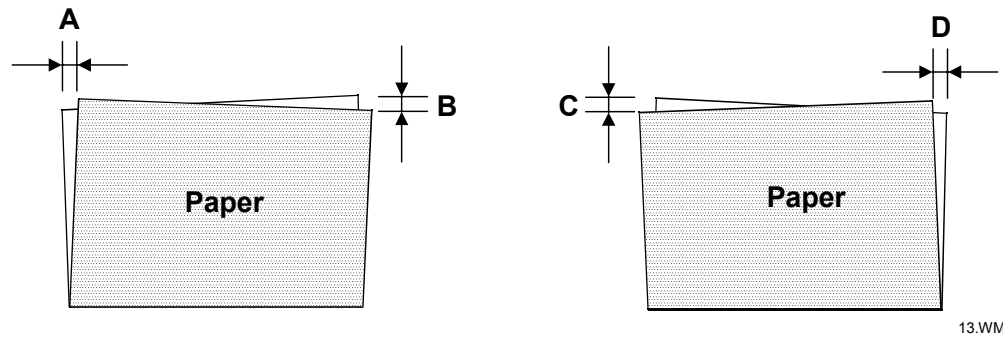
11. Check the copies for booklet folding skew, i.e. all distances shown below (A, B, C, D) should be 2mm or less.

12. If A/B or C/D are over 2 mm, adjust the folding position using SP6120 until the two edges intersect in the middle (point X).

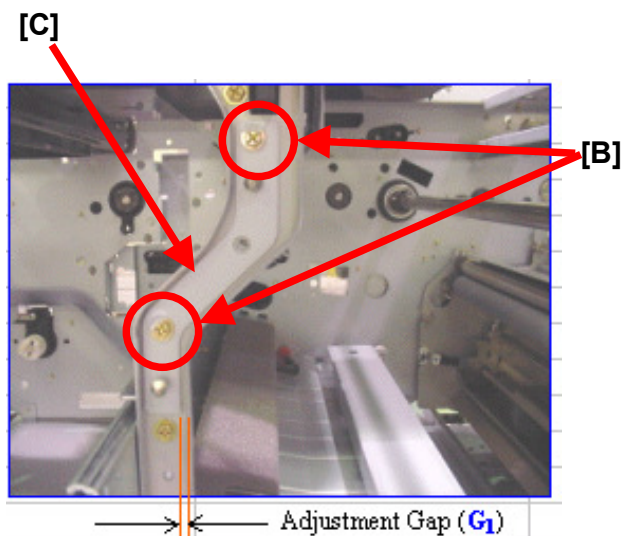
Due to a damaged special tool used on the production line, a 2.3mm gap developed between the positioning plate securing the transfer belt unit and the right edge of the machine frame (gap G₁ on next page, which should normally be about 1.5mm).

2. Remove the PCU Inner Cover (P/N B0651313), then remove the Transfer Unit Guide Plate [A].
3. Loosen the 2 paint-locked screws [B].
4. Insert a 1.5mm feeler gauge into the gap between the positioning plate [C] and the right edge of the machine frame (gap G_1 in photo below), then tighten the two positioning plate screws.

NOTE: Adjust the gap in increments of about 0.2mm. Then, repeat Steps 2 thru 6 until the transfer belt does not contact either edge through 100 sheets of duplex copies.

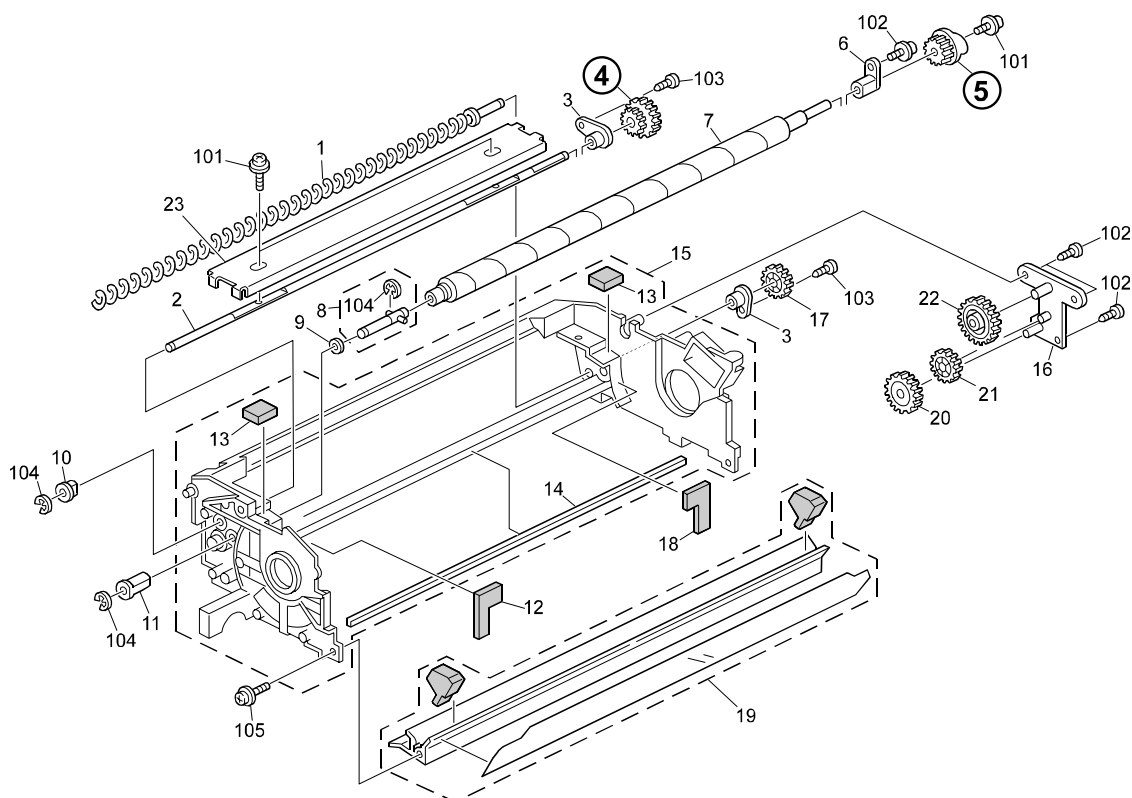
Noise from the PCU brush roller gear (PCU3 section 37, pg. 87, index #4, 5; P/N #B0652425, B0652428). In some cases the brush roller gear may break and black lines may appear, because the brush roller does not rotate.

The PCU brush wears down or becomes dirty, decreasing the friction between it and the inner wall of the PCU. This friction normally stops the cam, but as it decreases, the cam is rotated too far and contacts the stopper screw repeatedly. The gear can be damaged by this alone, or when the cam overrides the screw and cannot be turned back, applying an excessive load on the gear.

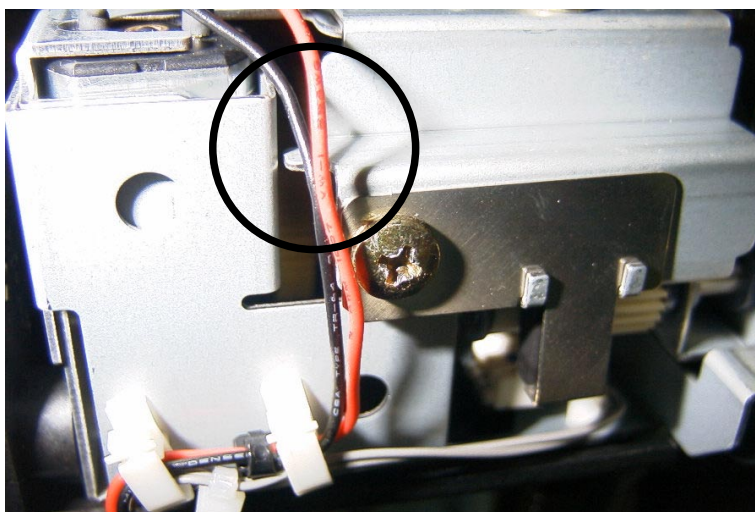
The harness is led as shown below during factory assembly.

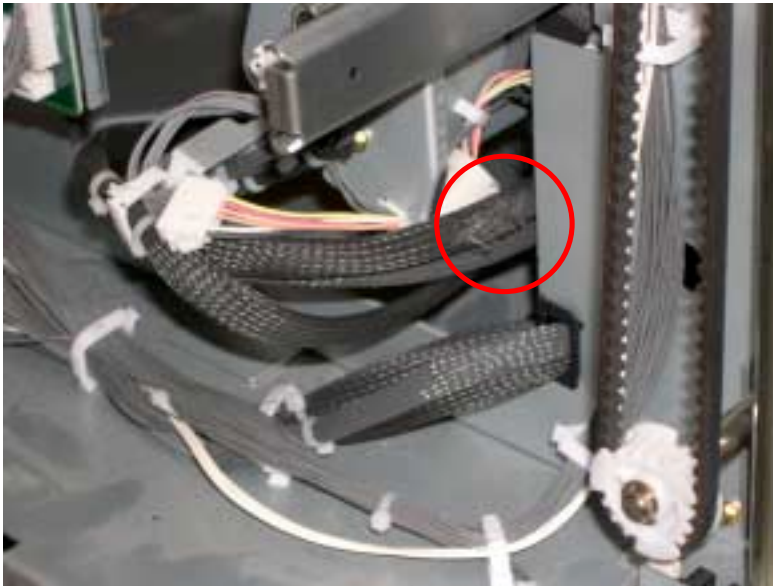
The outside of the stapler harness is damaged in the area shown in the photo. In some cases, a short circuit occurs in the damaged area.
