Model: Martini-C2	Date: 14-Oct-04	No.: RB140001d
-------------------	-----------------	----------------

Subject: Firmware Release History (BCU - Engine)		Prepared by: S. Watanabe	
From: 2nd Tech Support Sec. Service Support Dept.			
Classification:	<input type="checkbox"/> Troubleshooting	<input type="checkbox"/> Part information	<input type="checkbox"/> Action required
	<input type="checkbox"/> Mechanical	<input type="checkbox"/> Electrical	<input type="checkbox"/> Service manual revision
	<input type="checkbox"/> Paper path	<input type="checkbox"/> Transmit/receive	<input type="checkbox"/> Retrofit information
	<input checked="" type="checkbox"/> Other (      )

This RTB has been issued to announce the firmware release information for the Engine.

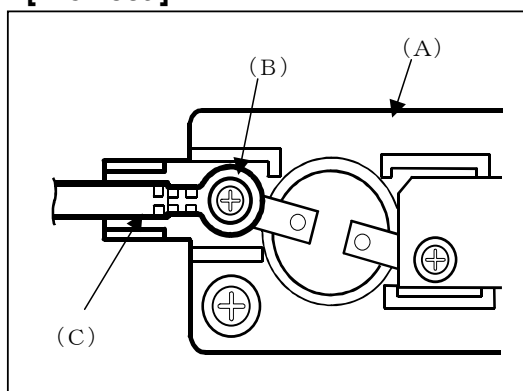
[ Correct ]

- Put the end of the thermostat harness that has the round lead [B] **in between the two bracket ribs [C]**.
- Tighten the screw for the round lead [B] **as tight as you can**.  
Do not damage the screw or screw hole.

Do the following when you replace the thermostat (**P/N#AW110040: Thermostat-192C**) on the MT-C2.

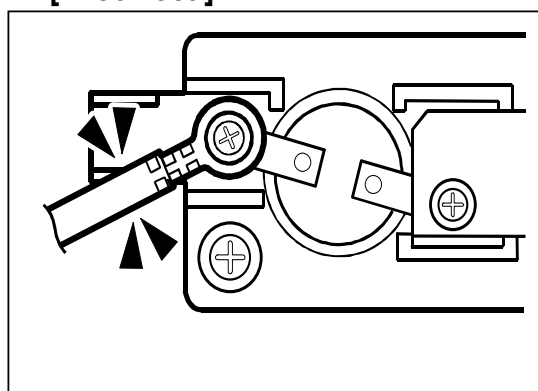
[ Incorrect ]

**NOTE:** If you do not put the harness in between the bracket ribs (see "Incorrect"), a thermostat disconnection or SC542/545 error may occur.

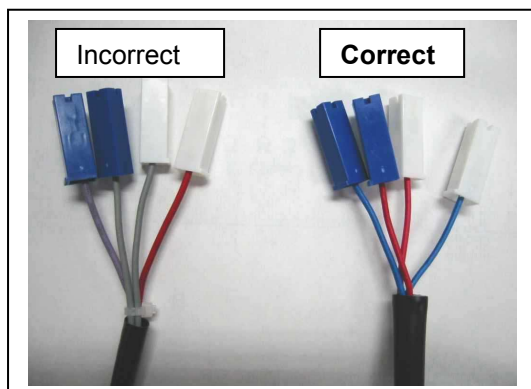
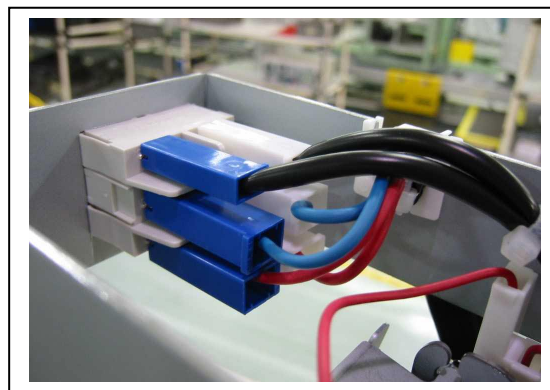
- Harness: P/N B1405615, "Harness: AC Power: Main: NA", index 22, pg.139 on the Parts Catalog
- This only occurs on the machines listed below.

Error by the vendor during the harness assembly process

When you replace the PSU on the machines listed below, attach the connectors according to the color of the **connectors**. Ignore the color of the harness cables.

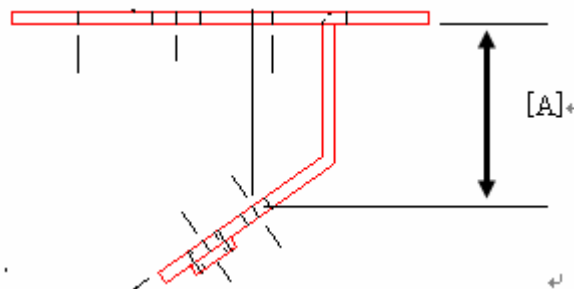
*The distance [A] is different between the new and old brackets .*

**B1404196/7: 14.8mm**

**D0624196/7: 15.3mm**

1. Clean the middle and rear thermistors.
2. If the SC still occurs even after cleaning the thermistors, replace the thermistor brackets with the new parts in the table below.

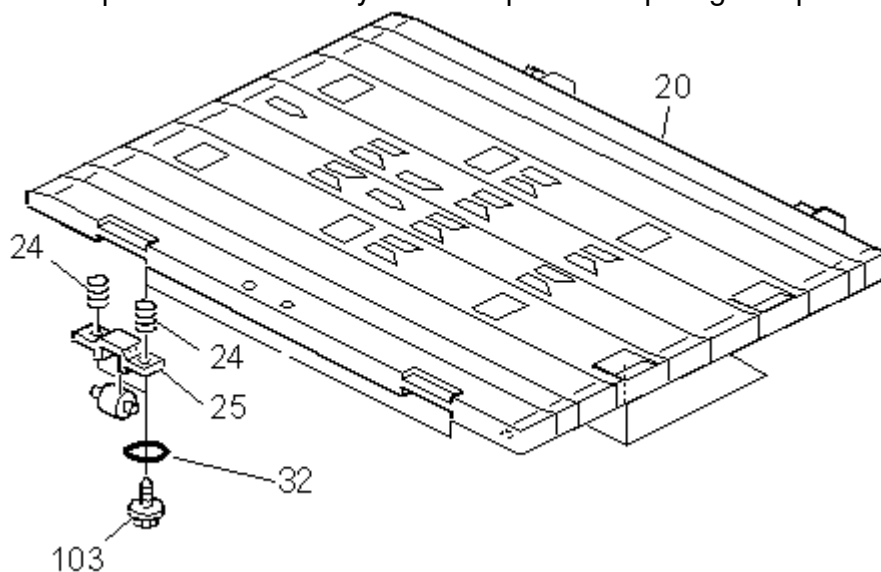
1. The thickness of the duplex transport guide plate was increased.
2. The diameter of the spring was increased.
3. A spacer was added.

**Reason:** To further improve the durability of the duplex transport guide plate.

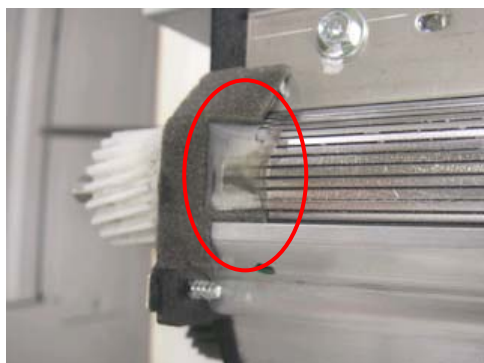
**CORRECT:**

5. Make sure that the sponge and both entrance Mylars are attached correctly.
