Model: Martini-C3.5	Date: 07-Feb-08	No.: RD052001a
----------------------------	-----------------	----------------

Subject: Firmware Release Note: Engine		Prepared by: S.Watanabe	
From: 2nd Tech. Support Sec. Service Support Dept.			
Classification:	<input type="checkbox"/> Troubleshooting	<input type="checkbox"/> Part information	<input type="checkbox"/> Action required
	<input type="checkbox"/> Mechanical	<input type="checkbox"/> Electrical	<input type="checkbox"/> Service manual revision
	<input type="checkbox"/> Paper path	<input type="checkbox"/> Transmit/receive	<input type="checkbox"/> Retrofit information
	<input checked="" type="checkbox"/> Other ()

Model: General		Date: 12-Mar-08	No.: RGene027
Subject: New Wireless LAN Option		Prepared by: H.K.	
From: 1st Tech. Support Sec. Service Support Dept.			
Classification:	<input type="checkbox"/> Troubleshooting <input type="checkbox"/> Mechanical <input type="checkbox"/> Paper path <input type="checkbox"/> Product Safety	<input type="checkbox"/> Part information <input type="checkbox"/> Electrical <input type="checkbox"/> Transmit/receive <input type="checkbox"/> Other ()	<input checked="" type="checkbox"/> Action required <in

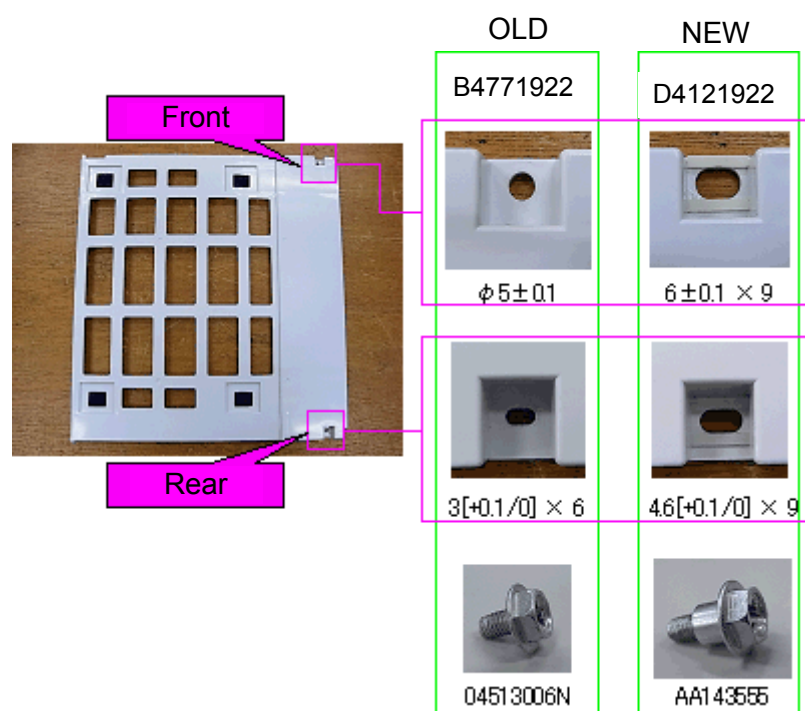
Change: The shape of the screw holes in the lower cover was changed.

Reason: To further minimize curving in the cover.

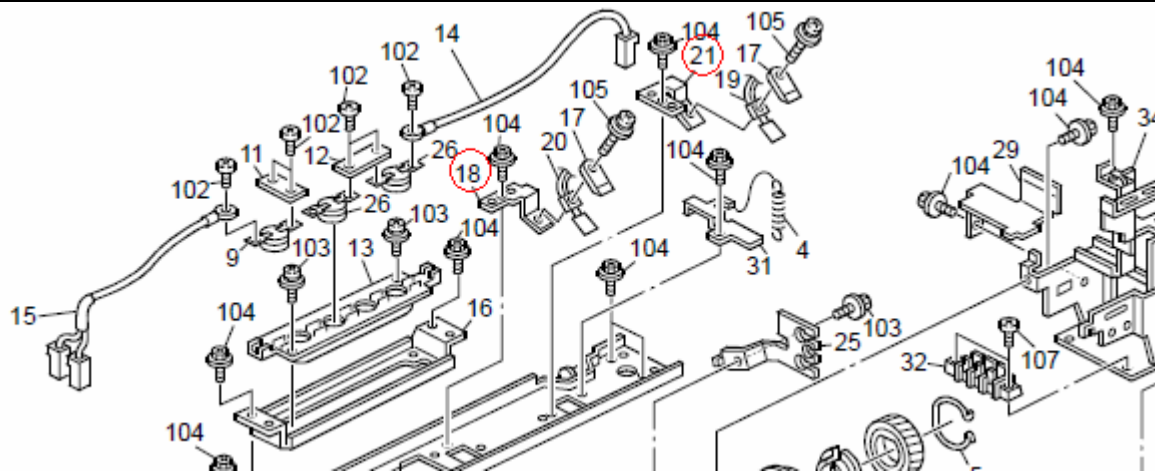
The distance [A] is different between the new and old brackets .

B1404196/7: 14.8mm

D0624196/7: 15.3mm

1. Clean the middle and rear thermistors.
2. If the SC still occurs even after cleaning the thermistors, replace the thermistor brackets with the new parts in the table below.

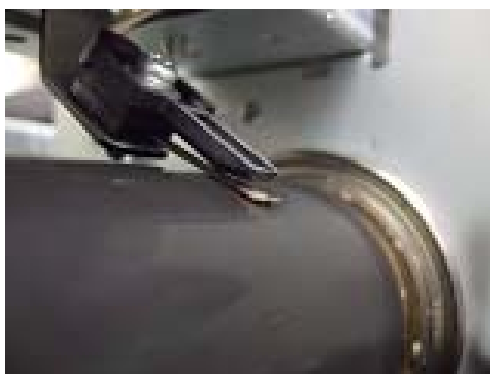
Correct position of the thermistor

3. Replace the middle and rear thermistors.

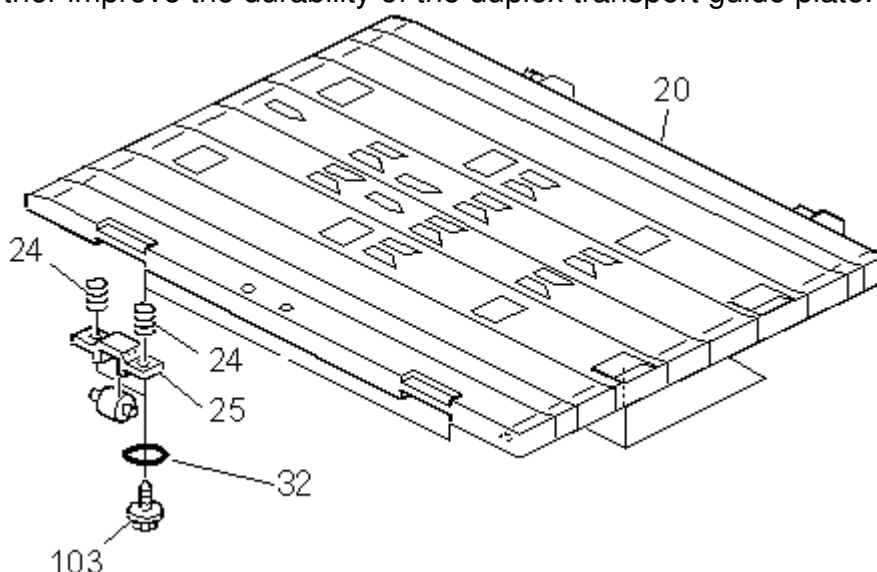
1. The thickness of the duplex transport guide plate was increased.
2. The diameter of the spring was increased.
3. A spacer was added.

Reason: To further improve the durability of the duplex transport guide plate.

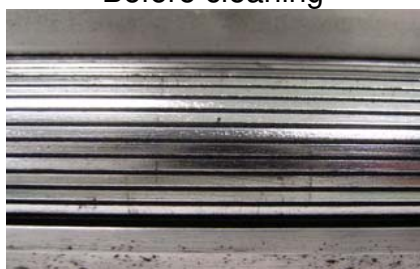
Before cleaning

4. Wipe the toner off the sleeve.

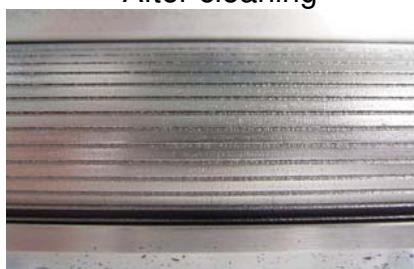
After cleaning

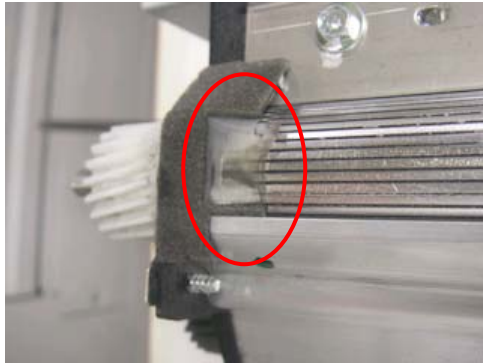
CORRECT:

5. Make sure that the sponge and both entrance Mylars are attached correctly.

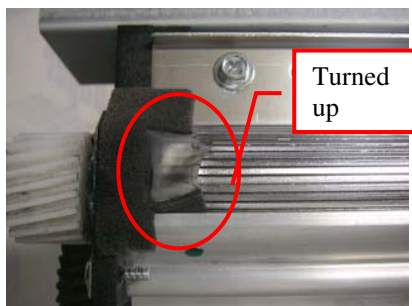
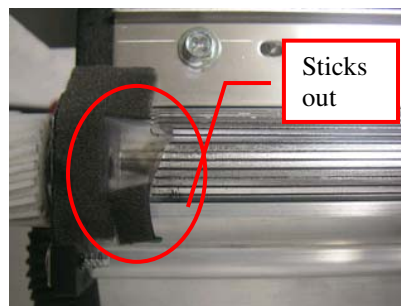
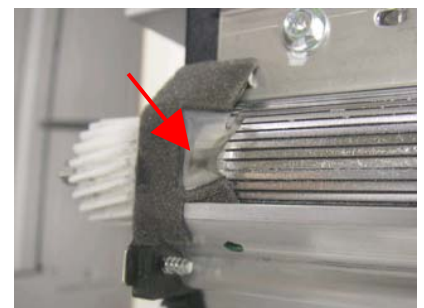
**Incorrect:**

6. Reattach the Mylar and install new developer.

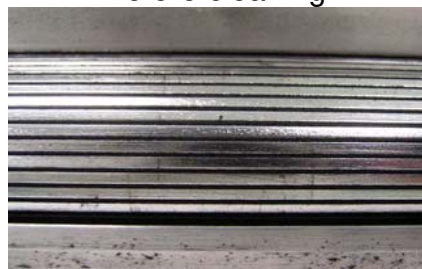
Before cleaning

4. Wipe the toner off the sleeve.

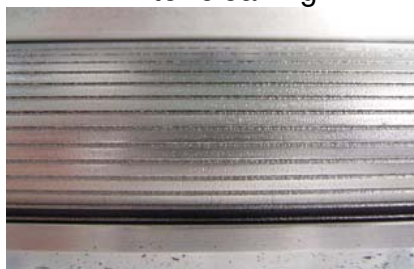
After cleaning

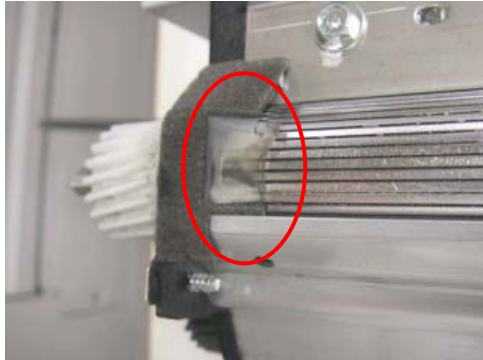
CORRECT:

5. Make sure that the sponge and both entrance Mylars are attached correctly.

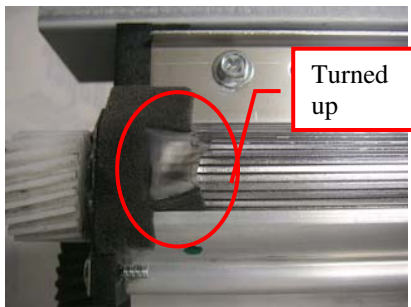
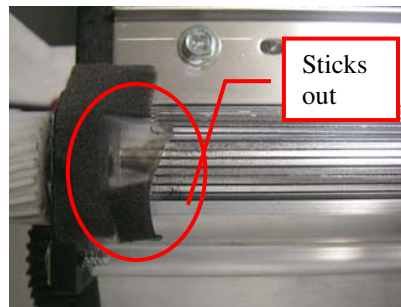
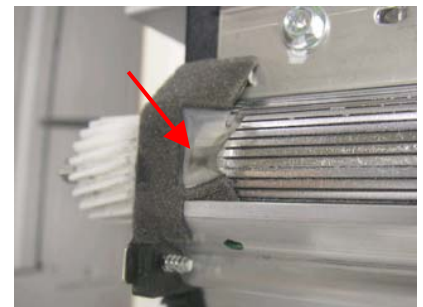
**Incorrect:**

6. Reattach the Mylar and install new developer.

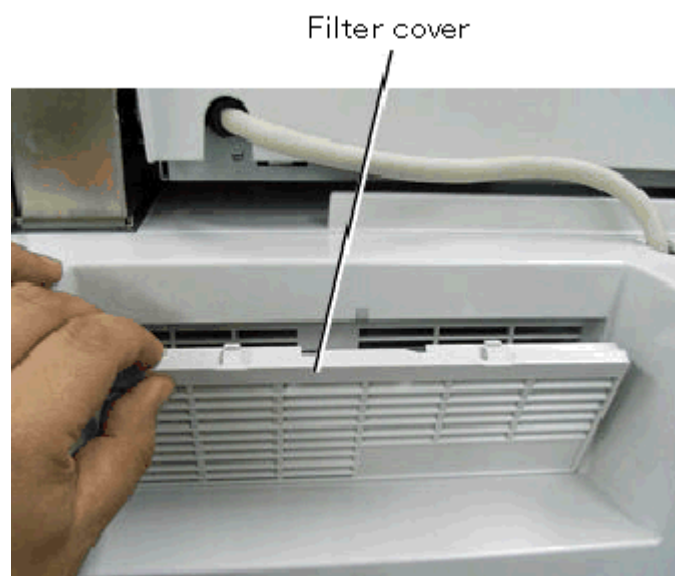
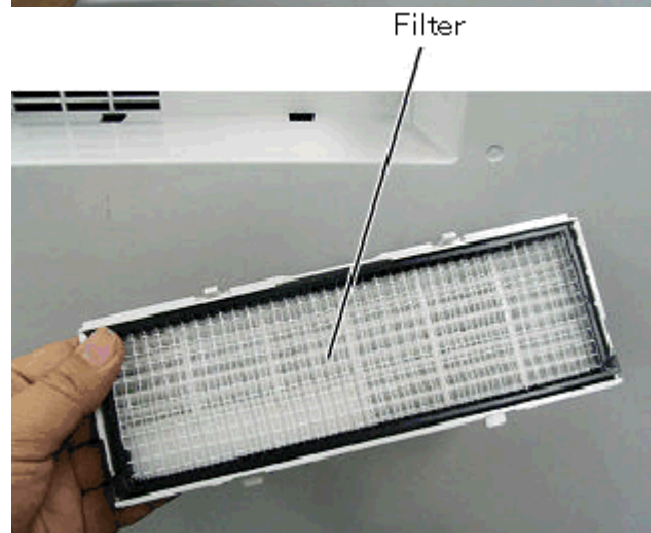
Note: If the symptom still occurs, the cause may be that the machine's internal temperature is high, causing the wax to separate from the toner. This can reduce the toner's charge performance.

Note: This will improve ventilation inside the machine.

2. Clean the following filter (B0654255).

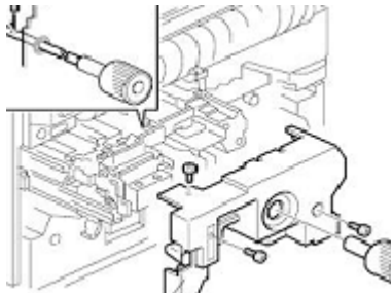
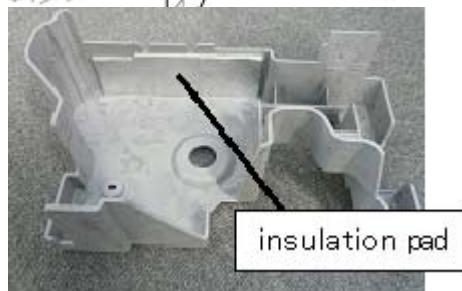
Note: This will prevent heat from being transferred from the fusing unit to the toner bottle.

3. Attach the extra insulation pad (B0654255).
