Model: Kir-C2		Date: 24-Mar-04	No.: RB121001
Subject: Important Notes for Fax Installation		Prepared by: H.Yokoyama	
From: 1st Tech. Support Sec. Service Support Dept.			
Classification:	<input type="checkbox"/> Troubleshooting	<input type="checkbox"/> Part information	<input type="checkbox"/> Action required
	<input type="checkbox"/> Mechanical	<input type="checkbox"/> Electrical	<input checked="" type="checkbox"/> Service manual revision
	<input type="checkbox"/> Paper path	<input type="checkbox"/> Transmit/receive	<input type="checkbox"/> Retrofit information
	<input type="checkbox"/> Other ()

Important Notes for When Installing the Optional Fax Feature

Model: Kir-C2		Date: 28-May-04	No.: RB121003
Subject: 128MB RAM DIMM connecting failure		Prepared by: M. Ishihara	
From: 1st Tech. Support Sec. Service Support Dept.			
Classification:	<input checked="" type="checkbox"/> Troubleshooting	<input type="checkbox"/> Part information	<input type="checkbox"/> Action required
	<input type="checkbox"/> Mechanical	<input type="checkbox"/> Electrical	<input type="checkbox"/> Service manual revision
	<input type="checkbox"/> Paper path	<input type="checkbox"/> Transmit/receive	<input type=

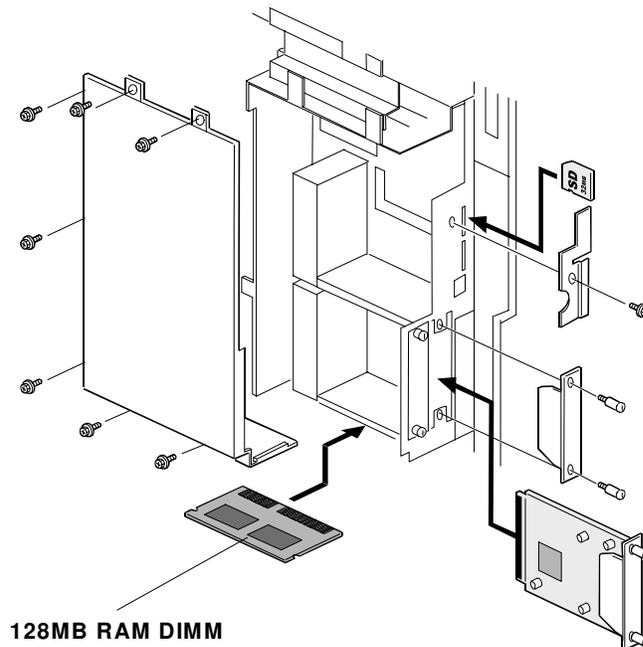
- The machine does not warm up to the ready status after installing the 128MB RAM DIMM on the GW controller board.
- SC998 occurs after installing the printer option.

- 1) The RAM DIMM has not been set in the controller board socket properly.
- 2) The RAM DIMM is defective.

- 1) Remove the RAM DIMM and insert it in the socket again. Try repeating this a few times.
- 2) If this is unsuccessful, replace the RAM DIMM.

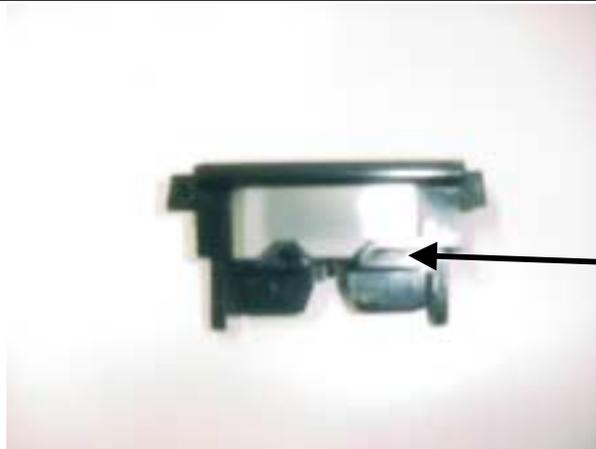
A defect in one of the molds that the manufacturer uses to produce the friction pad left a burr on the pad surface, catching the paper and preventing it from being fed.

Note: Only one of the two molds used to form the friction pad was defective (Cav 2).

Cav number (1 or 2) is visible here.
 Cav 1: Normal
Cav 2: May be defective

- (1) Replace the friction pad.

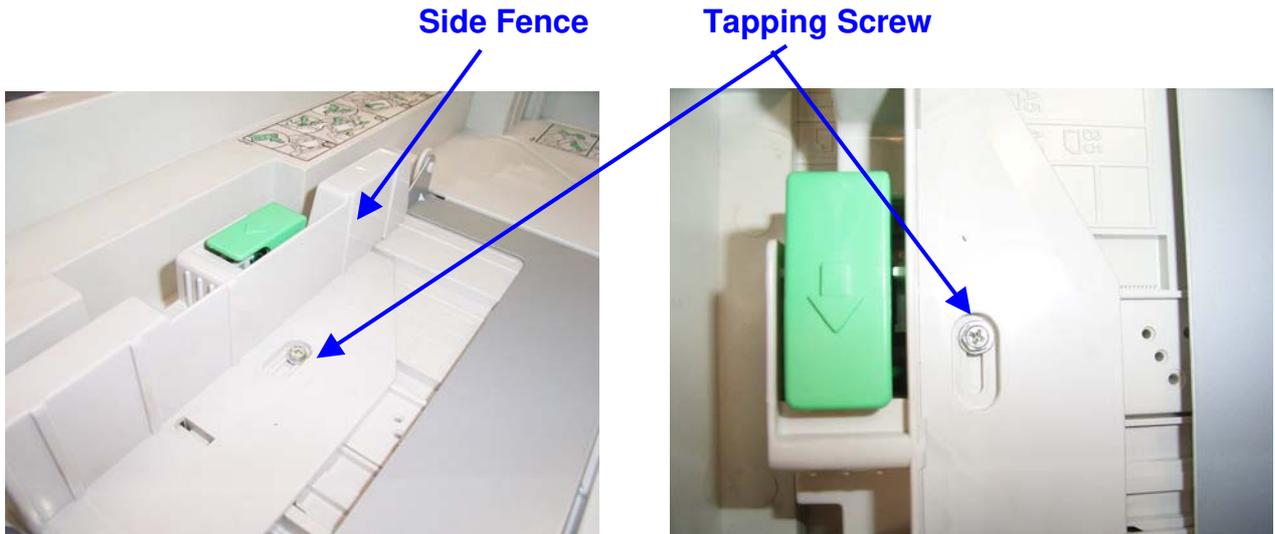
Fixing the Side Fence in Place

The operator loads paper incorrectly (e.g. not setting the end fence and side fence correctly, not fanning the stack, not placing it in the tray properly), so that the fences restrict or change the movement of the paper and cause it to feed incorrectly.

Attention: After fixing the side fence with a tapping screw, please check that the paper feeds smoothly by hand. If the paper will not feed smoothly, please loosen the screw by one rotation.

- Please inform the customer that once the side fence and the end fence are secured in place, 1) the paper size cannot be changed (until the next service visit), and 2) moving the fixed fence by force may damage the fence and/or tray base.
