Model: Bellini-C1		Date: 28-Aug-03	No.: RA294000b
Subject: Troubleshooting		Prepared by: M. Matsuda	
From: 2nd Tech Support Sec. Service Support Dept.			
Classification:	<input checked="" type="checkbox"/> Troubleshooting <input type="checkbox"/> Part information <input type="checkbox"/> Action required <input type="checkbox"/> Mechanical <input type="checkbox"/> Electrical <input type="checkbox"/> Service manual revision <input type="checkbox"/> Paper path <input type="checkbox"/> Transmit/receive <input type="checkbox"/> Retrofit information <input type="checkbox"/> Other (      )

This bulletin is a troubleshooting guide for Bellini-C1.

# **Troubleshooting Guide for Bellini-C1**

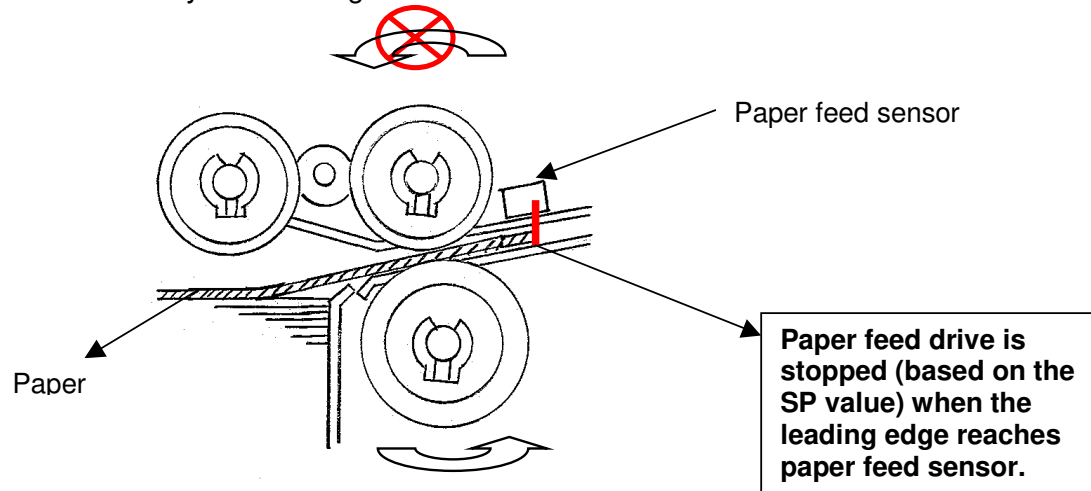
If the setting is not 0, the machine stops the paper when the leading edge reaches the paper feed sensor, increasing separation efficiency and making it difficult for block multi-feeds to occur.

1. Increase the value of SP1907-001 to 006 by 1x10msec, then check the result.
2. If it does not succeed, increase by 10msec again. Change in 10 ms steps until you eliminate this problem..

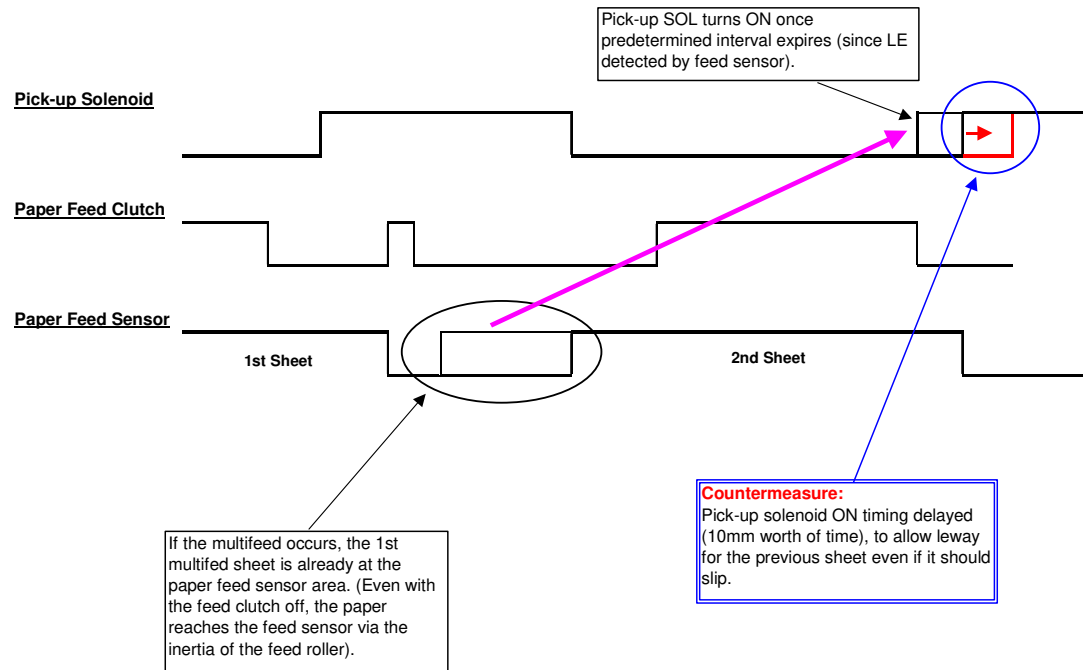
*Bellini-C2 Jam Code 53 Timing Chart (LT LEF - Tray 1)*

- Jam code 53: The tandem tray paper feed sensor detects the presence of paper past the predetermined time period (a certain number of ms after detecting the paper's leading edge).
- This symptom only occurs under the conditions described above, and not with any other paper sizes or feed trays.

The paper sometimes slips and does not clear the paper feed sensor in time, allowing the next sheet fed to catch up with it and cause the jam.

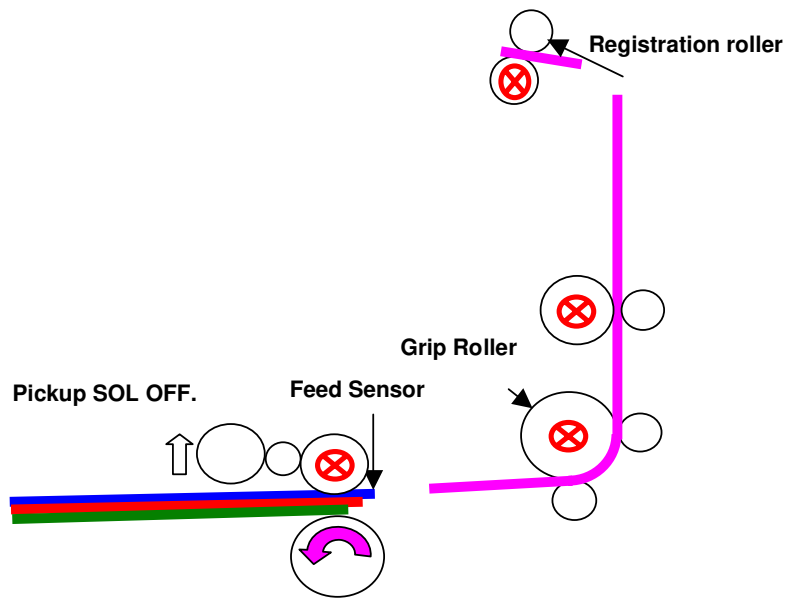
With multi-feeds of 3 sheets or more, the previous sheet stops at the registration section and then the next sheet (blue) is fed to the feed sensor via the inertia of the feed roller. The paper feed sensor then turns ON, followed by the pick-up solenoid a certain number of ms later. If the paper slips at all on the way to the grip roller, it can collide with the previous sheet around the feed sensor (which detects the presence of paper and triggers jam).

**Note:** This symptom occurs only for LT LEF fed from Tray 1.

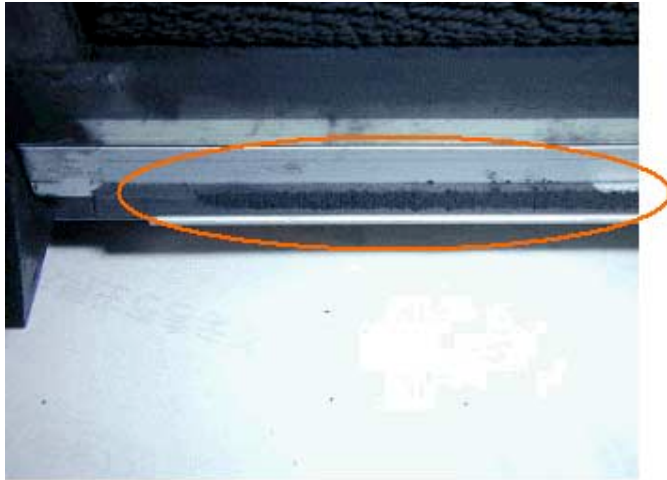
Carrier builds up on the drum unit carrier catcher as shown below, and then falls onto the transfer belt causing dirty paper stack edges (Bellini-C1c/d).

- B. Check to see that the Bellini-C1c/d development unit is installed and replace it if necessary.

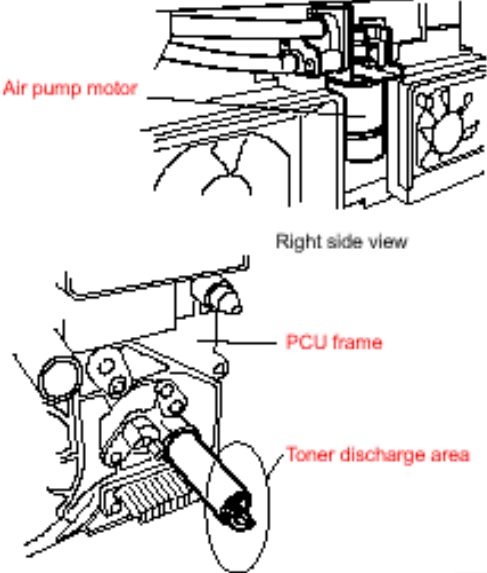
The toner transport screw (coil) has locked due to a toner blockage in the air pump motor.

<p>The image contains two technical diagrams. The top diagram is labeled 'Right side view' and shows a side profile of the printer's internal mechanism, with a red label 'Air pump motor' pointing to a component on the left. The bottom diagram is labeled 'Toner discharge area' and shows a top-down view of the same mechanism, with a red label 'PCU frame' pointing to a central component and another red label 'Toner discharge area' pointing to a circular area on the right.</p>	<p><b>Action:</b></p> <ol style="list-style-type: none"><li>1. Thoroughly clean the entire toner transport tube and transport screw (coil). If necessary, replace the parts (e.g., if the transport screw is bent).</li><li>2. Replace the air pump motor.</li></ol> <p><b>Note:</b> After performing these 2 steps, perform the following check on the toner discharge area of the PCU frame. This will further ensure the symptom does not reoccur.</p> <ul style="list-style-type: none"><li>• Check for any deformation of the toner transport screw on the PSU (power supply unit).</li><li>• Check for any toner blockages/clumping.</li></ul> <p>If either or both above items is YES, replace the PSU and thoroughly clean the entire toner transport path.</p>

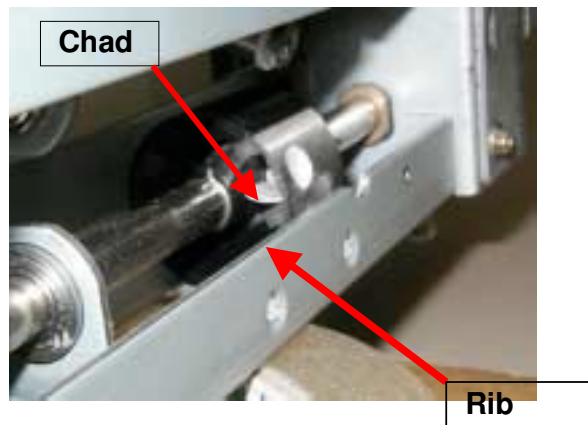
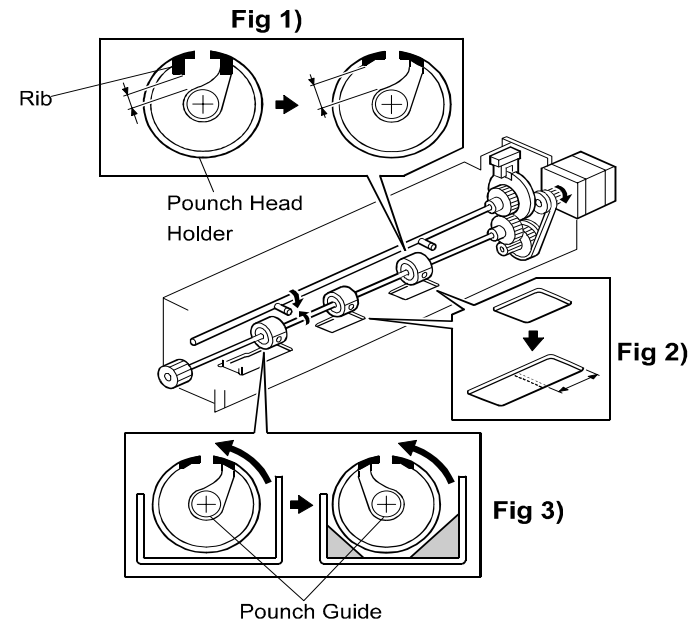
The punch waste (chads) built up in the punch unit assembly due to static electricity generated by the paper.

The following countermeasures have been applied:
