Model: General RTB	Date: 4-Feb-03	No.: RGene013b
--------------------	----------------	----------------

Subject: Service remarks at installation		Prepared by: T. Itoh	
From: Technical Service Sec. Service Planning Dept.			
Classification:	<input type="checkbox"/> Troubleshooting	<input type="checkbox"/> Part information	<input type="checkbox"/> Action required
	<input type="checkbox"/> Mechanical	<input type="checkbox"/> Electrical	<input type="checkbox"/> Service manual revision
	<input type="checkbox"/> Paper path	<input type="checkbox"/> Transmit/receive	<input type="checkbox"/> Retrofit information
	<input checked="" type="checkbox"/> Other (Specification change)

Model: Bellini-C2		Date: 1-Sep-03	No.: RB070024
Subject: File Format Converter supports DTB V2 from v3.0.0.0, error message unclear		Prepared by: K. Ichihara	
From: NS Support Sec. Service Support Dept.			
Classification:	<input type="checkbox"/> Troubleshooting	<input type="checkbox"/> Part information	<input type="checkbox"/> Action required
	<input type="checkbox"/> Mechanical	<input type="checkbox"/> Electrical	<input type="checkbox"/> Service manual revision
	<input type="checkbox"/> Paper path	<input type="chec

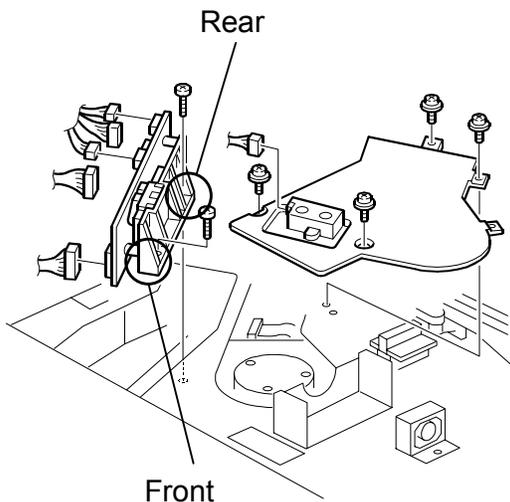
Please perform the following if the spacers attached to the bottom of the LD unit are misplaced or their original positions become unclear at LD unit replacement. This adjustment is necessary to ensure ID variations along the main scan direction do not occur, which result from beam pitch variations along the sub-scan direction.

2. Attach one 100 μ m (milk white) spacer in the **rear** of the unit. Print out the pattern again and compare with the sample from Step 1.
 - If the ID variation along the main scan direction decreases (improves) but is still visible, attach another 100 μ m spacer in the same position.
 - If the ID variation gets worse, go on to Step 3.
3. Attach one 100 μ m spacer in the **front** of the unit. Print out the pattern again and compare this with the sample from Step 2.
 - If the ID variation along the main scan direction decreases (improves) but is still visible, attach another 100 μ m spacer in the same position.

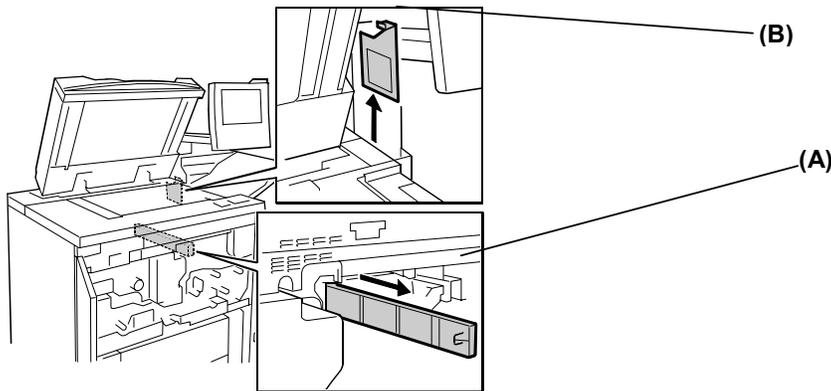
The above cleaning/replacements are also effective in maintaining proper machine internal temperature, which is key in minimizing scattering since slight rises in temperature can cause scattering to occur more easily.

1. Check the toner filter [A] and drum filter [B], and clean or replace them as necessary.

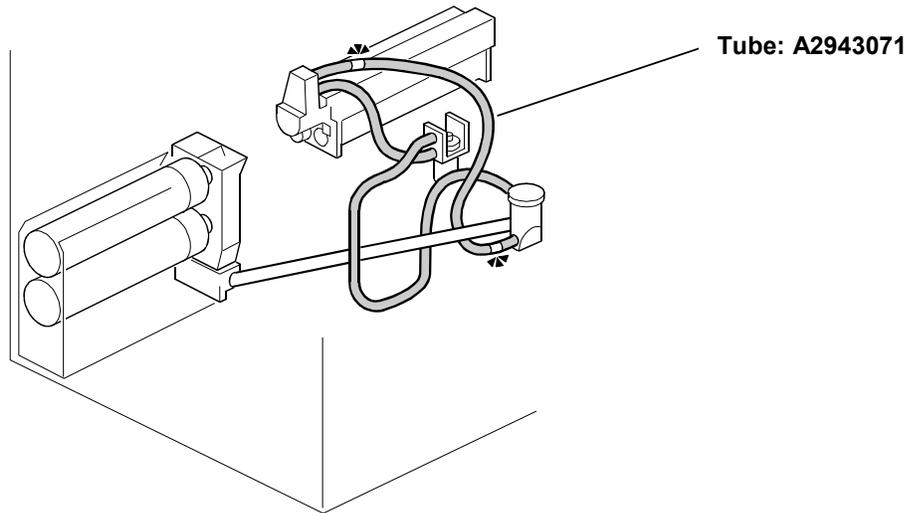
2. Toner scattering from the filters of the toner hopper

- b) Clean the tube (A2943071) between the toner hopper and the cylinder case (procedure below).

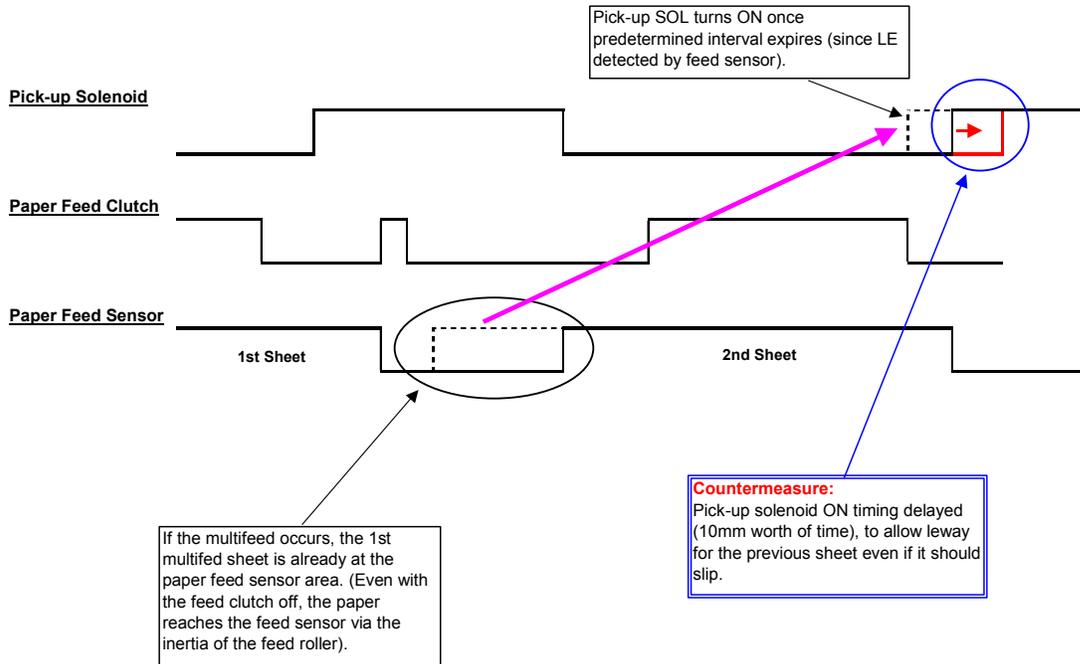
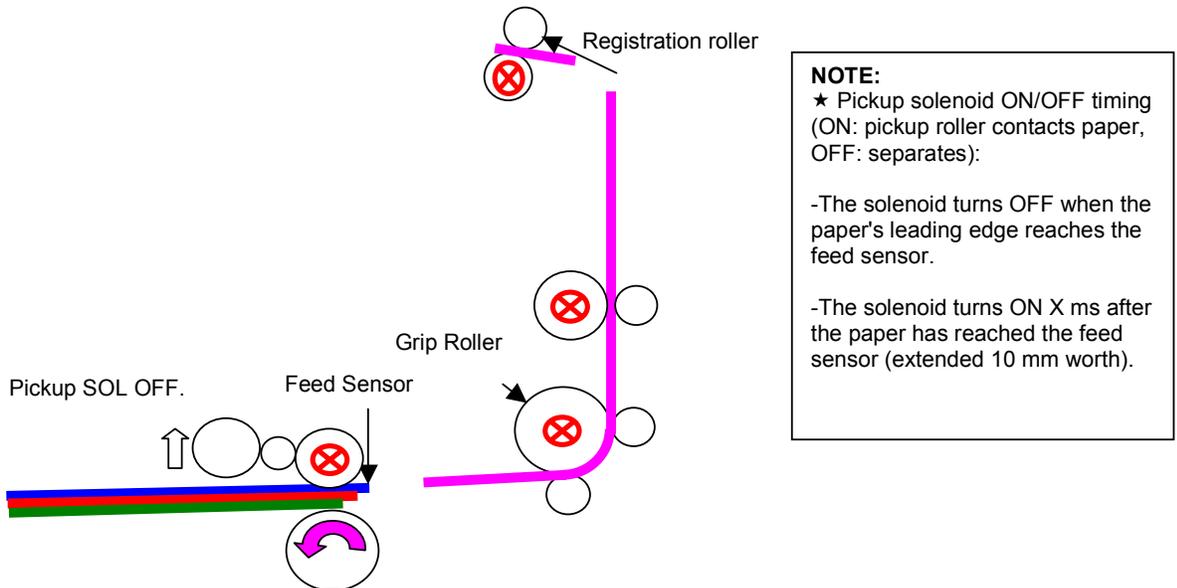
Bellini-C2 Jam Code 53 Timing Chart (LT LEF - Tray 1)

With multi-feeds of 3 sheets or more, the previous sheet stops at the registration section and then the next sheet (blue) is fed to the feed sensor via the inertia of the feed roller. The paper feed sensor then turns ON, followed by the pick-up solenoid a certain number of ms later. If the paper slips at all on the way to the grip roller, it can collide with the previous sheet around the feed sensor (which detects the presence of paper and triggers a jam).

Note: This symptom occurs only for LT LEF fed from Tray 1.

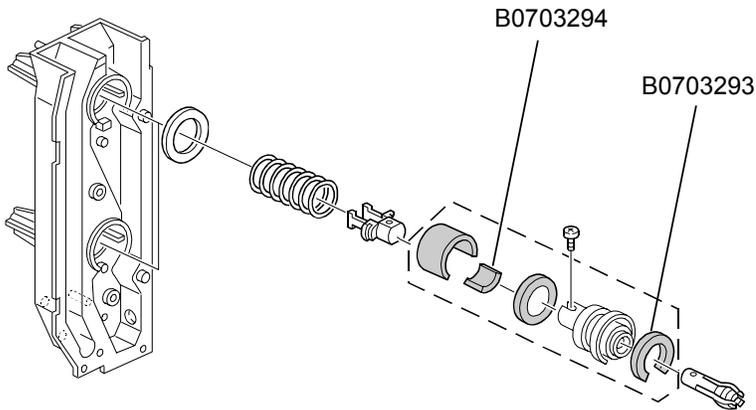
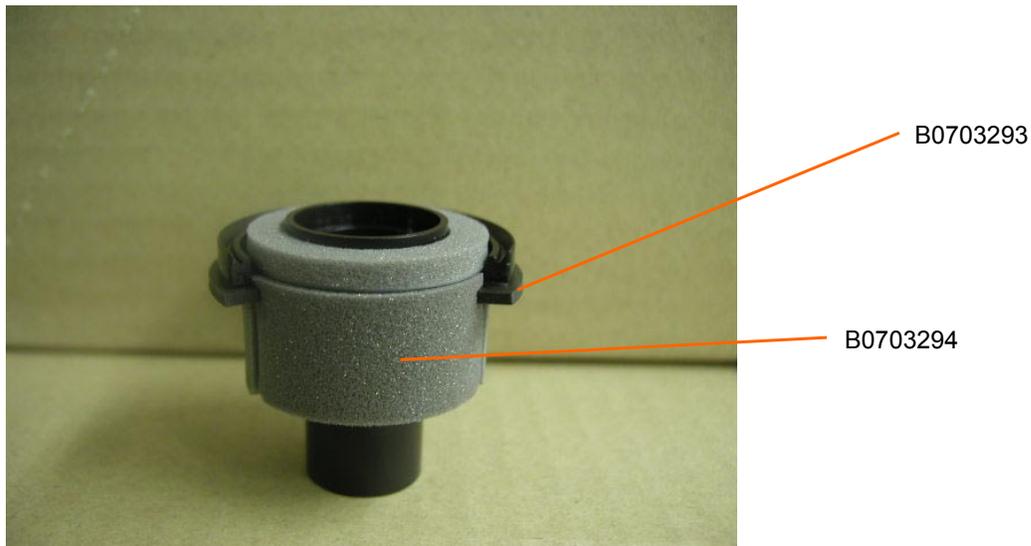
2. Toner bottle cannot be pulled out from the toner bank unit

- P/N: B0703293 (Shield Slider), B0703294 (Shield Slider Short)
- Attachment position:

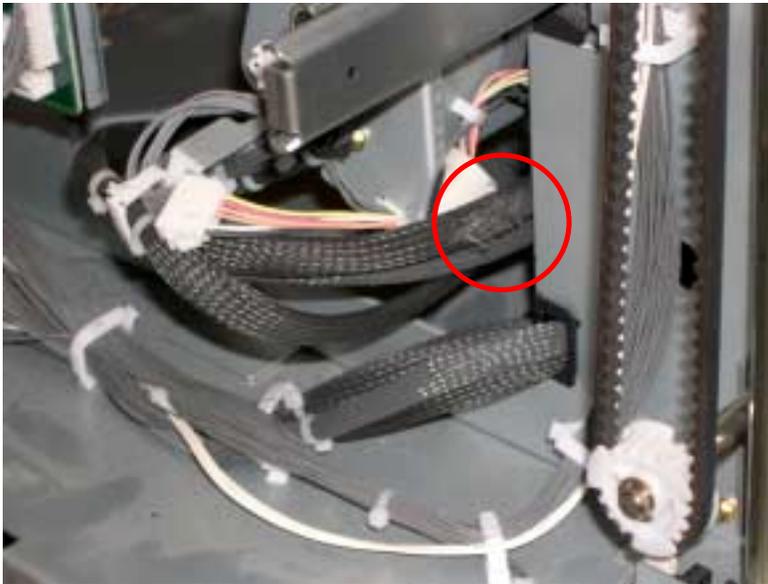
The outside of the stapler harness is damaged in the area shown in the photo. In some cases, a short circuit occurs in the damaged area.

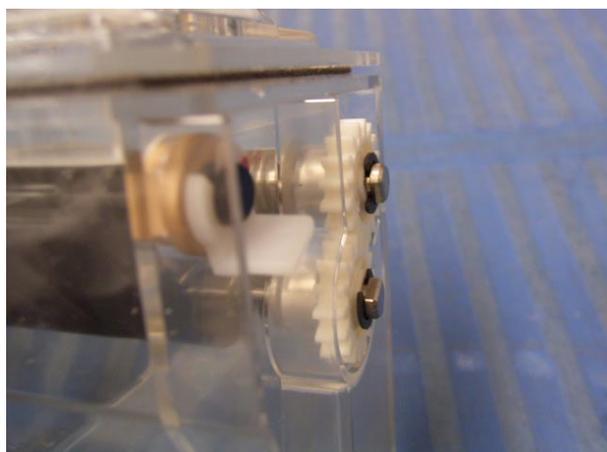
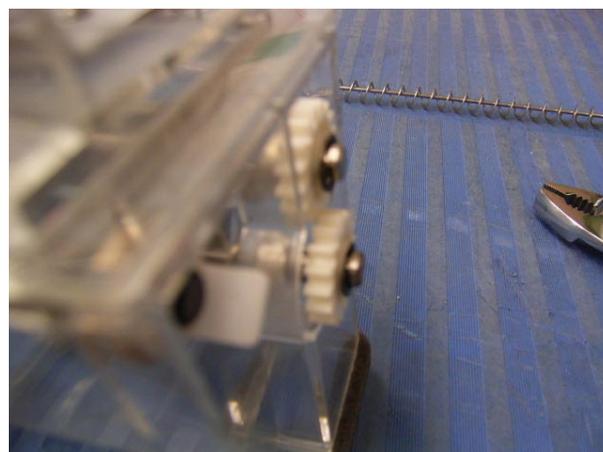
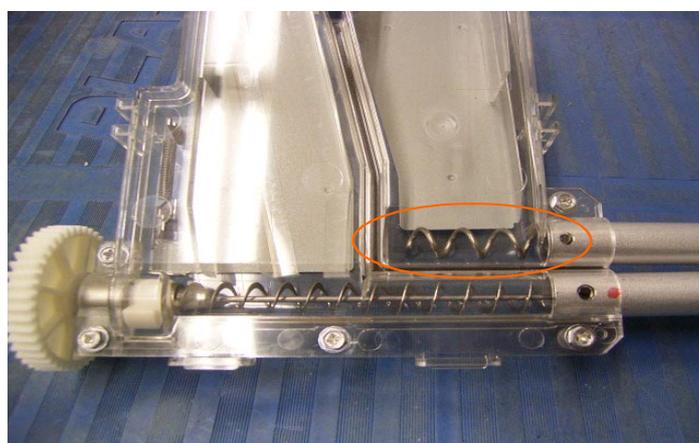
Note: If the drive gears are engaged correctly, the end of the coil will be in the position shown by the red circle in the photo below.
