Model: Model J-C1		Date: 26-Jan-04	No.: RB149001
Subject: Firmware Release History (Engine)		Prepared by: H. Someya	
From: 1st Tech. Support Sec. Service Support Dept.			
Classification:	<input type="checkbox"/> Troubleshooting <input type="checkbox"/> Part information <input type="checkbox"/> Action required <input type="checkbox"/> Mechanical <input type="checkbox"/> Electrical <input type="checkbox"/> Service manual revision <input type="checkbox"/> Paper path <input type="checkbox"/> Transmit/receive <input type="checkbox"/> Retrofit information <input checked="" type="checkbox"/> Other ()

This RTB has been issued to announce the firmware release information for the engine.

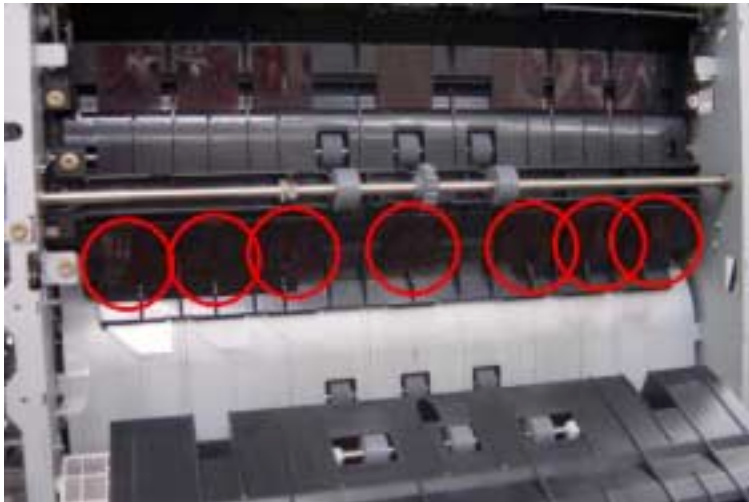
6. Replace the 7 Mylars shown in the photo (red circles).

Replace the seven Mylars shown below (P/N G3484682, Sheet: Gate: 2).

- Refer to the **Attachment Specifications** below.
- Clean the attachment area for each Mylar before you attach the new one.
- Press hard on the attachment area of the Mylar.
- Make sure the Mylar is not sticking out from the guide plate.

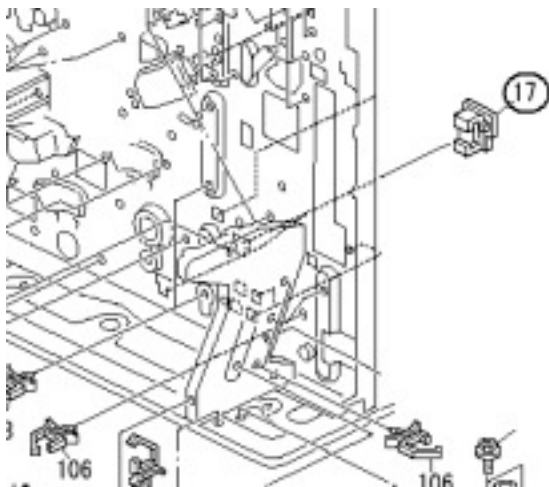
1. The paper tray holder (17: picture below) moves forward due to the defective rear metal board. This does not let the paper tray close correctly. This tends to occur in tray 2 because of the machine layout.
2. The tray holder cannot hold the paper tray firmly if these occur:
 - The paper tray gets pushed and pulled many times.
 - The tray holder is worn.

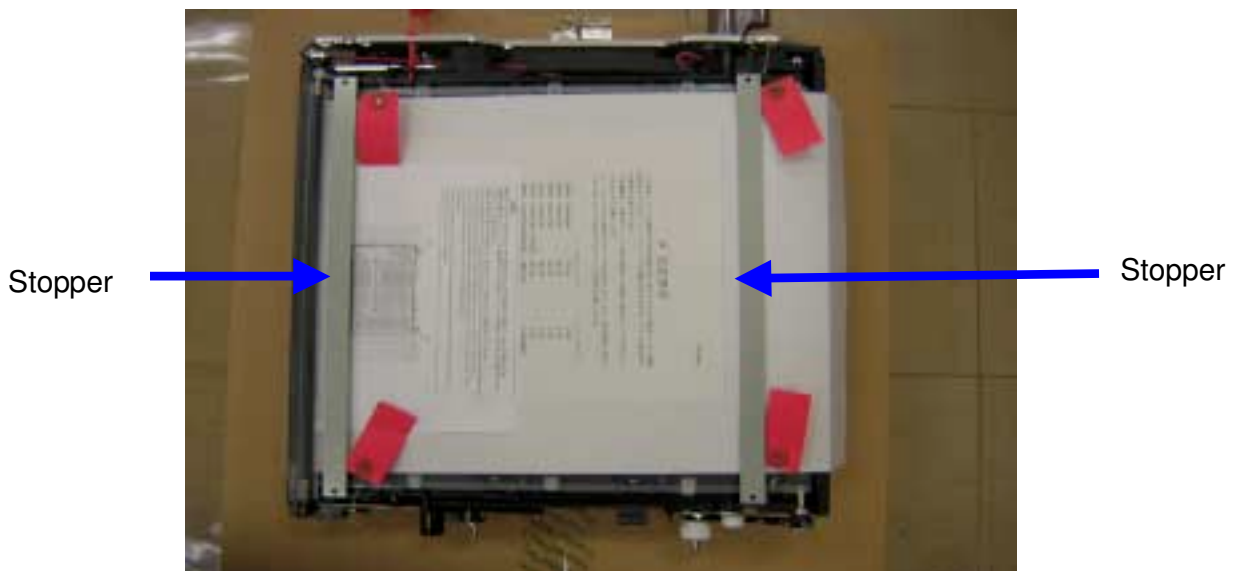
The springs for the transfer unit rollers come loose during transport.

Vibration during transport makes the springs come loose.

- Remove the two stoppers before you install the new transfer unit.
 - Remove the wires at the four ends of the stoppers
 - Remove the four red tags

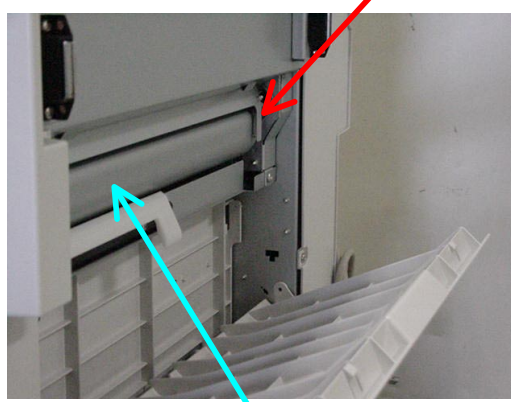
[B] DO NOT press the grounding plate

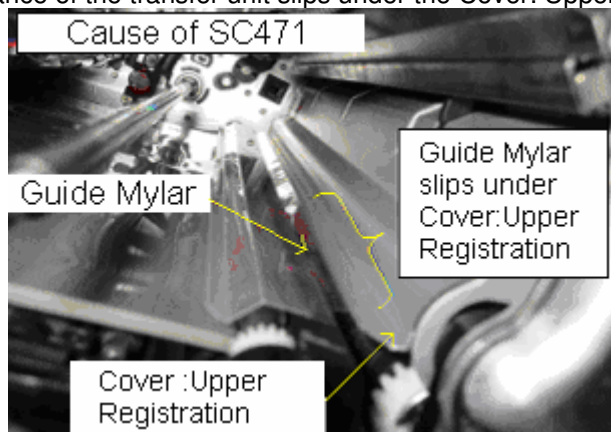
When the operator opens the vertical transport unit to clear a jam, sometimes the guide Mylar at the entrance of the transfer unit slips under the Cover: Upper Registration in the vertical transport unit.

Replace the guide Mylar at the entrance of the transfer unit with P/N **B1803908**.
