Model: Russian-C4	Date: 6-Sep-05	No.: RB205001n
-------------------	----------------	----------------

Subject: Firmware Release History (Controller)		Prepared by: S. Tomoe	
From: 2nd Tech Support Sec. Service Support Dept.			
Classification:	<input type="checkbox"/> Troubleshooting <input type="checkbox"/> Mechanical <input type="checkbox"/> Paper path <input checked="" type="checkbox"/> Other ()	<input type="checkbox"/> Part information <input type="checkbox"/> Electrical <input type="checkbox"/> Transmit/receive	<input type="checkbox"/> Action required <input type="checkbox"/> Service manual revision <input type="checkbox"/> Retrofit information

Model: Russian-C4		Date: 28-Sep-05	No.: RB205005
Subject: Rotate Sort		Prepared by: S. Tomoe	
From: 1st Tech. Support Sec. Service Support Dept.			
Classification:	<input checked="" type="checkbox"/> Troubleshooting	<input type="checkbox"/> Part information	<input type="checkbox"/> Action required
	<input type="checkbox"/> Mechanical	<input type="checkbox"/> Electrical	<input type="checkbox"/> Service manual revision
	<input type="checkbox"/> Paper path	<input type="checkbox"/> Transmit/receive	<input type="checkbox"/> Retrofit informat

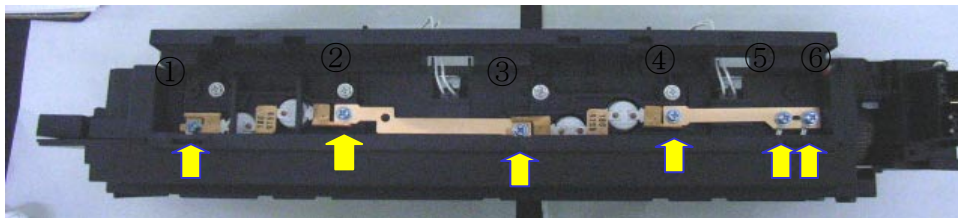
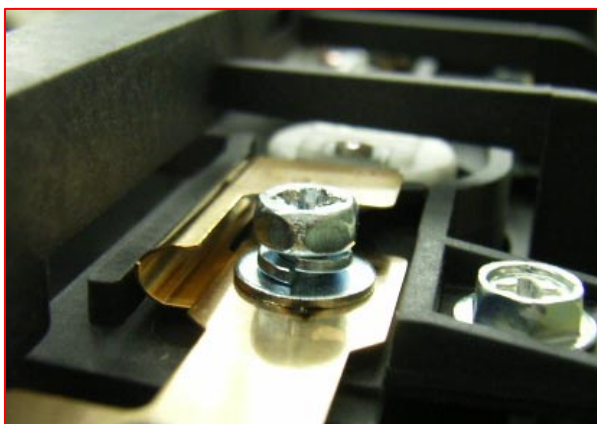
[Screw location]

The screws used to secure the bias plate were inserted at an angle, which caused the screw head to stick out from the plate. As a result, a spark is generated between the screw and plate, triggering SC542.

Visit the customer sites of the “**Affected Units**” listed below, and check the condition of the screws. If the screws were inserted incorrectly as described above, replace the fusing unit.

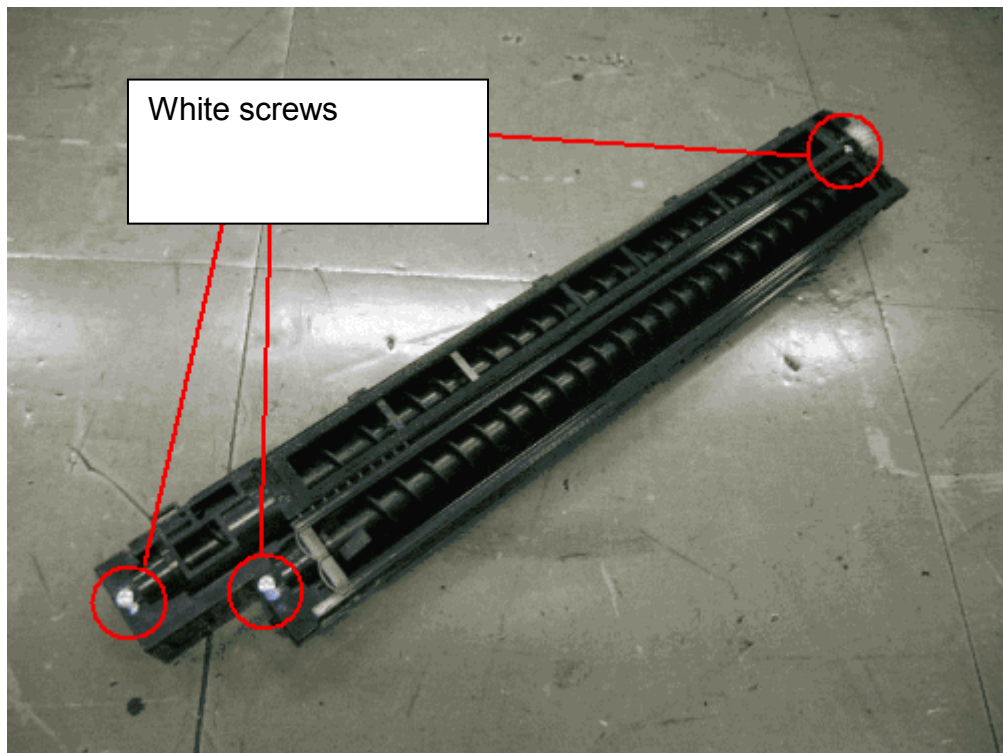
PCU with screws painted white (from Jan. 2007 R-C4/C4.5 production)**Do not** loosen or remove these screws.

From February 2007 production of R-C4/C4.5 mainframes, the screws of the PCU are painted white (see the next page). Therefore, when you replace the PCU in the field, **do not loosen or remove these screws.**

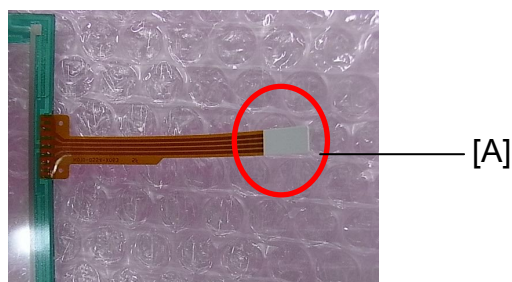
Old (B2135222): The tip [A] of the electrode attached to the touch panel is **brown**.

New (H3106173): This tip [A] is **white**.

IMPORTANT: Therefore, if the tip [A] is white, do not replace the touch panel.

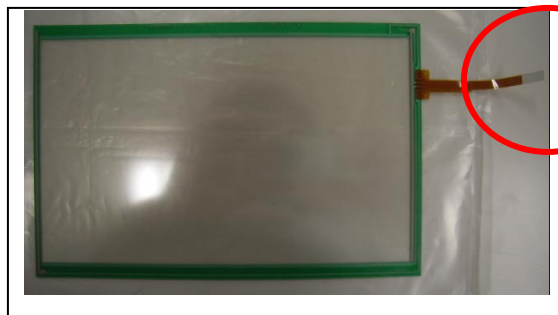
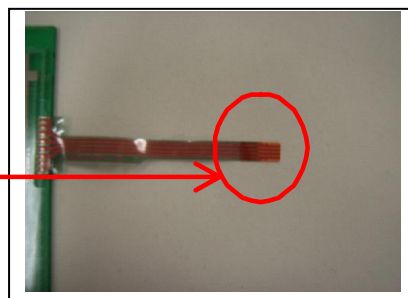
How to distinguish the new parts from the old parts

Old parts:
The tip of the electrode is **brown**.

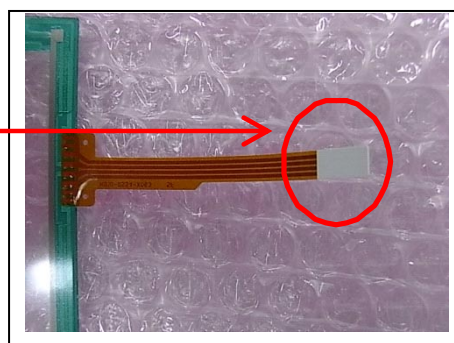
New parts:
The tip of the electrode is **white**.
