Model: Russian-C4.5	Date: 05-Sep-06	No.: RD007001g
---------------------	-----------------	----------------

Subject: Firmware Release History (Controller)		Prepared by: S. Tomoe	
From: 2nd Tech Support Sec. Service Support Dept.			
Classification:	<input type="checkbox"/> Troubleshooting	<input type="checkbox"/> Part information	<input type="checkbox"/> Action required
	<input type="checkbox"/> Mechanical	<input type="checkbox"/> Electrical	<input type="checkbox"/> Service manual revision
	<input type="checkbox"/> Paper path	<input type="checkbox"/> Transmit/receive	<input type="checkbox"/> Retrofit information
	<input checked="" type="checkbox"/> Other ()

Model: Russian-C4/C4.5		Date: 15-Feb-07	No.: RB205023
Subject: Leaking developer causes PCU gear damage		Prepared by: S. Tomoe	
From: 1st Tech. Support Sec. Service Support Dept.			
Classification:	<input checked="" type="checkbox"/> Troubleshooting <input type="checkbox"/> Mechanical <input type="checkbox"/> Paper path <input type="checkbox"/> Product Safety	<input type="checkbox"/> Part information <input type="checkbox"/> Electrical <input type="checkbox"/> Transmit/receive <input type="checkbox"/> Other ()	<input type="chec

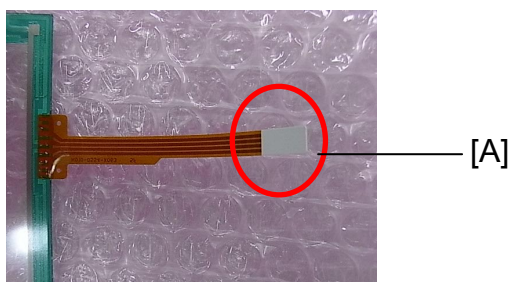
The adhesive that binds electrodes to the touch panel surface contains a polymer that tends to expand under normal office environmental conditions.

Old (B2135222): The tip [A] of the electrode attached to the touch panel is **brown**.

New (H3106173): This tip [A] is **white**.

Replace the touch panel (**see the procedure below**).

IMPORTANT: Therefore, if the tip [A] is white, do not replace the touch panel.
