Model: <b>Adonis-C4.5</b>	Date: 08-Nov-06	No.: RB296001a
---------------------------	-----------------	----------------

Subject: Firmware Release Note: Engine		Prepared by: K.Takagi	
From: 1st Tech. Support Sec. Service Support Dept.			
Classification:	<input type="checkbox"/> Troubleshooting <input type="checkbox"/> Part information <input type="checkbox"/> Action required		
	<input type="checkbox"/> Mechanical <input type="checkbox"/> Electrical <input type="checkbox"/> Service manual revision		
	<input type="checkbox"/> Paper path <input type="checkbox"/> Transmit/receive <input type="checkbox"/> Retrofit information		
	<input checked="" type="checkbox"/> Other (      )

Model: Adonis-C4.5		Date: 5-Oct-07	No.: RB296017
Subject: Platen cover sheet damage		Prepared by: K. Takagi	
From: 1st Tech. Support Sec. Service Support Dept.			
Classification:	<input type="checkbox"/> Troubleshooting <input type="checkbox"/> Mechanical <input type="checkbox"/> Paper path <input checked="" type="checkbox"/> Product Safety	<input type="checkbox"/> Part information <input type="checkbox"/> Electrical <input type="checkbox"/> Transmit/receive <input type="checkbox"/> Other (     )	<input type="c

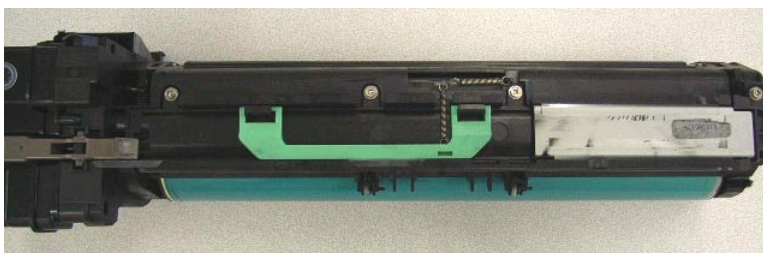
These procedures are for cleaning out the recycled toner (location shown in the following photo).

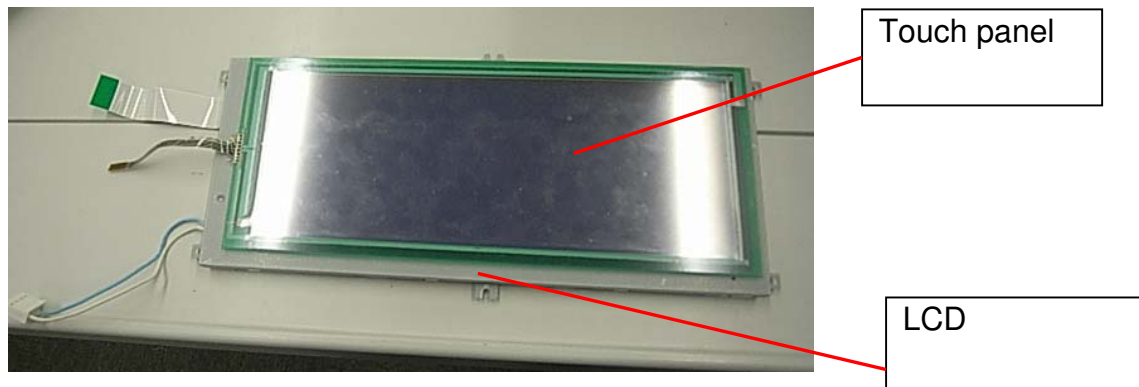
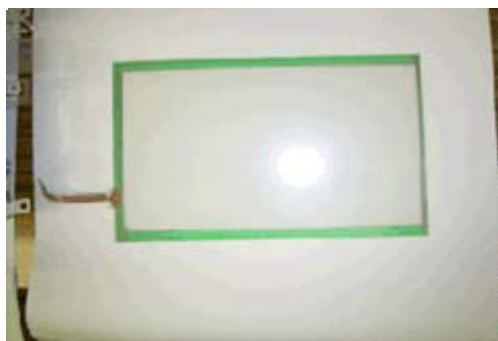
The adhesive that binds electrodes to the touch panel surface contains a polymer that tends to expand under normal office environmental conditions.

Replace the touch panel (**see the procedure below**).

7. Attach the new touch panel (P/N **H3106173**) to the LCD.  
**Important:** Only replace the touch panel. Do not replace the LCD.

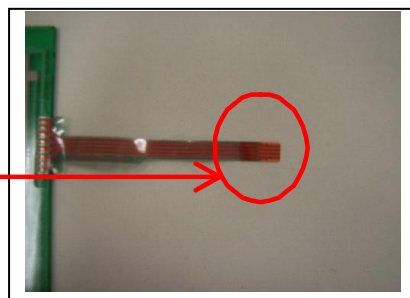
**New parts:**  
The tip of the electrode is **white**.

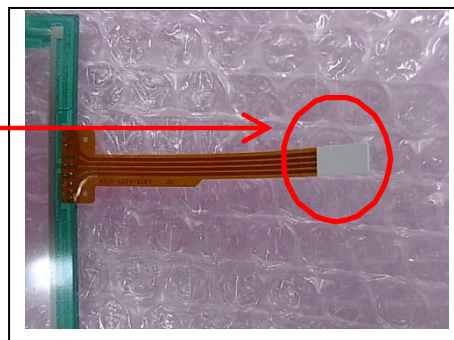
**Old parts:**  
The tip of the electrode is **brown**.

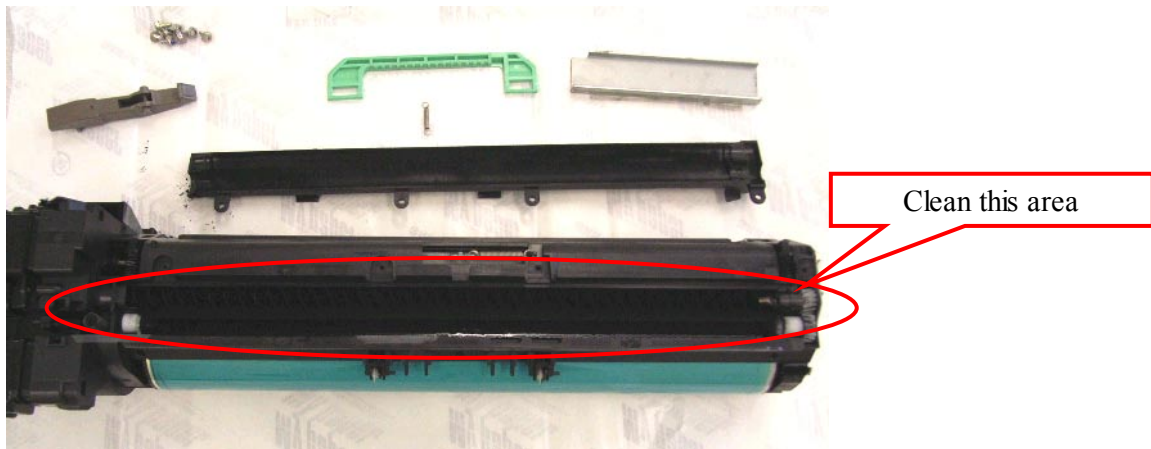
When one of the following conditions is met, the chargeability of the toner is decreased, and the machine responds by increasing the toner concentration (TC). As a result, toner filming on the development roller is accelerated, and poorly-charged toner is easily transferred onto the non-image areas of the OPC surface.

8. Remove the upper cover.
9. Clean out the recycled toner with a vacuum cleaner.
