Model: Model TH-C1	Date: 12-Apr-05	No.: RB156001a
--------------------	-----------------	----------------

Subject: Firmware History - PS3		Prepared by: H.K.	
From: 1st Tech. Support Sec. Service Support Dept.			
Classification:	<input type="checkbox"/> Troubleshooting	<input type="checkbox"/> Part information	<input type="checkbox"/> Action required
	<input type="checkbox"/> Mechanical	<input type="checkbox"/> Electrical	<input type="checkbox"/> Service manual revision
	<input type="checkbox"/> Paper path	<input type="checkbox"/> Transmit/receive	<input type="checkbox"/> Retrofit information
	<input checked="" type="checkbox"/> Other (Firmware History)

Model: Model TH-C1		Date: 17-May-05	No.: RB156002
Subject: Notes for Installation		Prepared by: H.K.	
From: 1st Tech. Support Sec. Service Support Dept.			
Classification:	<input type="checkbox"/> Troubleshooting	<input type="checkbox"/> Part information	<input type="checkbox"/> Action required
	<input type="checkbox"/> Mechanical	<input type="checkbox"/> Electrical	<input checked="" type="checkbox"/> Service manual revision
	<input type="checkbox"/> Paper path	<input type="checkbox"/> Transmit/receive	<input type="checkbox"/> Retr

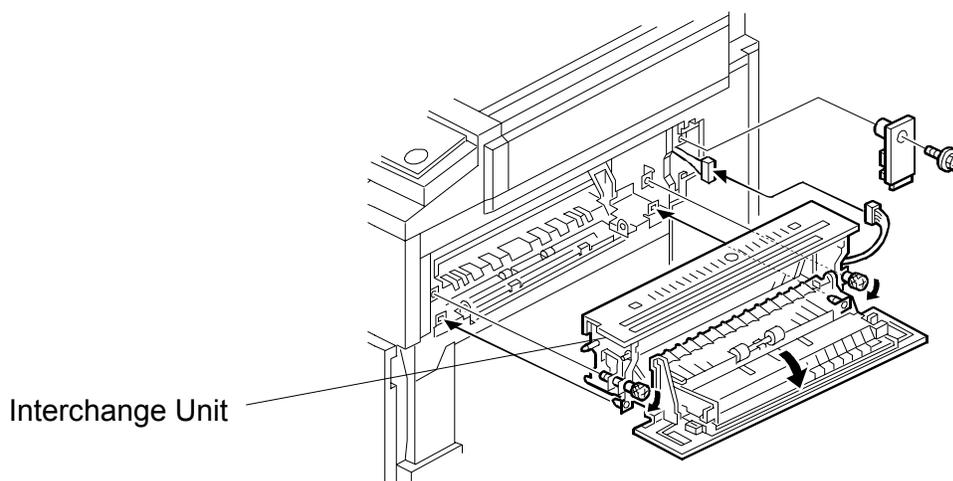
1. Interchange Unit Installation (S/M: 1-25)

Make sure to insert **both sides of the interchange unit together**, so that the unit is parallel to the machine. If you attach one side at a time, duplex jams or noise from the interchange unit can occur.

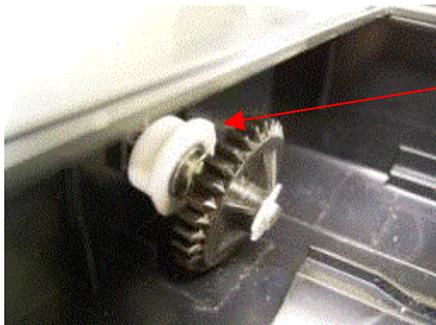
White bearing

The toner-supply-drive gear shaft in the development unit comes out of its position, because the shaft stopper is worn out by the shaft, which was not manufactured correctly. This causes the toner supply paddle to not rotate, and toner is not supplied to the toner hopper in the development unit. The white bearing also comes out of position.

- **The development unit that shows the symptom.** Replace the development unit with the corrected one when the development unit is available. And add the spacers to the shaft in the other development units.
- If the development unit is not available, see the procedure for adding the spacer to the toner supply drive gear shaft (see below).

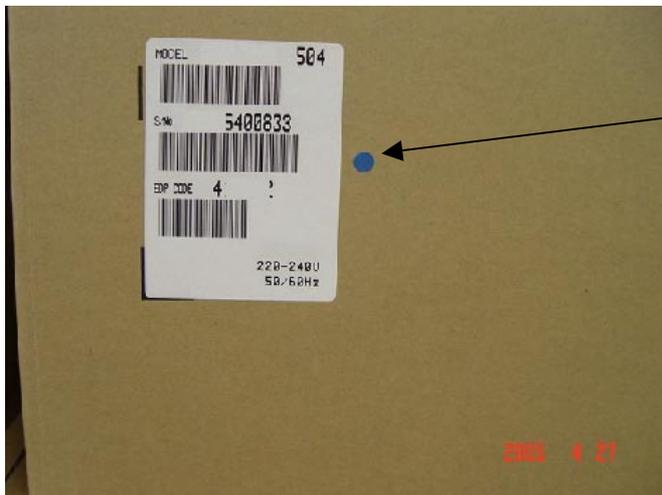
Blue decal, or blue dot (ink)

A blue spot has been added on the carton of the modified machine.
Machines: To the right side of the bar code label on the machine carton

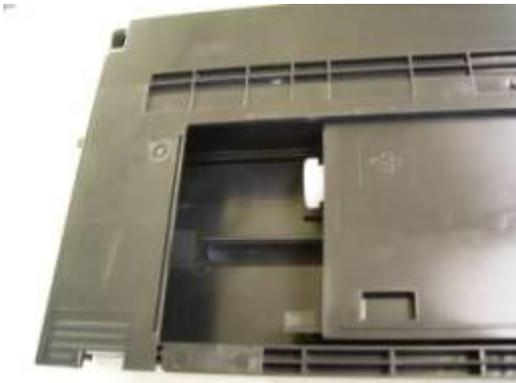
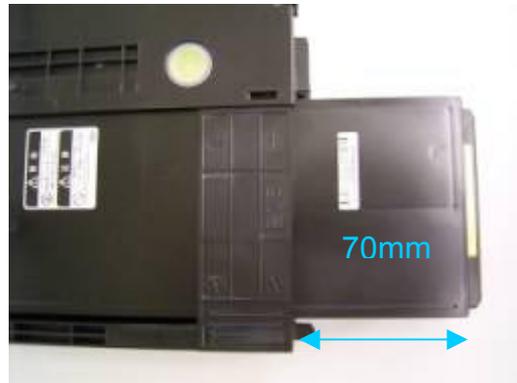
Do not pull out the toner cartridge too far. If you do, toner can leak out of the cartridge (circled in red in the photos).

If this happens, remove the leaked toner.

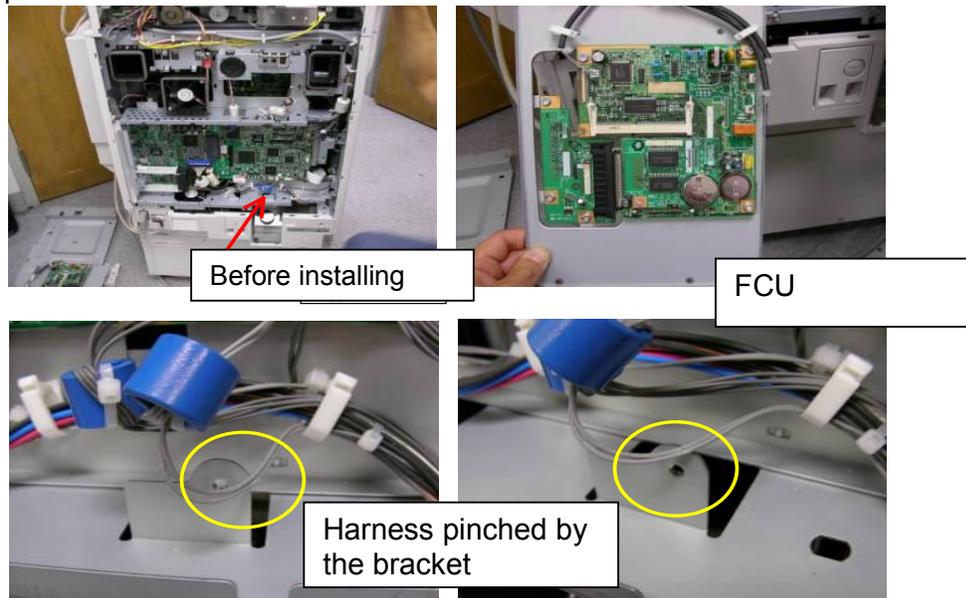
Photo No.1

FU11 (+5V) was open on the PSU because the harness connected to the BICU may be pinched by the bracket. This can cause the harness and the bracket to short circuit.

Replace the PSU and correct the pinched harness. Replace the harness if it is damaged.

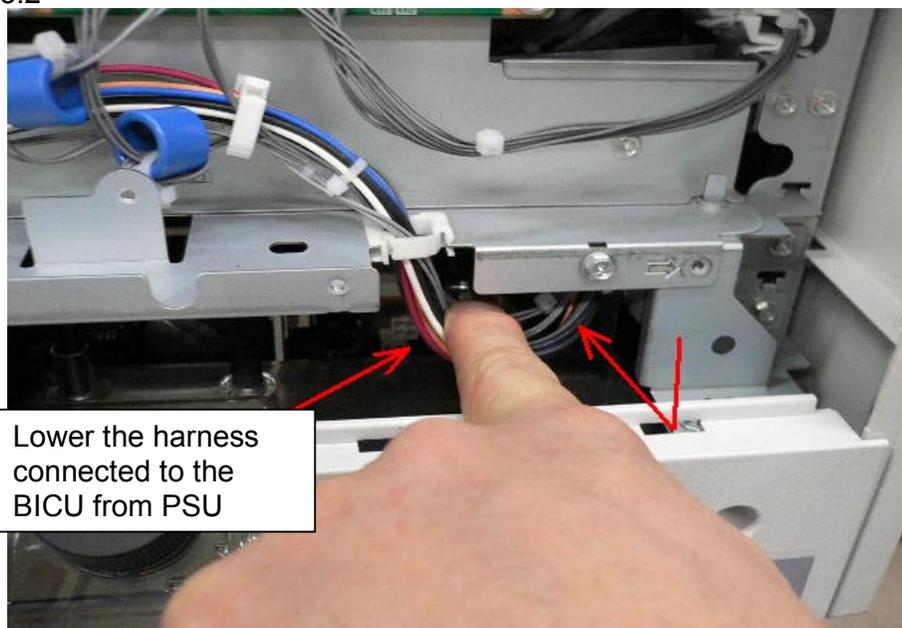
Photo No.2

Lower the harness as shown with the red arrow when you put back the controller box cover.

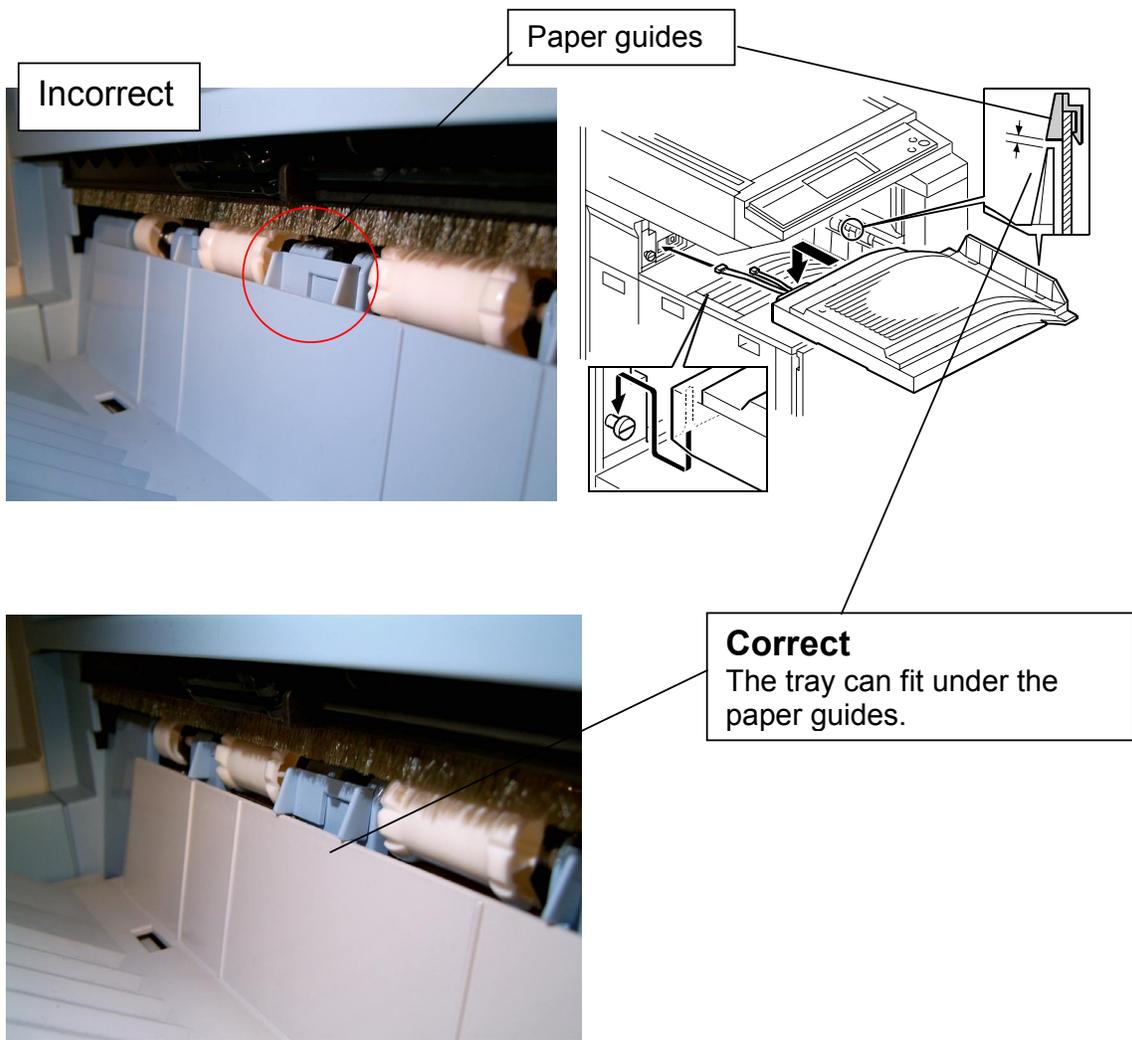
The shift tray unit (B510-27, -66) cannot be installed correctly.

Replace the Shift Tray Cover (B5106873: Tray: Shift) when this symptom occurs.

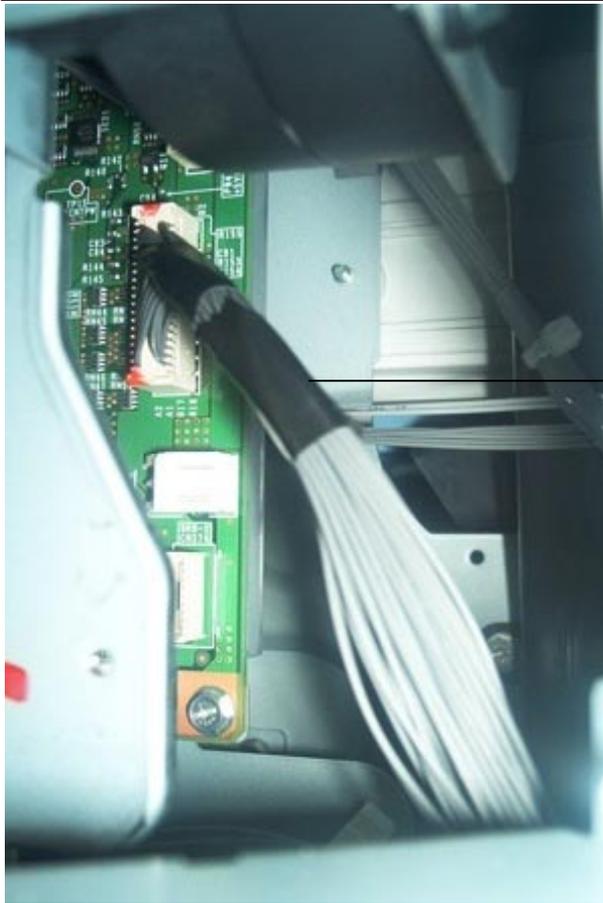
Protective electrical tape

2. Check the B1545408 harness for damage
 - If it is damaged, cover the damaged part with electrical tape (see the photo on the next page).
3. If SC838 occurs, follow the instructions in the Service Manual.
4. If the BICU board or controller board is defective, replace it.

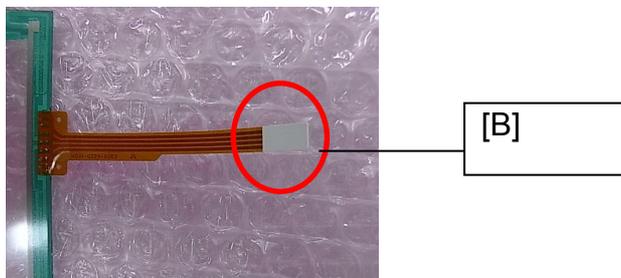
IMPORTANT: Therefore, if the tip [B] is white, do not replace the touch panel.
