| Model: Model J-C2 | | Date: 29-Mar-05 | No.: RB178001 |
| Subject: Firmware Release History (Engine) | | Prepared by: H.Taguchi | |

This RTB has been issued to announce the firmware release information for the engine.

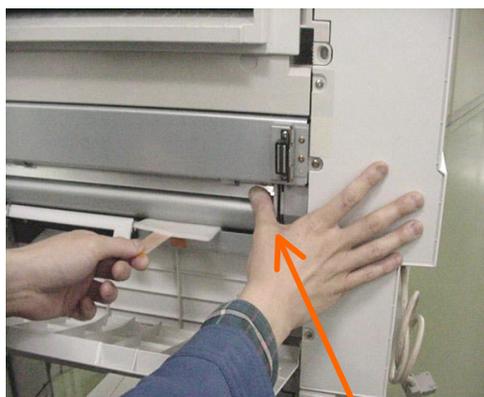
[B] DO NOT press the grounding plate

- At machine installation:**
Do not press [B] the grounding plate when you remove the shipping tape.
 - If the symptom occurs in the field:**
 - 1) Check the grounding plate to see if it is bent.
 - 2) If the plate is bent:
 - 1) Bend it back as follows:
 - Direction: Away from the paper path
 - Amount: Target **2-3mm** (max. 5mm)
- OR**
- 2) Replace the grounding plate.

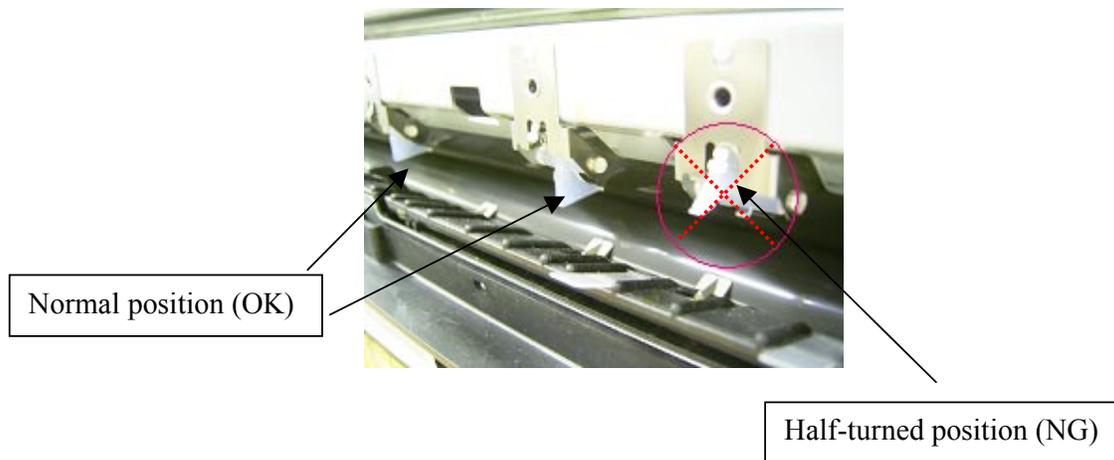
The pick-off pawl damages the fusing belt when the operator removes jammed paper from the fusing unit.

The user does not turn the knob when they remove the jammed paper. As a result, the pick-off pawls are locked at the half-turned position and damage the fusing belt.

Shorten the pick-off pawl stopper (see the procedure below).

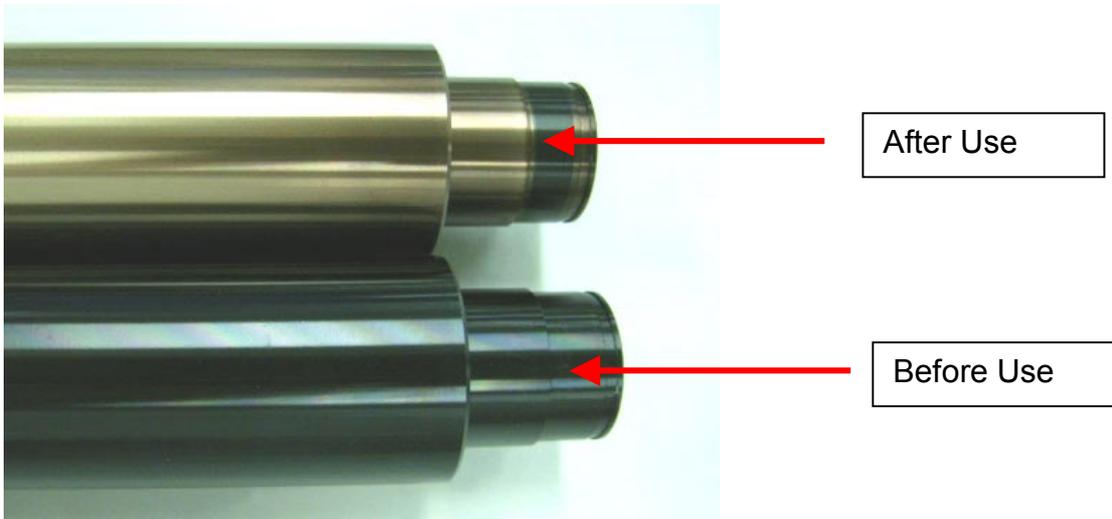
The color of the pressure roller after use is different from the one before use as shown below. However this is not related to the product quality in any regard.

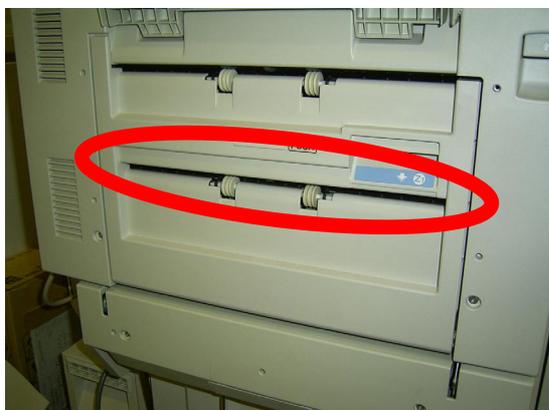
A paper jam or dog-ear may occur at the lower exit area of the inverter unit.

The paper curls and gets stuck in the opening of the lower exit area.

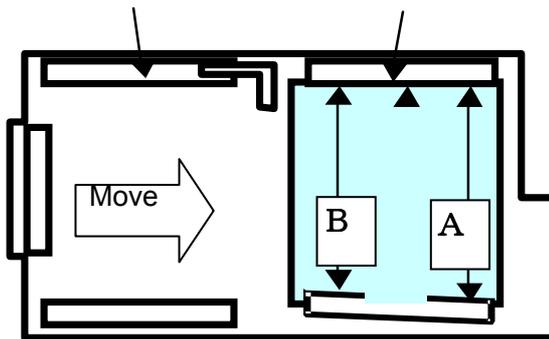
- The distance between the side fences is narrow. As a result, the paper is not moved correctly to the right side of the LCT, and the timing belt is overloaded.
- The paper is wider than specification or has burrs on its edge

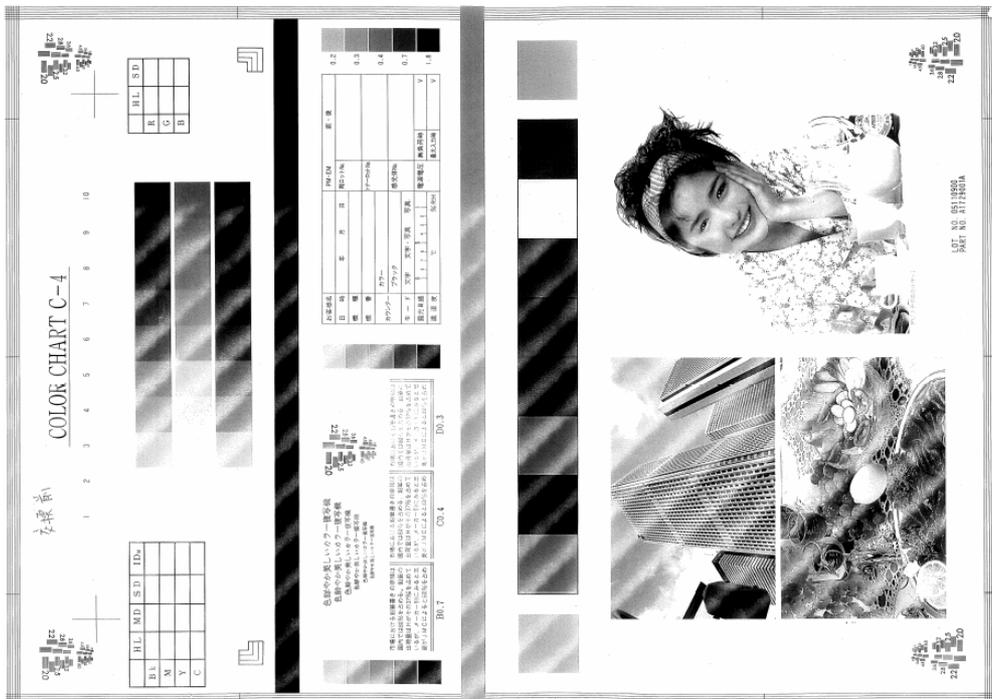
Diagonal lines of low image density can be seen on the printout.

The development clutch continues rotating even after the machine disengages the clutch, and a small amount of developer leaks out of the development unit. As this continues, the amount of developer in the development unit decreases.

Replace the development clutch for the toner color on which the symptom occurs.

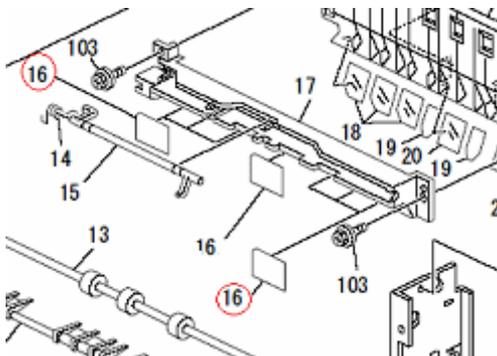
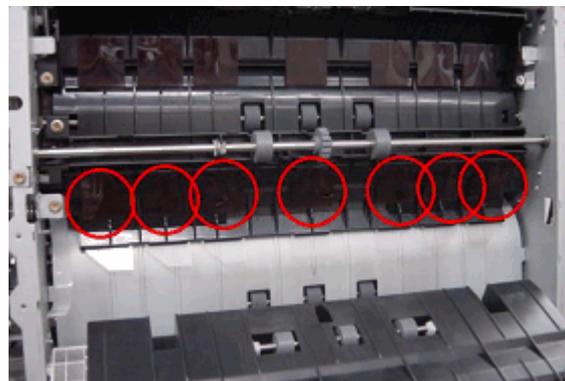
Index 16, Page 78 of J-C2 Part Catalog

The junction gate Mylar at both ends of the duplex inverter unit bends. This happens most often when using paper that has a high stiffness and has a large curl. The paper hits the Mylar and causes it to bend.

1. Replace the junction gate Mylar (index #16) at both sides of the duplex inverter unit with **P/N B1809005**.
2. If any of the other junction gate Mylars are bent, replace all junction gate Mylars.

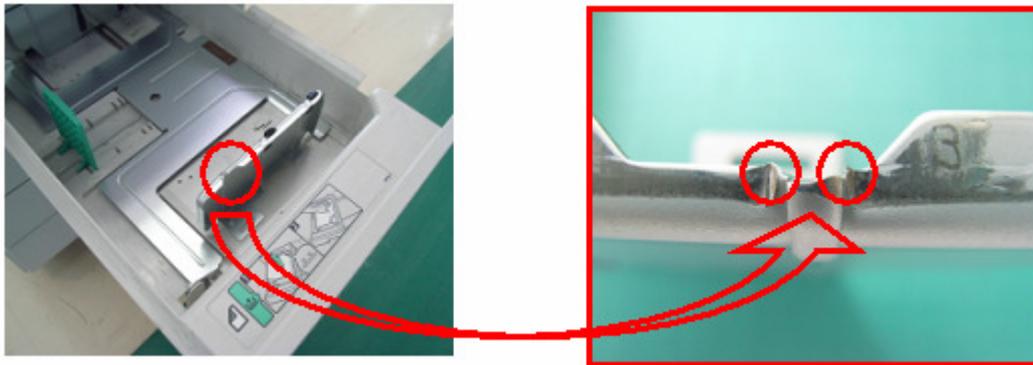
There are small burrs on the top edge of the side fence. In a small number of cases, this may cause injury if touched.

Burrs, which form as a normal part of the sheet metal stamping process, can sometimes be as prominent as those shown in the photo.

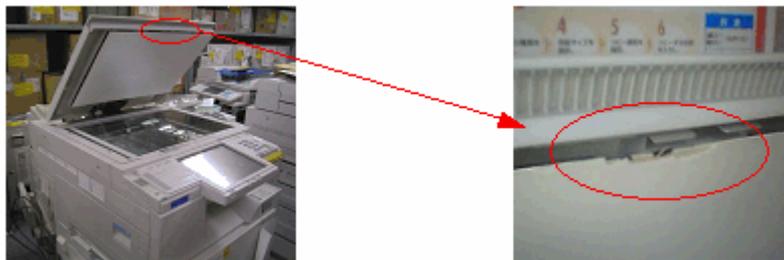
A small area on the lower front edge of the platen cover sheet is damaged. This may have a potential safety risk, depending on the amount of damage.

The platen cover is opened/closed repeatedly over a long period of time, and each time, the operator touches the platen cover sheet. As a result, this area of the platen cover sheet is gradually worn down.

- Remove the platen cover sheet and reattach it in the reverse orientation (turn it 180 degrees so that the damaged edge is at the rear side).
- Cover the damaged area of the platen cover sheet with transparent tape.
