| Model: Model V-C1 | Date: 2-Jun-05 | No.: RB132001a |

| Subject: Service Manual Revision | | Prepared by: H.Matsui | |
| From: 2nd Tech. Support Sec. Service Support Dept | | | |

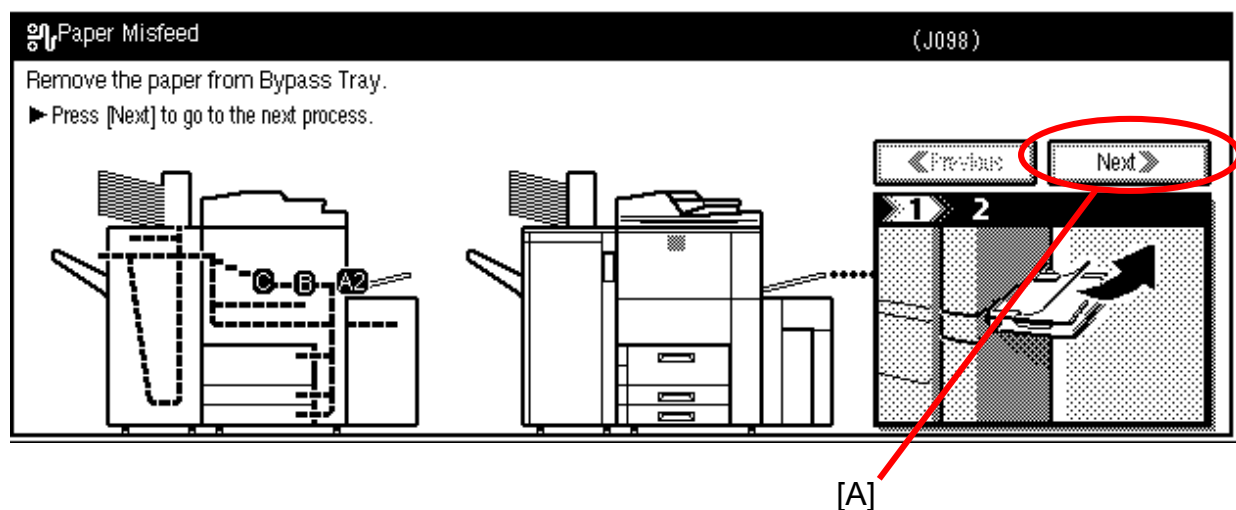
"Paper Misfeed (J098)" or "Paper Misfeed (J099)" is displayed on the operation panel.

- J098:
  - The Paper Type Detect setting is ON, and
  - The paper type or thickness setting does not match that of the first sheet
- J099:
  - The Double Feed Detect setting is ON, and
  - The paper type or thickness setting does not match that of the second or later sheets

1. If J098 or J099 occur, press the "Next" button [A] on the operation panel. Then, follow the instructions that are displayed.

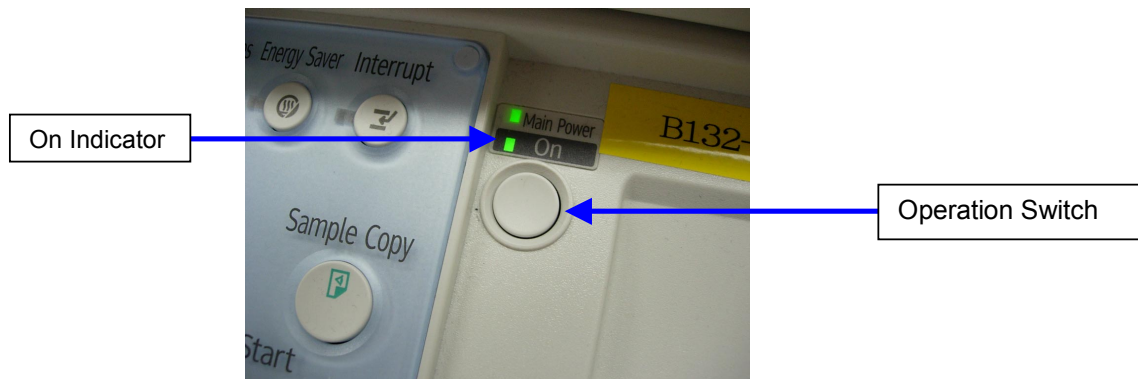
**Important:** Before you do Step 2, make sure that the green light of the "On" indicator **turns off**. If you do Step 2 when the indicator is still on, this can damage the hard disk and cause a malfunction.

1. Press the operation switch until the "On" indicator turns off.

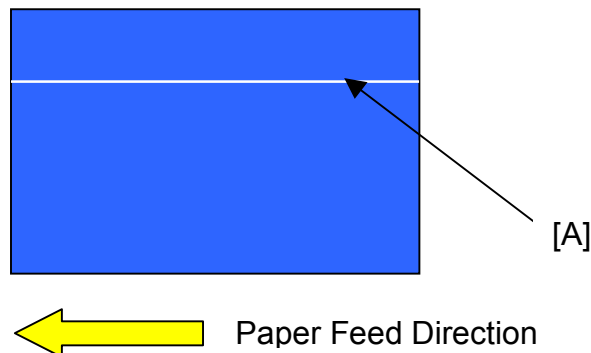
A white line [A] appears along the paper feed direction in solid image areas that use one toner color (C, M, Y or K).

Dust or other foreign particles get into the development unit, and then get stuck between the doctor blade and development sleeve.

- When the symptom occurs:
  1. Remove the developer from the development unit(s) that show the symptom.
  2. Remove the extra toner and developer from the development unit(s) with a vacuum cleaner.
  3. Install the new developer.
- When you install the developer cartridge or replace the developer:

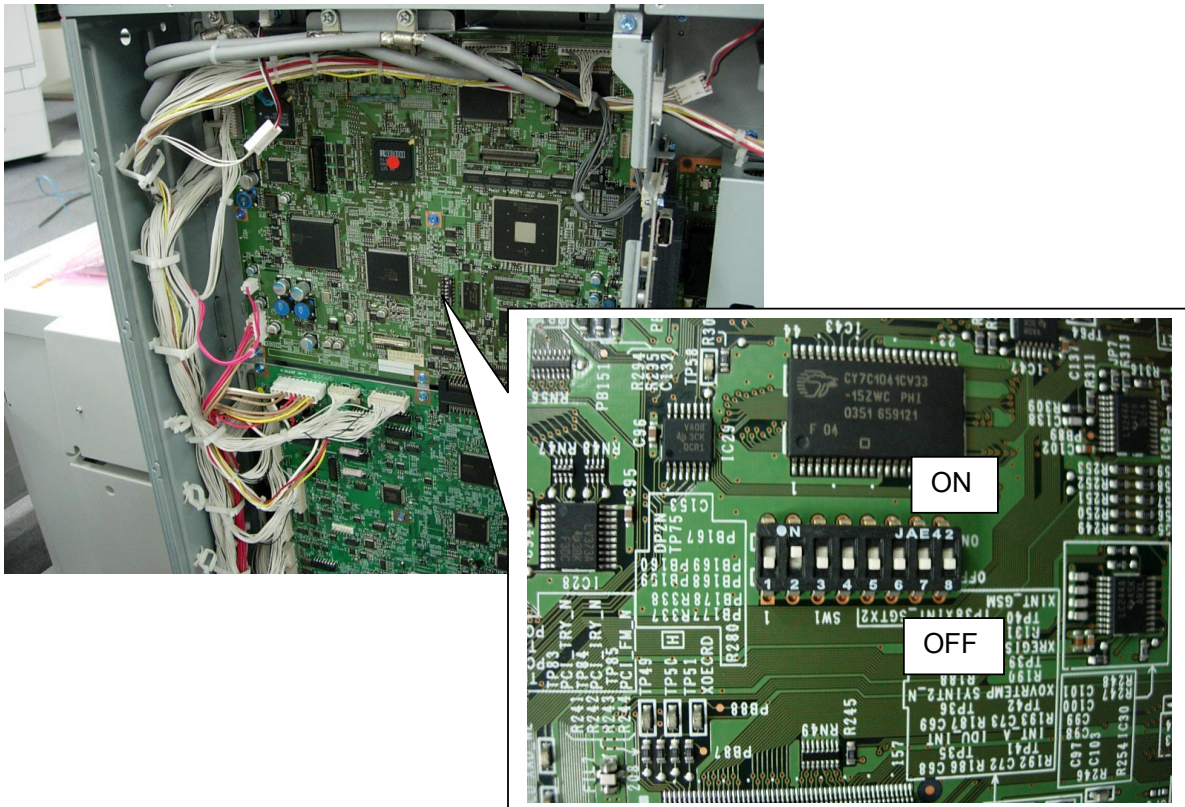
When you replace the BICU board, make sure that the DIP switches are set to the correct positions.

**Example:** A **220/230/240V** machine (only DIP SW #2 is ON, the others are OFF).

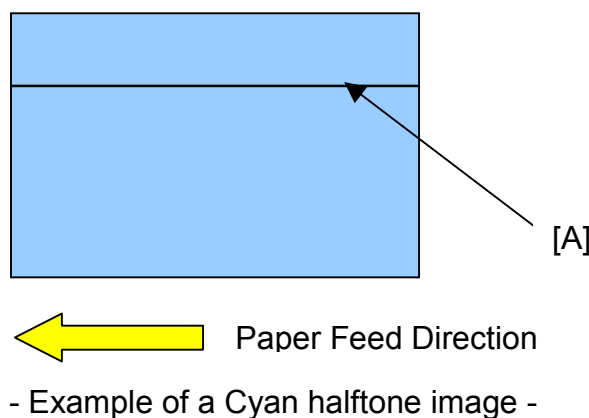
- (1) A dirty black line [A] shows in the sub scan direction in single color (C, M, Y or K) halftone images

The drum charge roller becomes dirty. This can be a common occurrence especially in high CV machines, or in machines used under low temperature/low humidity conditions (temperature 10 degrees C [50 degrees F] / humidity 15%).

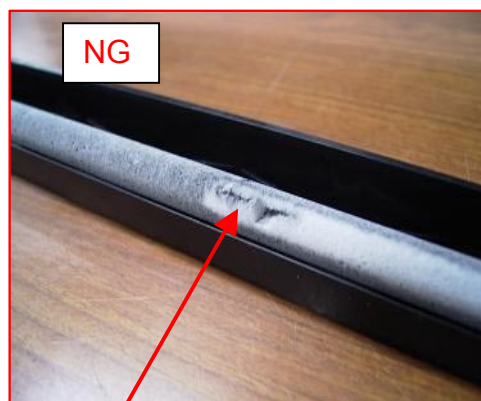
If the vacuum nozzle touches the cleaning roller, this kind of damage will occur.

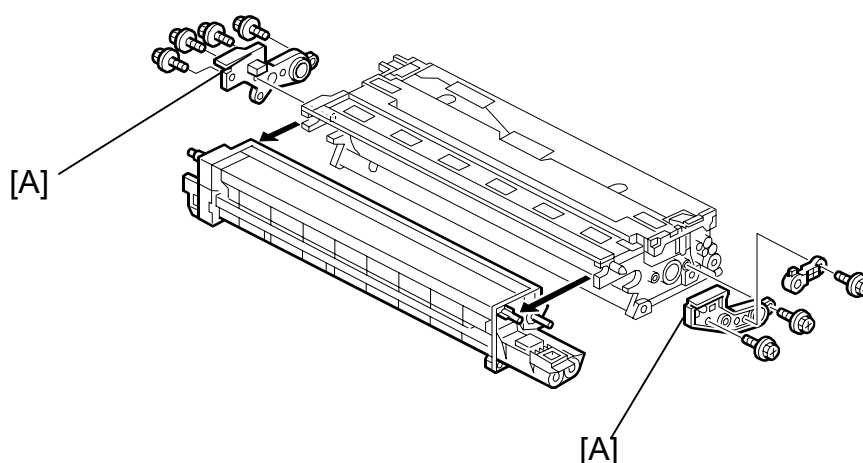
Rust can develop on the surface of the ball bearings inside the PCU faceplates, as the bearings are made of degreased chrome steel (not stainless steel).

At the time of machine installation, replace the defective PCU faceplates with modified ones, whose ball bearings are made of stainless steel.

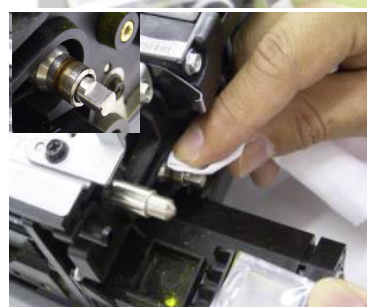
**Note:** This can occur if the lower shaft (shown by the pink arrow) gets stuck in the hole.

4. If you see rust on the surface of the lower shaft:

- Wipe off the rust with a dry cloth, and then clean the shaft with alcohol

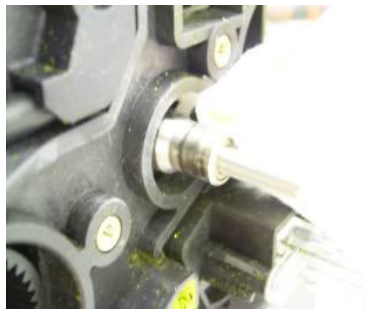
7. Remove the "PCU Face Plate-Rear".  
Use a pair of needle-nosed pliers as shown if the removal procedure is difficult.  
**Note:** This can happen if the lower shaft (shown by the pink arrow) gets stuck in the hole.

8. If you see rust on the surface of the lower shaft:

- Wipe off the rust with a dry cloth, and then clean the shaft with alcohol.
