Model: General		Date: 23-Jan-06	No.: RGene021
Subject: Data Overwrite Security Unit Installation		Prepared by: H.Matsui	
From: 2nd Tech Support Sec. Service Support Dept.			
Classification:	<input type="checkbox"/> Troubleshooting	<input type="checkbox"/> Part information	<input type="checkbox"/> Action required
	<input type="checkbox"/> Mechanical	<input type="checkbox"/> Electrical	<input checked="" type="checkbox"/> Service manual revision
	<input type="checkbox"/> Paper path	<input type="checkbox"/> Transmit/receive	<input type="checkbox"/> Retrofit information
	<input type="checkbox"/> Product Safety	<input type="checkbox"/> Other ()

Service Manual Revision

Model: Dolphin-C2	Date: 19-May-06	No.: RB188001a
-------------------	-----------------	----------------

Subject: Firmware Release History (Scanner:scn)		Prepared by: F. Noguchi	
From: 1st Tech. Support Sec. Service Support Dept.			
Classification:	<input type="checkbox"/> Troubleshooting	<input type="checkbox"/> Part information	<input type="checkbox"/> Action required
	<input type="checkbox"/> Mechanical	<input type="checkbox"/> Electrical	<input type="checkbox"/> Service manual revision
	<input type="checkbox"/> Paper

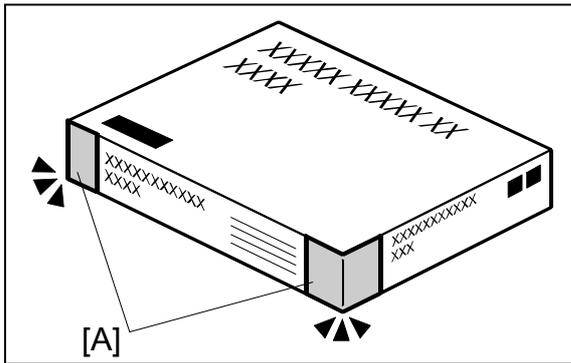
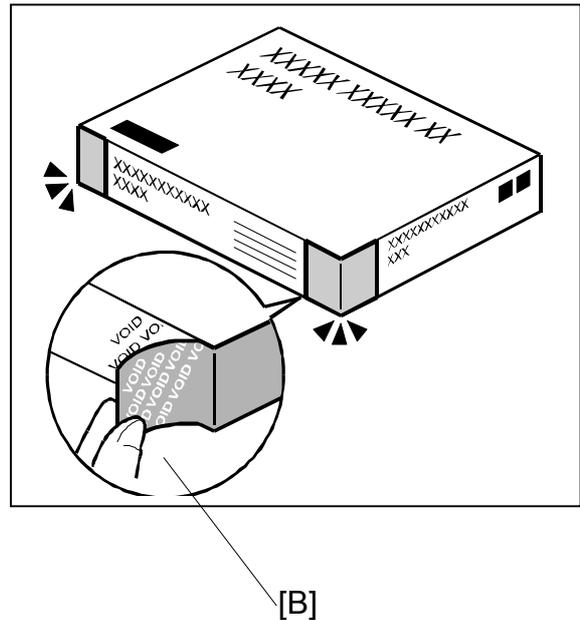
1. Make sure that:
 - 1) The box has **two pieces of tape** [A] attached to the corners in the photo, **AND**
 - 2) These two tapes are **blank**.

➤ If you can see “VOID” on the surface of the tape, DO NOT install the components in the box. Stop this procedure and contact your Sales division.
2. If the results of Step 1 are OK, remove the two pieces of tape from the box.
Note: After you remove the tapes, you will see “VOID” written on the box under the tape [B]. This is normal.

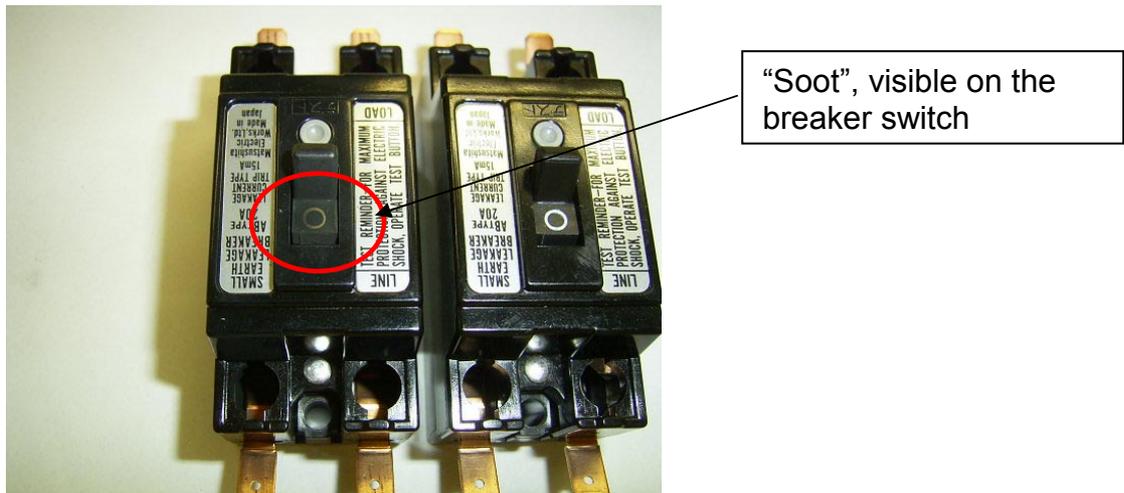
The machine does not power up when the main power switch is turned ON.

Damaged breaker

Normal breaker

The AC power source fluctuates to a level of 400V or higher, which damages the breaker.

Replace the breaker.

Important: Never continue using a damaged breaker. Always replace it. If a damaged breaker is used, spikes in the AC power source can damage the PSU.

Note: To prevent any damage to the breaker from fluctuations in the AC power source, it is recommended to install a constant-voltage transformer (voltage stabilizer).

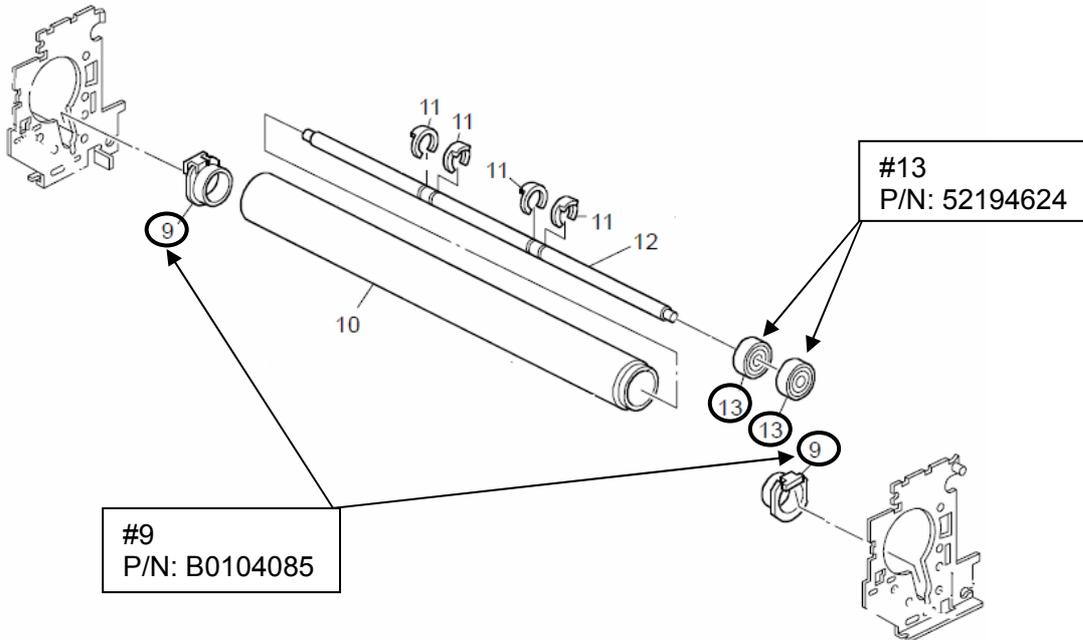
Part number	Description	Q'ty	Page	Index	Note
Incorrect	52194624	Ball Bearing – 20x42x12	2	57	9	
	B0104085	Pressure Roller Holder	2	57	13	
Correct	52194624	Ball Bearing – 20x42x12	2	57	13	
	B0104085	Pressure Roller Holder	2	57	9

Change/Reason: The index numbers in the parts list were corrected as shown.

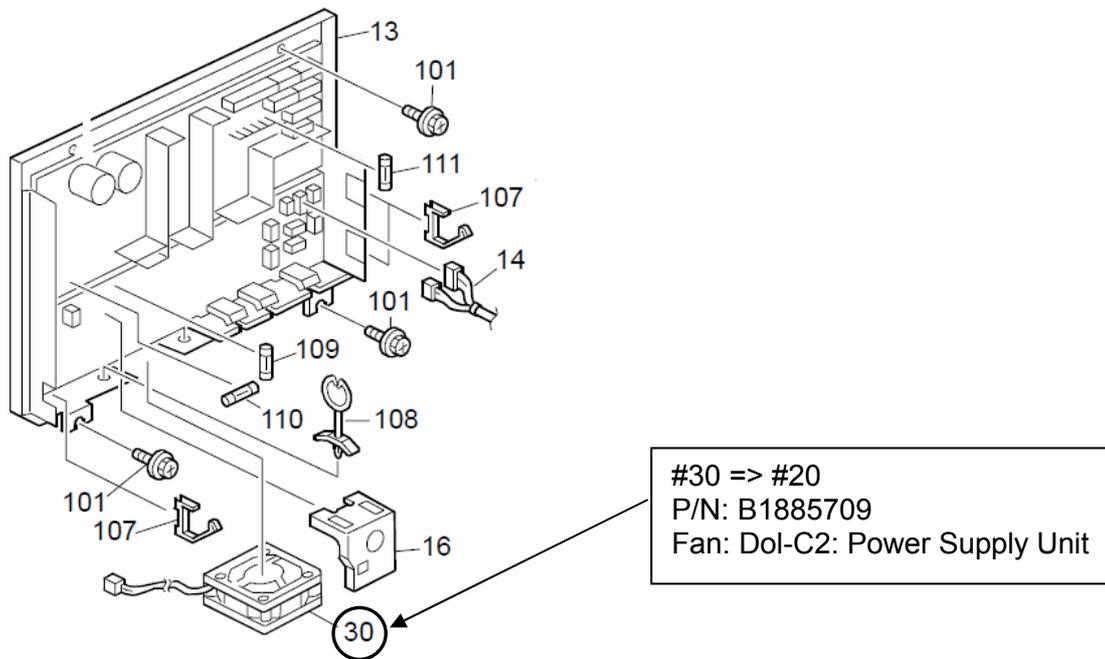
30. Electrical Section 1 (B188)

Change/Reason: The index number in the illustration was corrected as shown.

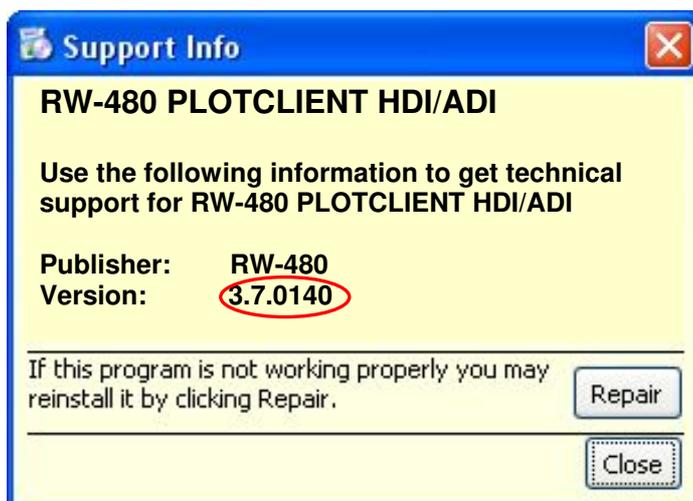
You can find that the version number "3.7.140" is displayed as "3.7.0140".
