Model: Stinger – C1		Date: 31-Aug-99	No.: RA250001
Subject: Exit plate guide location		Prepared by: K. Miura	
From: Technical Service Dept., GTS Division			
Classification:	<input checked="" type="checkbox"/> Troubleshooting <input type="checkbox"/> Mechanical <input checked="" type="checkbox"/> Paper path <input type="checkbox"/> Other ()	<input type="checkbox"/> Part information <input type="checkbox"/> Electrical <input type="checkbox"/> Transmit/receive	<input type="checkbox"/> Action required <input type="checkbox"/> Service manual revision <input type="checkbox"/> Retrofit information

Model: Stinger-C1		Date: 30-Sep-99	No.: RA250002
Subject: ROM History (Stinger-Copy Version)		Prepared by: K. Miura	
From: Technical Service Dept., GTS Division			
Classification:	<input type="checkbox"/> Troubleshooting <input type="checkbox"/> Part information <input type="checkbox"/> Action required <input type="checkbox"/> Mechanical <input type="checkbox"/> Electrical <input type="checkbox"/> Service manual revision <input type="checkbox"/> Paper path <input type="checkbox"/> Transmit/receive <input checked="" type="checkbox"/> Retrofit information <input type="checkbox"/> Other ()

Model:

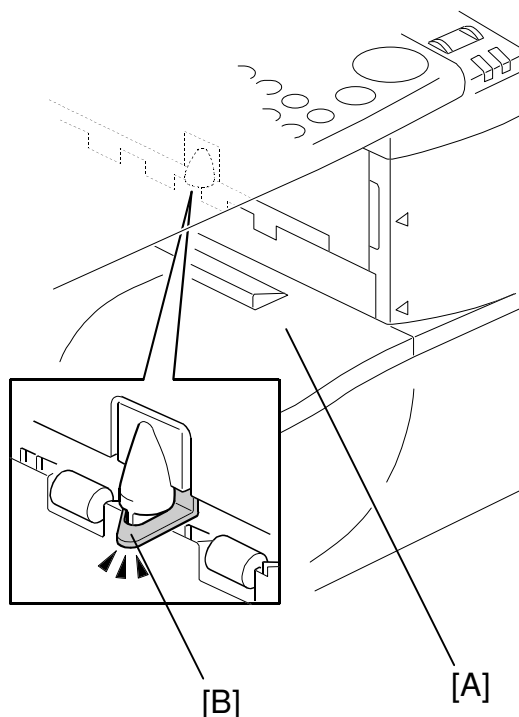
Paper misfeed at the exit guide plate.

The exit cover [A] was reinstalled without first pushing up on the exit guide plate [B], causing the exit guide plate to become caught between the cover and copier. This caused the paper to misfeed when it was fed out.

When reinstalling the exit cover, hold up the exit guide plate so that it will remain positioned above the cover.

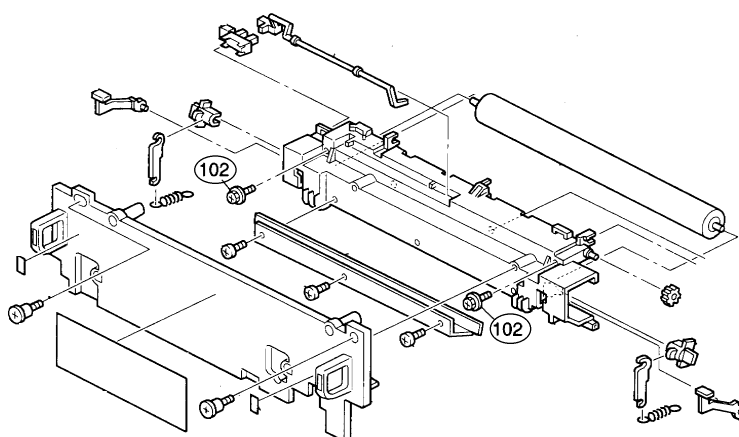
Please instruct all field technicians to tighten and loosen this screw very gently, as the metal will tend to grind away at the plastic screw holes.

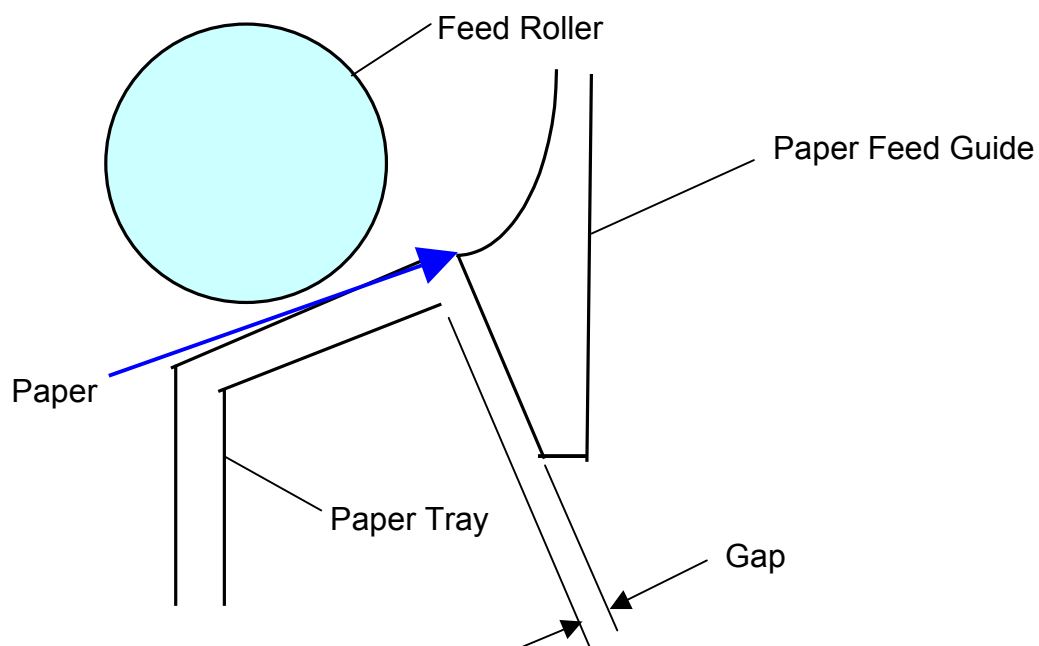
Illustration A

If paper is used that is already curled to begin with, the leading edge will run into the paper feed guide (A2502725) after the paper is fed by the feed rollers. This can cause dog ears and/or a paper jam to occur. See illustration A.

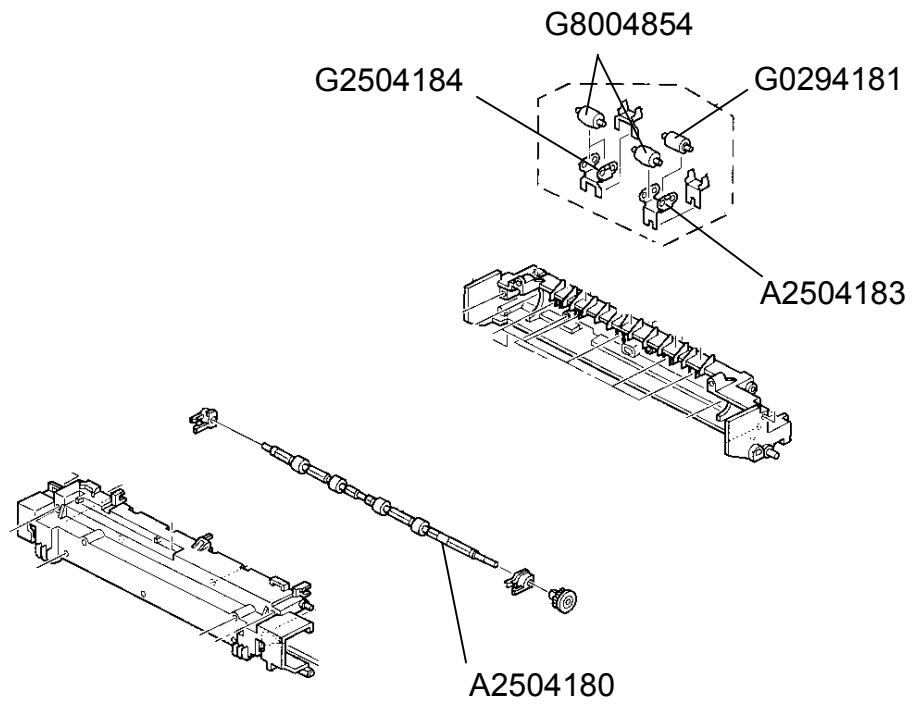
When the user tries to remove the jammed paper without first releasing the pressure release lever, this can put excessive stress on the spring plate causing it to deform. This can also put excessive stress on the roller shaft, causing shaft damage and noise.

Replace the rollers that exhibit the noise, along with their spring plates (A2504183/ A2504184, respectively). Although the noise may subside temporarily with the Barierta grease mentioned above (A2579300), the cause for this noise is not friction, but physical damage. Therefore, the noise would most likely reoccur without roller/plate replacement.

However if the replacement parts were not available and the grease was needed as a temporary solution, it is critical to use grease A2579300 only. As stated above, any other grease will cause a gradual buildup of friction and cause a recurrence of the noise.

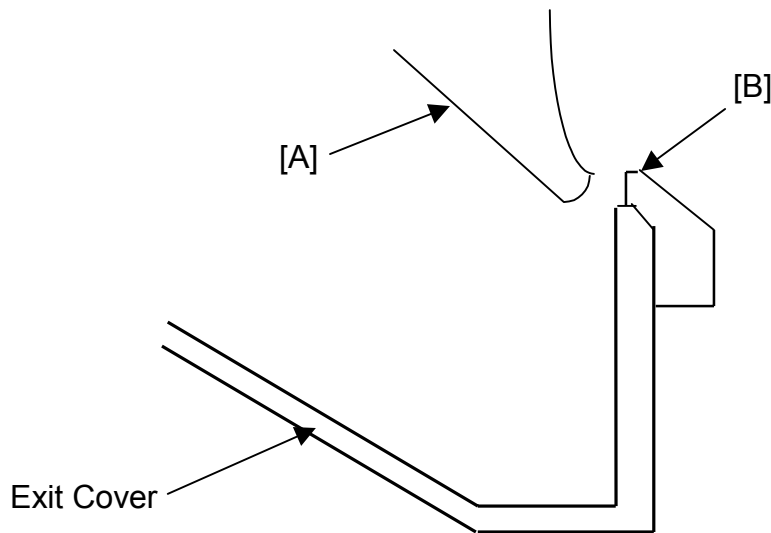
The junction gate [A] of the 1-bin sorter contacts the exit cover ribs [B], causing the gate not to function properly, which leads to the jam.

By moving the junction gate back and forth manually, check to see if the gate can move free of the exit cover ribs. If it cannot, replace exit cover A2501324 (Europe) or A2501274 (other) with the modified cover (A2501327), which has been designed to prevent any interference between the ribs and gate.

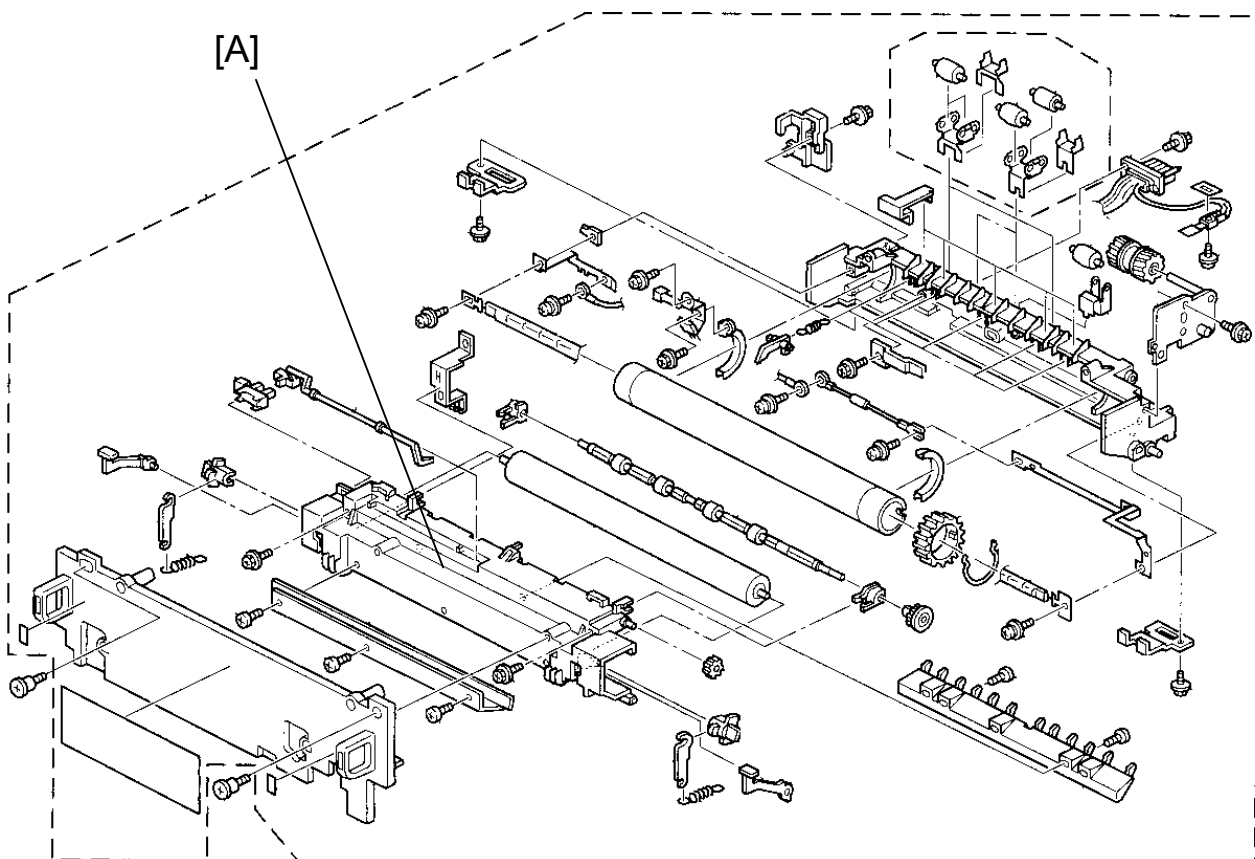
The paper is normally fed out by guiding the leading edge between the two sets of exit rollers. However when the paper is curled, it impacts with the pressure roller case and causes a jam.

To ensure that the leading edge of the paper is properly fed between the exit rollers, a rib has been added to the pressure roller case [A] that will act as a guide. The P/N was changed from A2504105 to A2504106. Please refer to MA250033 for the cut-in serial numbers.

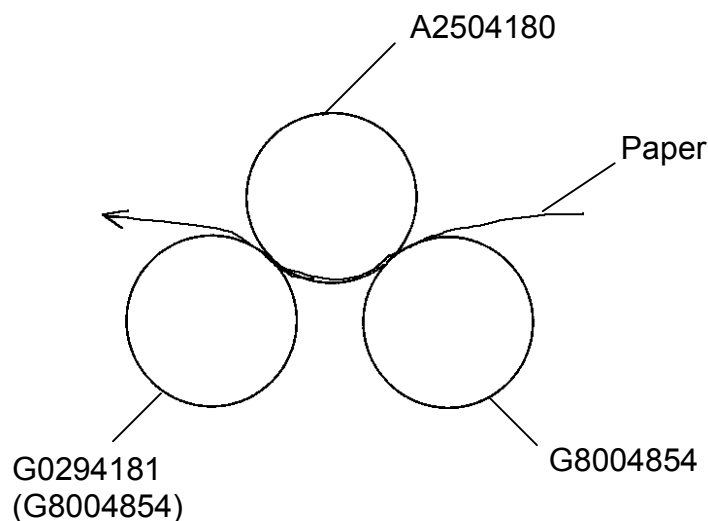
One cause for this is the bending/deforming of the plate spring when the customer forcefully removes the paper from the exit unit without using the pressure release lever. In addition, the rollers can come out of position if the screws in the fusing unit cases are loose (having stripped the hole threading).

Check the spring plate to see if it is bent and the exit rollers to see if they are tightly in position as they should be. If this is difficult to determine from a visual inspection, the surest way to fix this is to replace the fusing unit with a new one (or one that is known to have no problems).
