RIGON **Technical Bulletin** No. RTB-001 SUBJECT: Service manual correction DATE:Nov. 15, '96 PAGE: 1 of 4 PREPARED BY: T. Itai FROM: 2nd Field Information Dept. QAC CHECKED BY: S. Fujii **CLASSIFICATION:** MODEL: AD1 Revision of service manual Information only ☐ Troubleshooting Retrofit Information Other

The following parts of the service manual have been corrected.

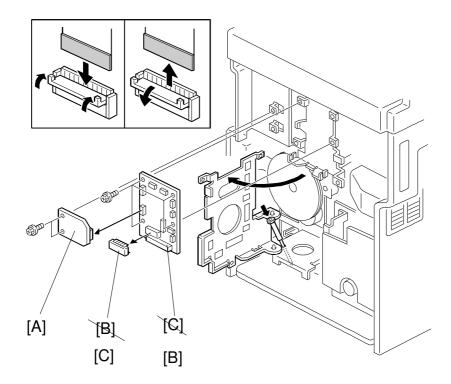
11. MSU BOARD/BICU BOARD, page 6-36The callouts should be corrected as follows.

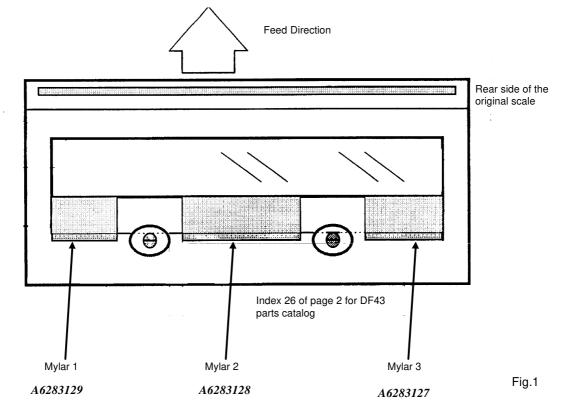
1. The *three* mylars have been added on the original scale (A6283192) to prevent the scanning position on the exposure glass from becoming dirty.

Because the contact position of the original becomes dirty with paper dust, it has been moved from the scanning position by using mylars.

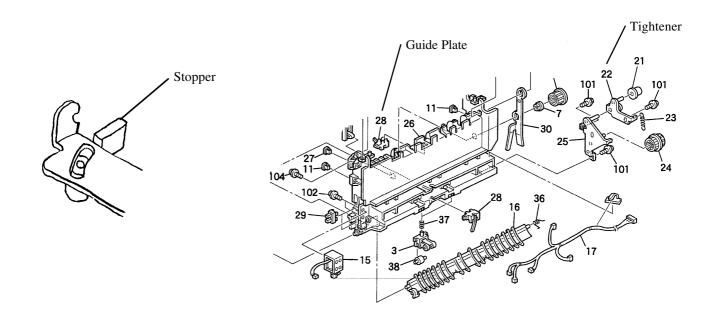
A stopper has been added on the guide plate.

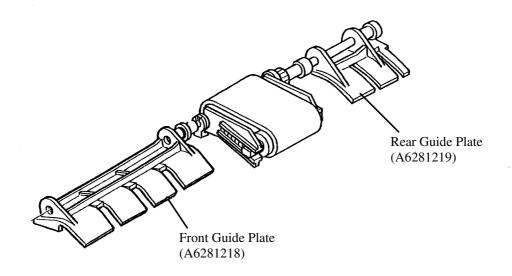
The color of the Front and Rear Guide Plates has been changed from black to a clear color.

Current	New
Front Guide Plate	A628 1218B	A628 1218C
Rear Guide Plate	A628 1219B	A628 1219C

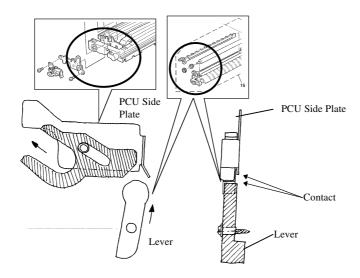
When the PCU is not installed completely, the side plate is shifted to the front and the lever of the transfer unit may come in contact with the side plate.

The corner of the lever has been cut to prevent the lever from coming in contact with the side plate of the PCU.

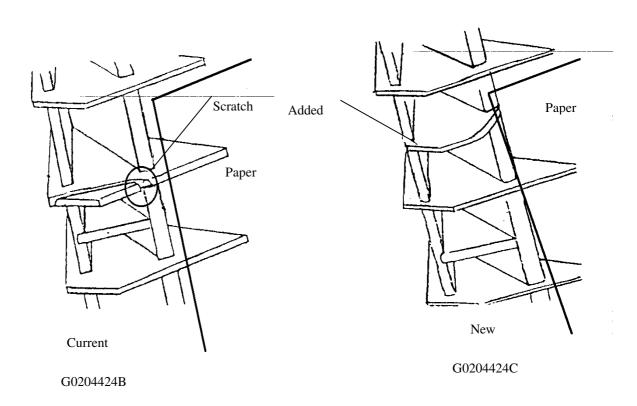
A rib has been added to the Junction Gate inside the Legal paper width.

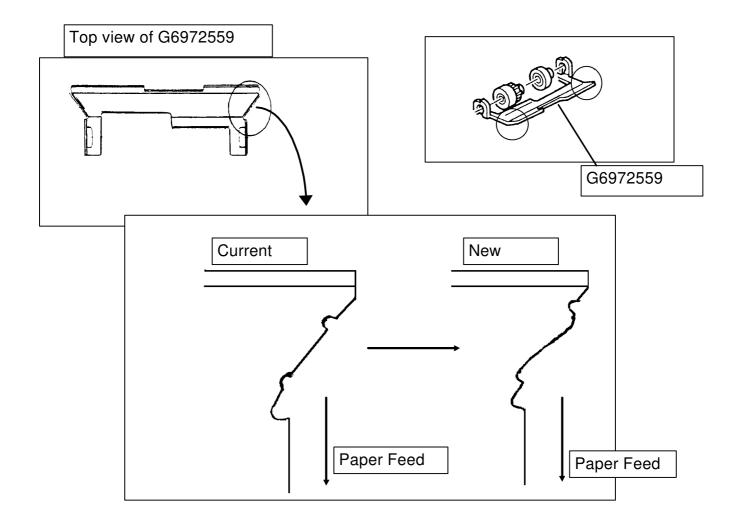
The shape of the upper guide - paper feed has been changed from January Production '97.

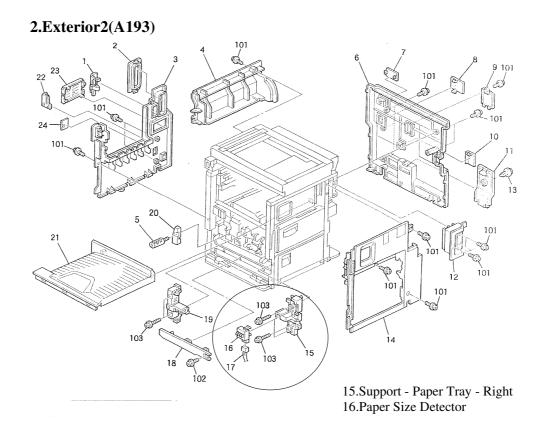
The position of the switch has been shifted to the front by changing the shape of the Support - Paper Tray (G0202676) from January '97 production.

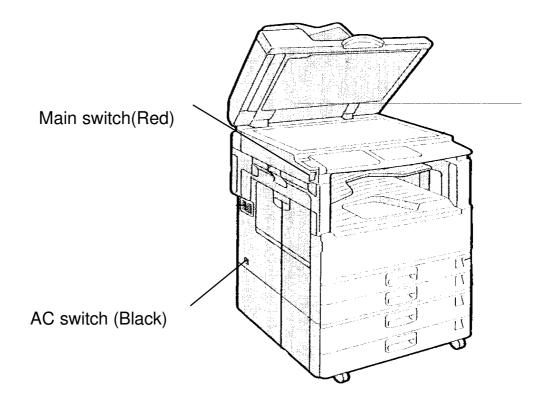
Arcing occurs and a surge current flows into the main control board (P/N A666-5550) of the AD-1 Finisher when the power cord is plugged into the power source of the main frame (copier) while power is applied. This may result in possible damage to IC116 and /or IC110 on the main control board.

If only the main switch (Red) is turned off, power is still applied to the Finisher. The AC switch (Black) should also be turned off to shut down the power to the Finisher.

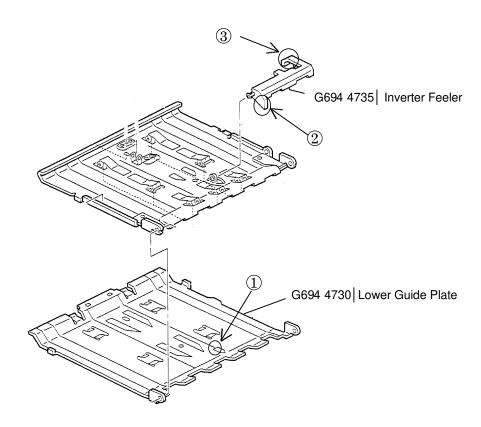
Figure 1

This moves component ③ of the Inverter Feeler closer to the Photointerrupter (AW020075). Then, the Inverter Feeler may often vibrate after the paper passes.

This may lead to the Inverter Feeler interfering with the signals from the Photointerrupter.

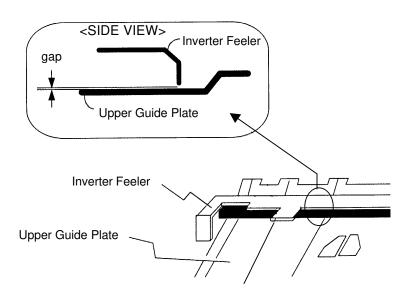
Figure 2

The Inverter Feeler normally rests on the Upper Guide Plate if it is free. Replace or reshape the Lower Guide Plate if you find a gap between the Inverter Feeler and the Upper Guide Plate, because the uplifted Lower Guide Plate has lifted up the Feeler.

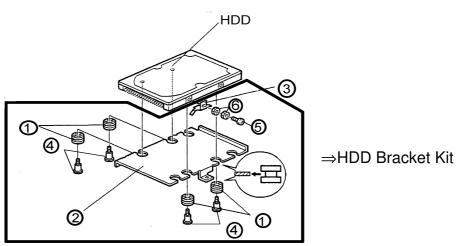
The HDD bracket has been modified for the print-overrun problem caused by vibration from the duplex unit (refer to RTB37). These new brackets have been available from June production in 1997 (the cut-in serial number is A7327060001-)

If you have the print overrun problem on an AD1 with a duplex unit or when you visit a customer whose machine has the old HDD bracket, please change the bracket to a new type.

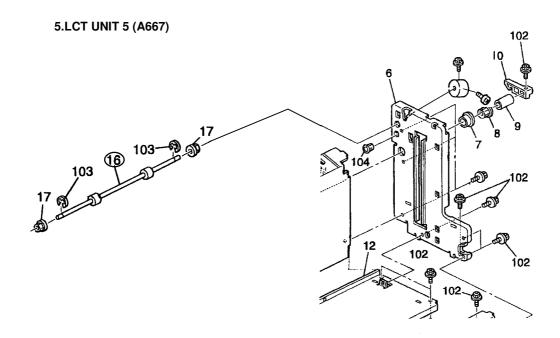
To reduce the rotation noise from the relay roller, a fly wheel is added to stabilize the rotation. The material of the shaft and the shape of the timing pulley have been modified.
