Model: Russian-C		Date: 15-Dec-99	No.: RA265001
Subject: Quick dial problem		Prepared by: K. Miura	
From: Technical Services Dept., GTS Division			
Classification:	<input checked="" type="checkbox"/> Troubleshooting	<input type="checkbox"/> Part information	<input type="checkbox"/> Action required
	<input type="checkbox"/> Mechanical	<input type="checkbox"/> Electrical	<input type="checkbox"/> Service manual revision
	<input type="checkbox"/> Paper path	<input type="checkbox"/> Transmit/receive	<input type="checkbox"/> Retrofit information
	<input type="checkbox"/> Other (      )

Model: Russian-C1		Date: 15-Feb-00	No.: RA265002
Subject: Service Manual Correction		Prepared by: S. Tomoe	
From: Technical Services Dept., GTS Division			
Classification:	<input type="checkbox"/> Troubleshooting <input type="checkbox"/> Part information <input type="checkbox"/> Action required <input type="checkbox"/> Mechanical <input type="checkbox"/> Electrical <input type="checkbox"/> Service manual revision <input type="checkbox"/> Paper path <input type="checkbox"/> Transmit/receive <input type="checkbox"/> Retrofit information <input checked="" type="checkbox"/> Other (      )

Model: Russian-C1

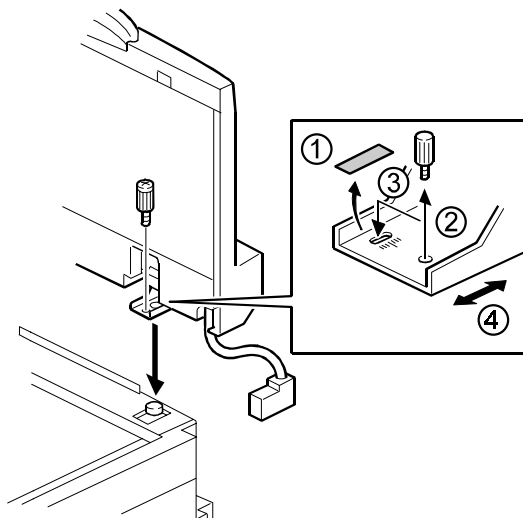
Figure 1

Scanner rear upper cover

If the skewing on the original cannot be corrected, replace the scanner rear upper cover and/or the right hinge of the ADF.

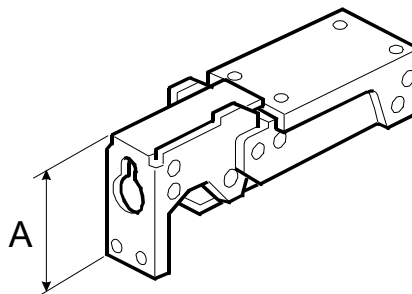
Figure 2

Right hinge

A: 58.5 mm → 57.5 mm

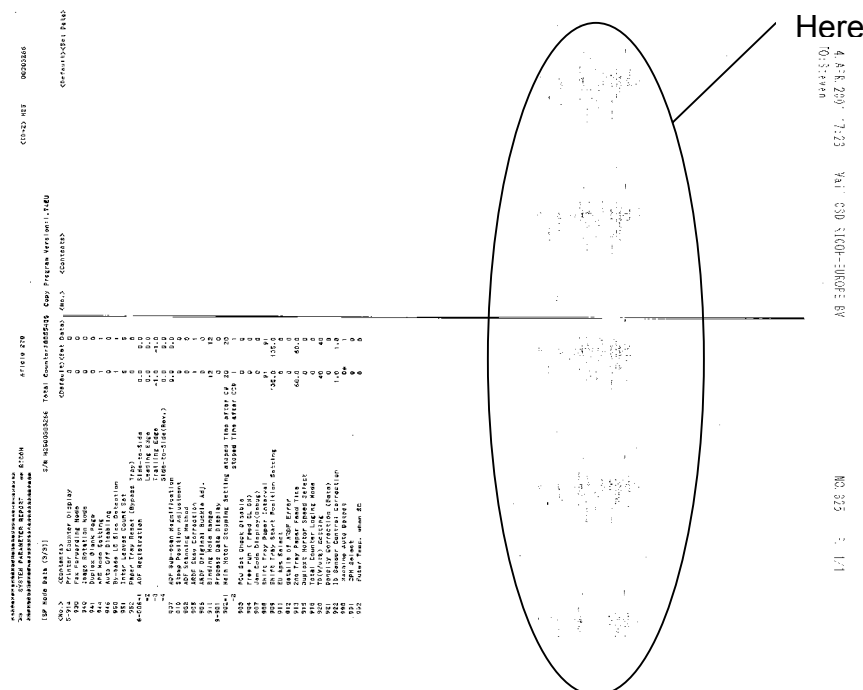
Broken black stripes appear on copies (see below).

The Russian-C1 has toner recycling mechanisms. However, there are cases where broken black stripes can appear on copies when paper dust in this recycled toner builds up on the drum or charge roller surfaces. If the paper dust is on the charge roller surface, the stripe intervals will be in the pitch of the roller. The cleaning mylar, which contacts the registration roller, normally collects paper dust and prevents such copy problems. However, when there is an abnormally large amount of paper dust present, the mylar is not able to collect all of it, which can cause some to get into the PCU.

Clean out the paper dust that has accumulated between the dust cleaning mylar and registration roller:

1. Detach the support arm from the right cover, then remove the ID sensor connector and right cover.
2. Being careful not to scratch the mylar, slide the vertical transport guide plate to one side and remove it.
3. Remove the registration guide plate (2 screws).
4. Slide a piece of thick paper, or other material that will not scratch the roller, in between the registration roller and mylar. Then, while sliding the paper back and forth, remove the accumulated paper dust.

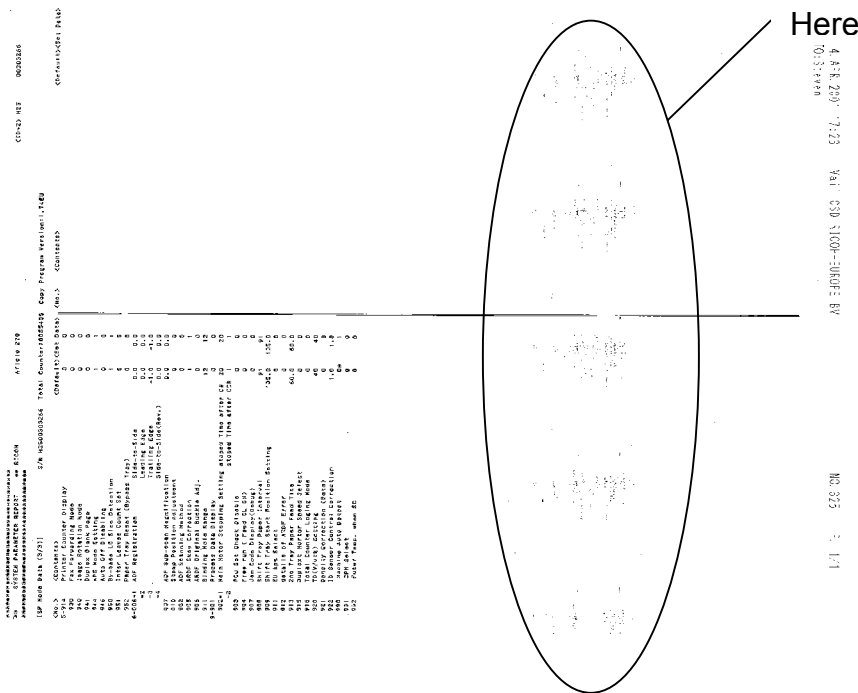
Broken black stripes appear on copies (see below).

The Russian-C1 has toner recycling mechanisms. However there are cases where broken black stripes (see below) can appear on copies when paper dust in this recycled toner builds up on the drum or charge roller surfaces. If the paper dust is on the charge roller surface, the stripe intervals will be at the pitch of the roller. The cleaning mylar, which contacts the registration roller, normally collects paper dust and prevents such copy problems. However, when there is an abnormally large amount of paper dust present, the mylar is not able to collect all of it, which can cause some to get into the PCU.

Clean out the paper dust that has accumulated between the dust cleaning mylar and registration roller:

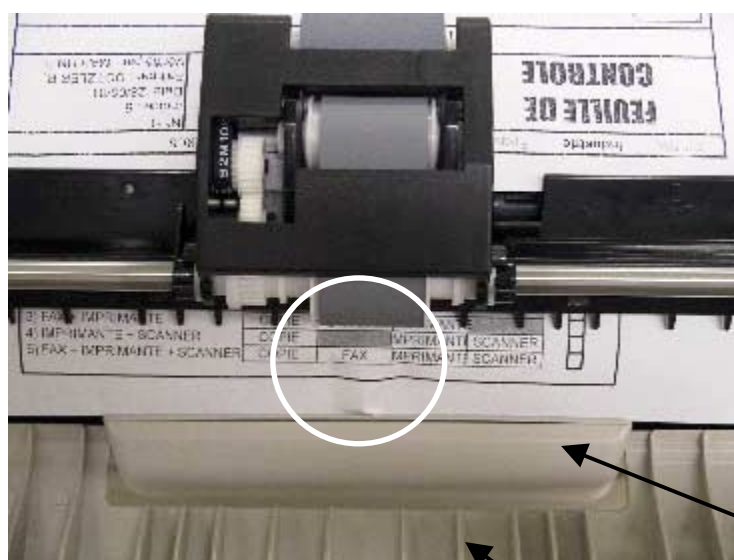
Pull out Roller Guide

An original jam occurs if the leading edge contacts the pull-out roller guide while the second side is being scanned.
