Model: Adonis-C1 (Scanner Option)		Date: 05-Apr-00	No.: RA283001
Subject: Service Manual Correction		Prepared by: K. Takagi	
From: Technical Services Dept., GTS Division			
Classification:	<input type="checkbox"/> Troubleshooting <input type="checkbox"/> Part information <input type="checkbox"/> Action required <input type="checkbox"/> Mechanical <input type="checkbox"/> Electrical <input checked="" type="checkbox"/> Service manual revision <input type="checkbox"/> Paper path <input type="checkbox"/> Transmit/receive <input type="checkbox"/> Retrofit information <input type="checkbox"/> Other (      )

Please add the following SP mode in your Adonis-C1 Scanner Kit service manual, on page 4-2.

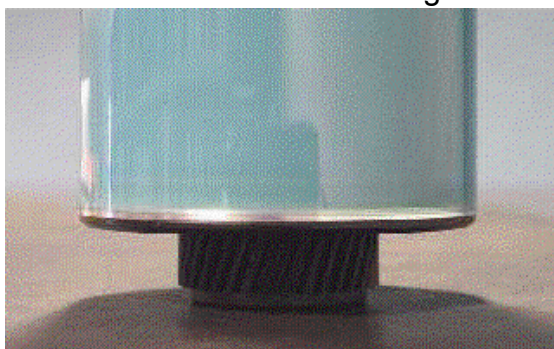
Before/After Nov '00 Change:

The following picture can be used to visually distinguish between drums from November 2000 production and those from before/after:

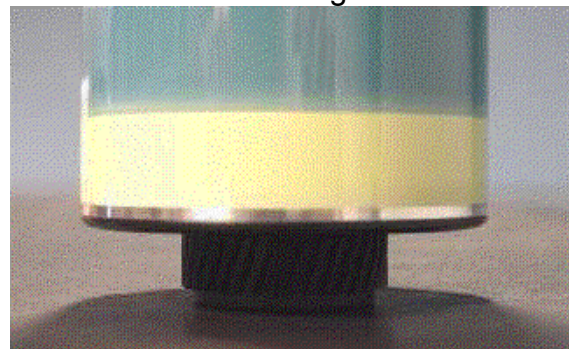
Nov '00 Change:

The photo-conductive CGL layer is not applied to an area 14 mm from one end of the drum edge (see photographs below). This area is outside the image writing area. Tests on the prototypes confirmed that there was no change in performance or quality between the two drums, and therefore no effect on image quality.
