Model: NAD 30S/30/40		Date: 31-May-98	No: MA230001a												
Subject: China/Taiwan Version Information		Prepared by: S. Tomoe													
From: Technical Service Department.															
Classification:

The China and Taiwan version are going to be produced from June 1998. This RTB clarifies the differences between other Ricoh versions and China/Taiwan versions.

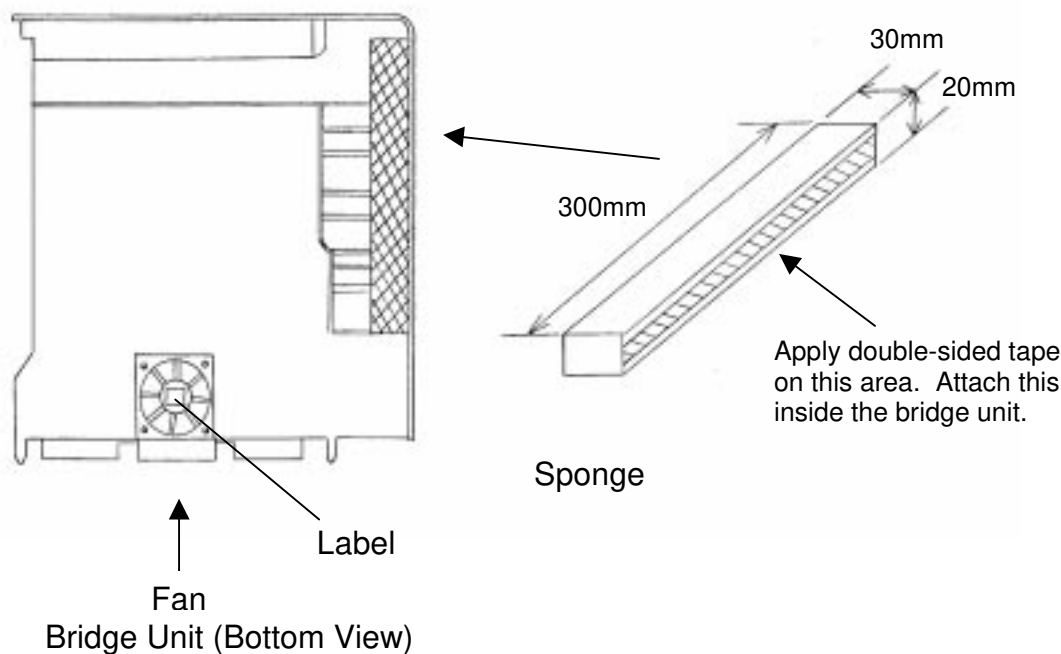
If a large number of copies are made shortly after the power has been turned on, condensation may develop inside the bridge unit. Droplets of water will then adhere to the edge of the paper and eventually lead to leaking from the bridge unit. In low humidity environments, the paper may absorb the humidity.

Please see below for details concerning the size of the sponge and the position where it should be attached.

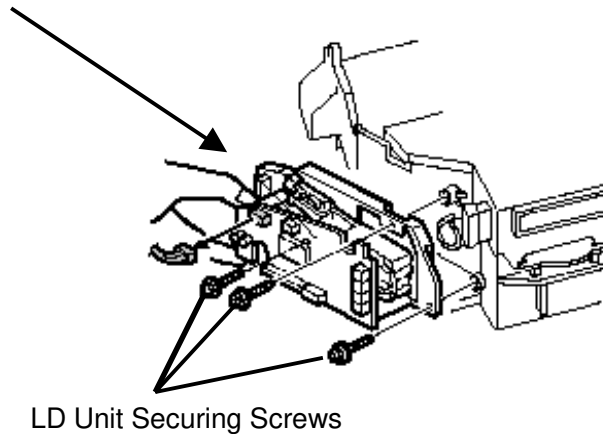
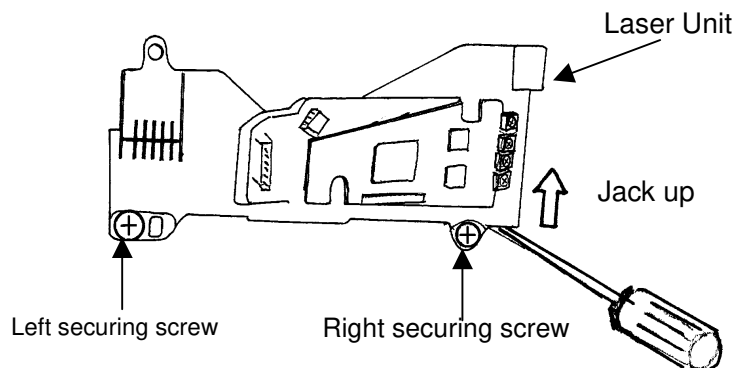
Laser Diode Unit

2. Make sure the three laser diode unit securing screws are not loose. If the screws are loose, tighten the screws and check to see if the SC322/SC326 has been solved. If the SC Code still appears, follow the steps below to twist the laser unit.

3. Loosen the two securing screws for the laser unit (see the illustration below).
4. Tighten the right securing screw while jacking up the right side of the laser unit with a screwdriver.

5. Tighten the left securing screw and put the inner cover back on.
6. If SC322/SC326 is still indicated after the above action, replace the laser unit with a brand new one.

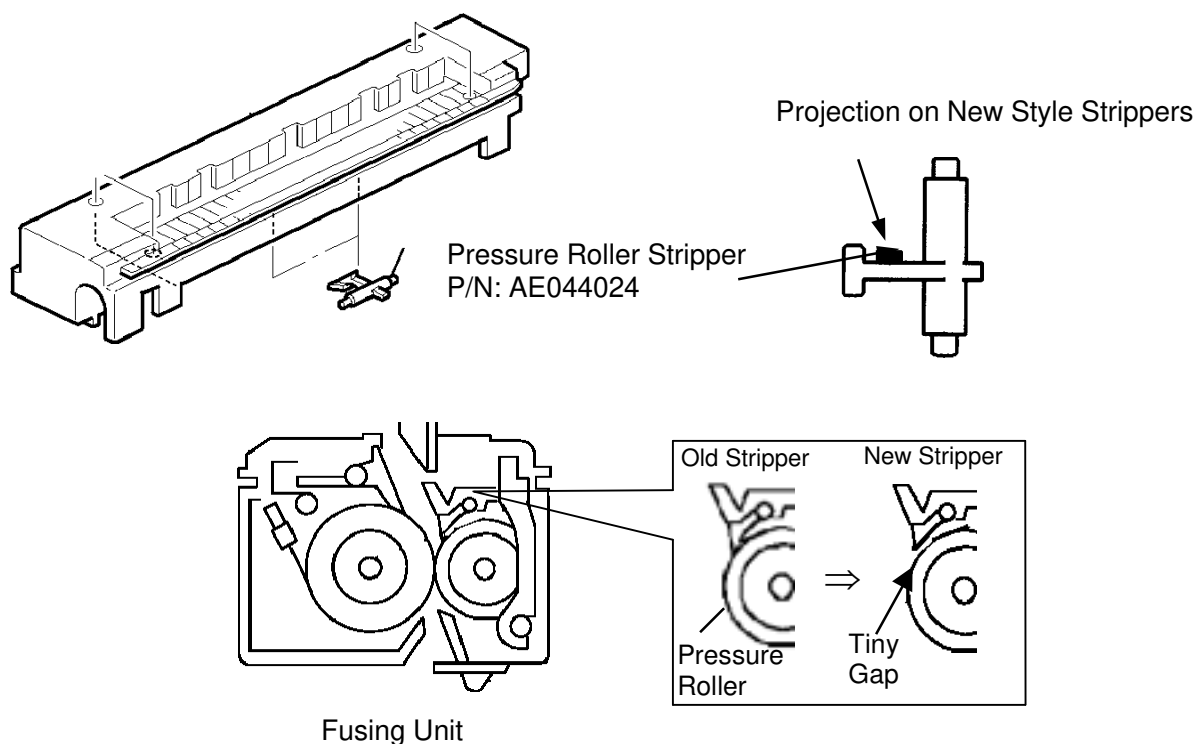
The fusing pressure roller is damaged by the pressure roller stripper.

When the copies jam in the fusing section, are not removed completely and the customer restarts copy job, the copies jammed in the fusing section bunch up and press the pressure roller stripper. This causes the stripper edges to dig into the pressure roller.

Replace the strippers to the new style ones and ask customer to check the fusing section by opening the right side cover when a paper misfeed occurs.

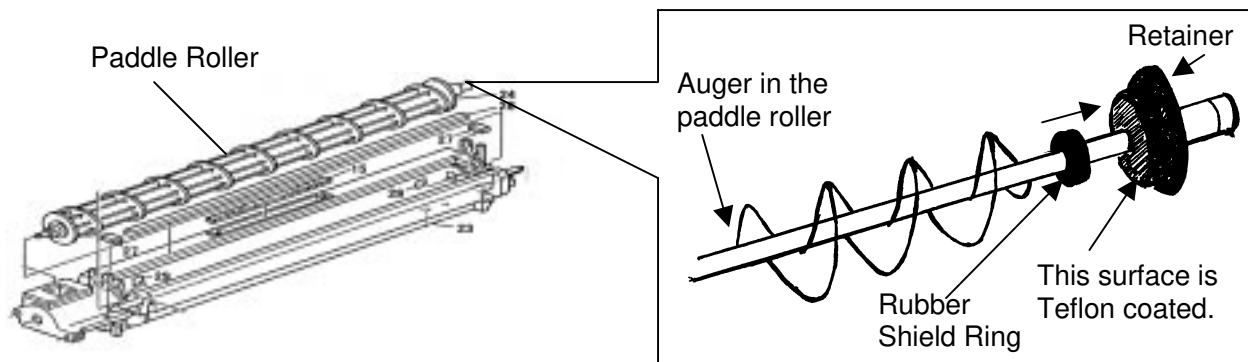
The temperature of the rubber shield ring in the paddle roller goes up in a repeat copy mode of more than 40 and friction occurs between the rubber ring shield and the retainer. This friction results in noise from the retainer and the ring.

The development unit should be replaced with the new type if the noise from the development unit does not disappear. The part number for the new development unit is A232-7460 . The start serial number of the machines with the new development unit will be announced by an MB.

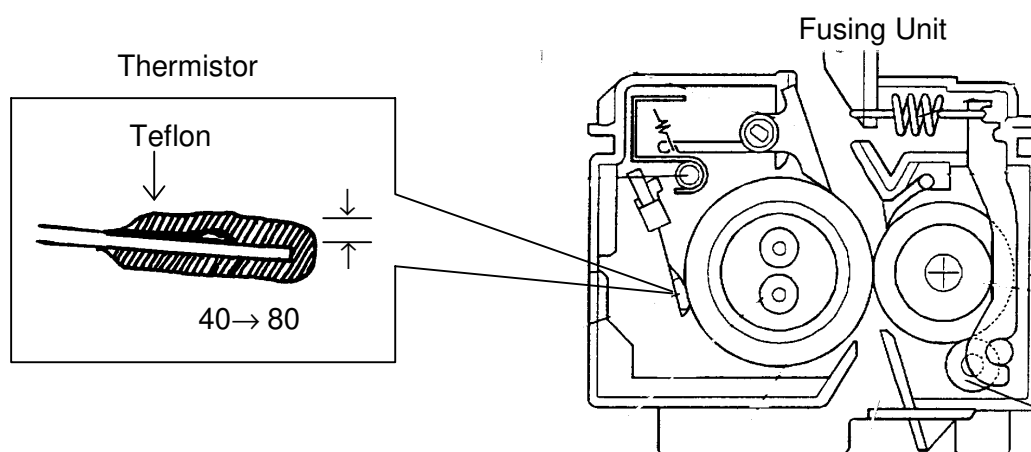
A mixture of toner and paper dust is stuck on the surface of the thermistor. This mixture hardens as the fusing temperature goes up and down. Therefore, the amount and the hardness of the solid stuck on the thermistor are affected by the type of paper and operating conditions. Please note that these conditions may only exist on a limited number of rollers.

Replace the thermistor with one of the new type.

The thickness of the Teflon cover on the new type of thermistor has been increased to reduce the pressure on the hot roller in the event that a toner/paper mixture is stuck to it.

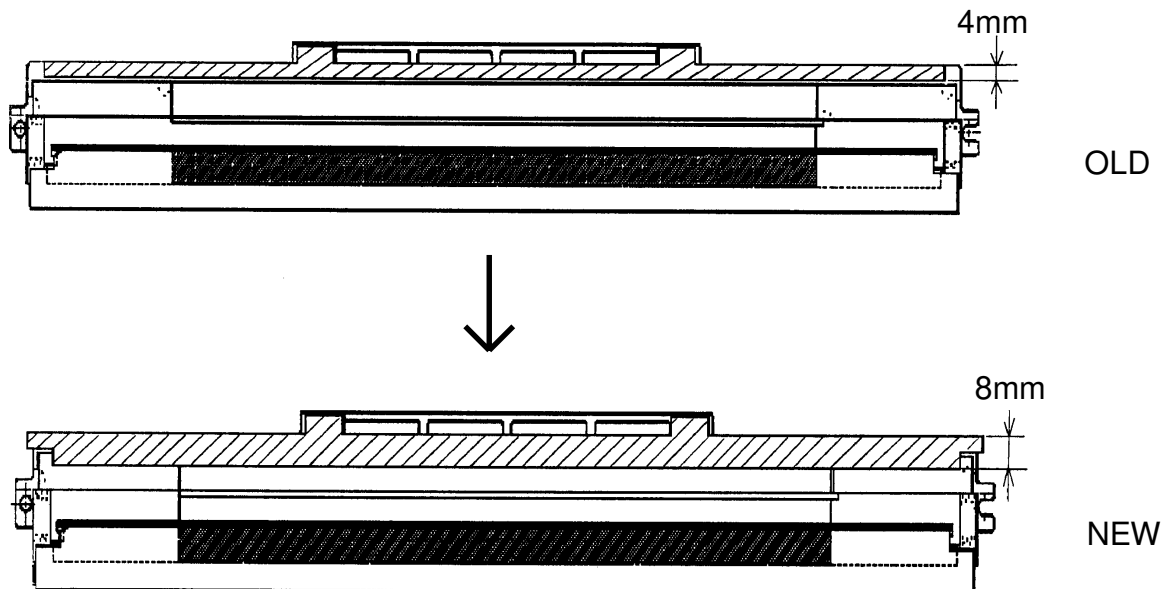
① : Entrance Seal Ass'y

Developer leakage from the development unit.

② : The width of seal 1 has been changed from 7 mm to 8 mm.
