Modification Bulletin

Model: SP3 Date			e: 15-Feb-98	No: 1		
Modified Article: Bushing for Development			Prepared by: E.Fukuyama			
From: QAC Field Information Dept.						
Reason for	□ Parts catalog correction	☐ Vend	lor ch	ange 🔲 To n	neet standards	
Modification:	☐ To facilitate assembly	☐ To im	nprove	ve reliability ⁽)		
	☐ Part standardization	Other

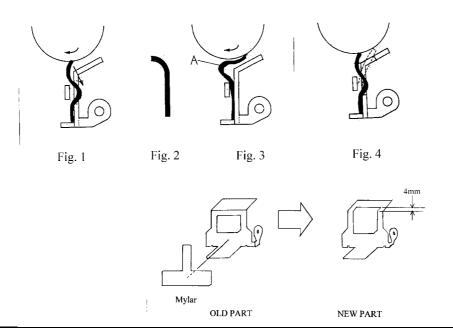
Mylar damage

The mylar should move as shown in Figure 1, but after repeated use of the 50-sheet stack mode in the duplex unit, the mylar may curl as shown in Figure 2. If the mylar becomes deformed as shown in Figure 2, then its movement will resemble that shown in Figure 3. If this movement is repeated, then section A of the mylar will be damaged.

To prevent the mylar from curling, the shape of the bracket has been changed so that the mylar will bend as shown in Figure 4 below.

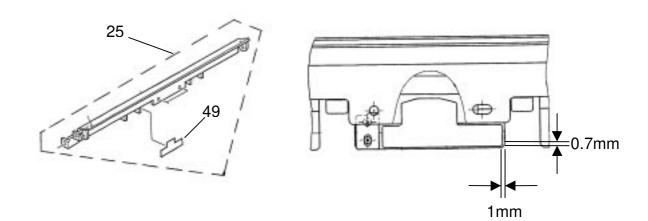
Please refer to the illustration below for the attachment position of the mylar.

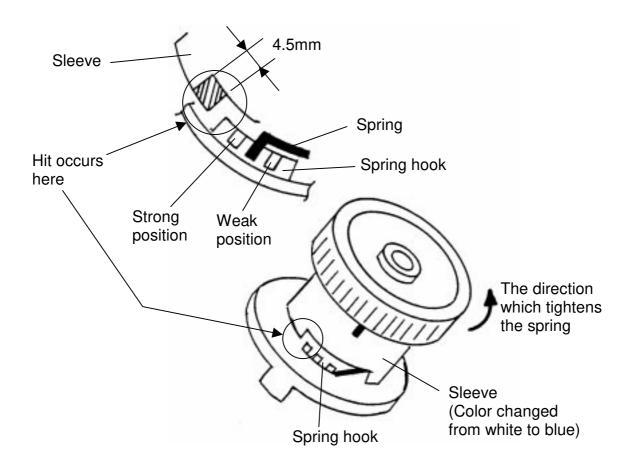
To reduce no-feed jams in the duplex unit caused by insufficient pressure from the bottom plate, the shape of the spring clutch has been changed. To distinguish between the old and new clutches, the color of the sleeve has been changed from white to blue.

The insufficient pressure occurs when the clutch turns in the direction which tightens the spring. This is because when the sleeve hits the spring hook, the spring cannot turn completely, so the bottom plate cannot be lifted up to the highest position.

To prevent the sleeve from hitting the spring hook, a 4.5-mm wide section of the sleeve has been cut away as shown.

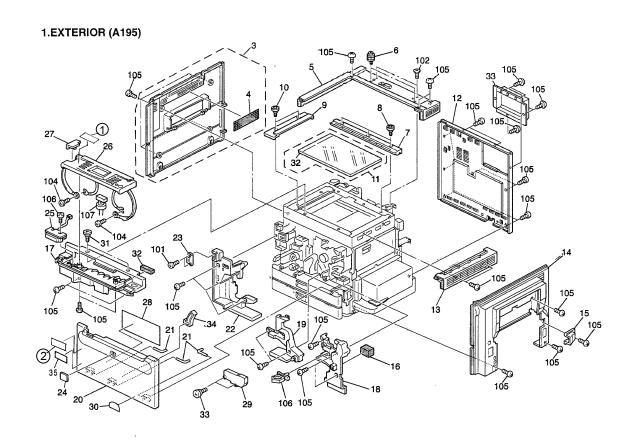
The Copy Tray Slide (index no.1), Copy Tray Guide (index no.2) and Copy Tray (index no. 30) should be deleted from the illustration on page 10.

Index number 30 listed on page 11 refers to the energy star decal. Index numbers 1 and 2 both refer to the decals that were not included in the original illustration.

Please adjust your illustrations accordingly as shown below.
