Model: AD50 Date			e: 15-Feb-98	No: 1	
Modified Article: Bushing for Development Unit		Prepared by: E.Fukuyama			
From: QAC Field Inf	ormation Dept.				
Reason for	□ Parts catalog correction	☐ Venc	lor ch	ange 🔲 To n	neet standards
Modification: ☐ To facilitate assembly ☐ To in		nprove	e reliability ()	
	☐ Part standardization	☐ Othe	r

Modification Bulletin

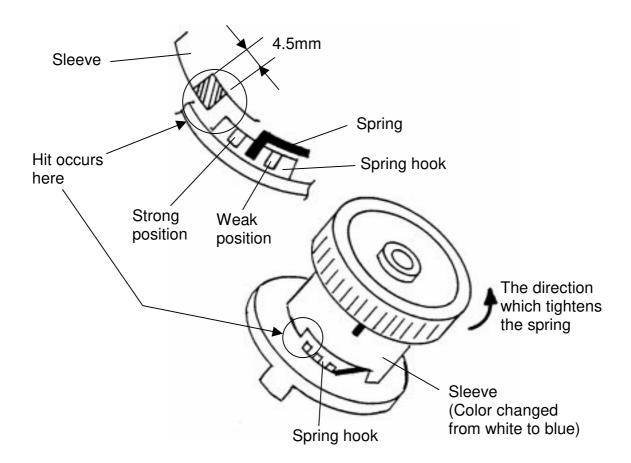
To reduce no-feed jams in the duplex unit caused by insufficient pressure from the bottom plate, the shape of the spring clutch has been changed. To distinguish between the old and new clutches, the color of the sleeve has been changed from white to blue.

The insufficient pressure occurs when the clutch turns in the direction which tightens the spring. This is because when the sleeve hits the spring hook, the spring cannot turn completely, so the bottom plate cannot be lifted up to the highest position.

To prevent the sleeve from hitting the spring hook, a 4.5-mm wide section of the sleeve has been cut away as shown.

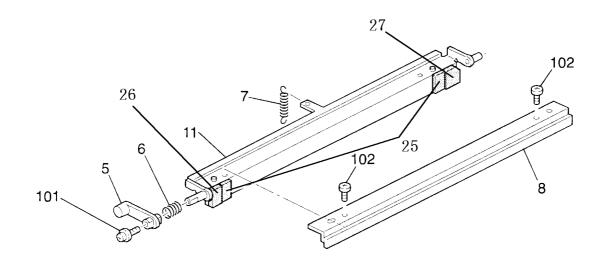
Model: AD50 D			Date	e: 30-Apr-98	No: 4
Modified Article: S	Seals on the Cleaning Blade B	de Bracket Prepared by: E.Fukuy		ukuyama	
From: QAC Field Inf	formation Dept.				
Reason for Modification:	☐ Parts catalog correction☐ To facilitate assembly	☐ Vend		ange	neet standards)
iviouilication.	Part standardization	☐ Other		- · · · · · · · · · · · · · · · · · · ·

The following parts have been added as service parts.

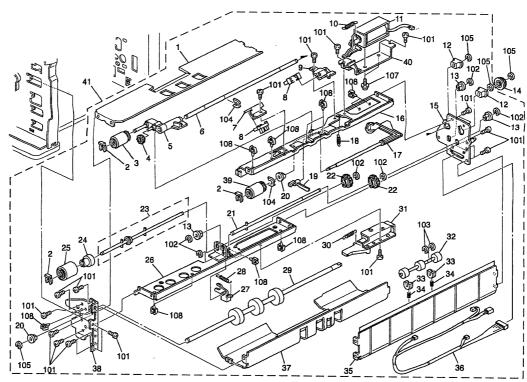
5.TRAY PAPER FEED (A217)

Model: AD50			Date	e: 31-May-9	9	No.: MA217015
Modified Article: F	Paper Feed Unit - Lower			Prepared	by: E.	Fukuyama
From: Technical Se	rvice Dept., GTS Division					
Reason for	□ Parts catalog correction	☐ Vend	lor ch	ange	☐ To n	neet standards
Modification:	☐ To facilitate assembly	☐ To im	nprov	e reliability	()
	☐ Part standardization	☐ Othe	r

The following parts have been added. Please correct your parts catalog.

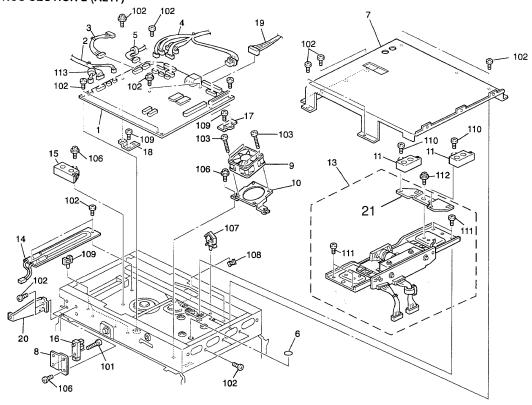
Model: AD50 Date				e: 15-Sep-9	9	No.: MA217016
Modified Article:	Bracket: Original Size Sensor	Prepared	by: E.	Fukuyama		
From: Technical S	ervice Dept., GTS Division					
Reason for	Parts catalog correction	☐ Vend	or ch	ange	☐ To n	neet standards
		☐ To improve reliability		e reliability	()
		Other	r

The following part has been registered as a service part. Please add this to your parts catalog.

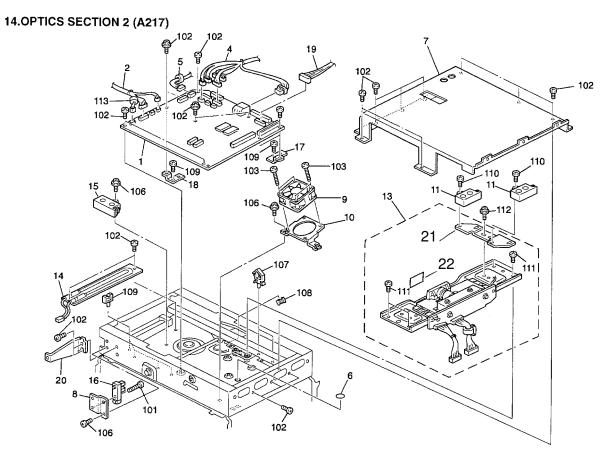
Model: AD50 Date				e: 15-Dec-9	9	No.: MA217018
Modified Article:	Light Filter-G530/G533	Prepared	by: E.F	- ukuyama		
From: Technical S	Services Dept., GTS Division					
Reason for	☐ Parts catalog correction	☐ Vendo	or ch	ange	☐ To n	neet standards
Modification: ☐ To facilitate assembly ☐ To improve		prove	e reliability	()

The following part has been added as a service part. Please add this to your parts catalog.
