Model: SP3		Date: 30-Sep-97	No: 1
Subject: SCU ROM Modification		Prepared by: A.Tokoyama	
From: QAC 2nd Field Information Dept.			
Classification:	<input type="checkbox"/> Troubleshooting	<input checked="" type="checkbox"/> Part information	<input type="checkbox"/> Action required
	<input type="checkbox"/> Mechanical	<input type="checkbox"/> Electrical	<input type="checkbox"/> Service manual revision
	<input type="checkbox"/> Paper path	<input type="checkbox"/> Transmit/receive	<input type="checkbox"/> Retrofit information
	<input type="checkbox"/> Other ()

This bulletin describes the software modifications for the SCU board.

Model: Finisher for SP3		Date: 30-Sep-97	No: 2
Subject: SC101		Prepared by: E.Fukuyama	
From: QAC 2nd Field Information Dept.			
Classification:	<input checked="" type="checkbox"/> Troubleshooting	<input type="checkbox"/> Part information	<input type="checkbox"/> Action required
	<input type="checkbox"/> Mechanical	<input type="checkbox"/> Electrical	<input type="checkbox"/> Service manual revision
	<input type="checkbox"/> Paper path	<input type="checkbox"/> Transmit/receive	<input type="checkbox"/> Retrofit information
	<input type="checkbox"/> Other ()

M

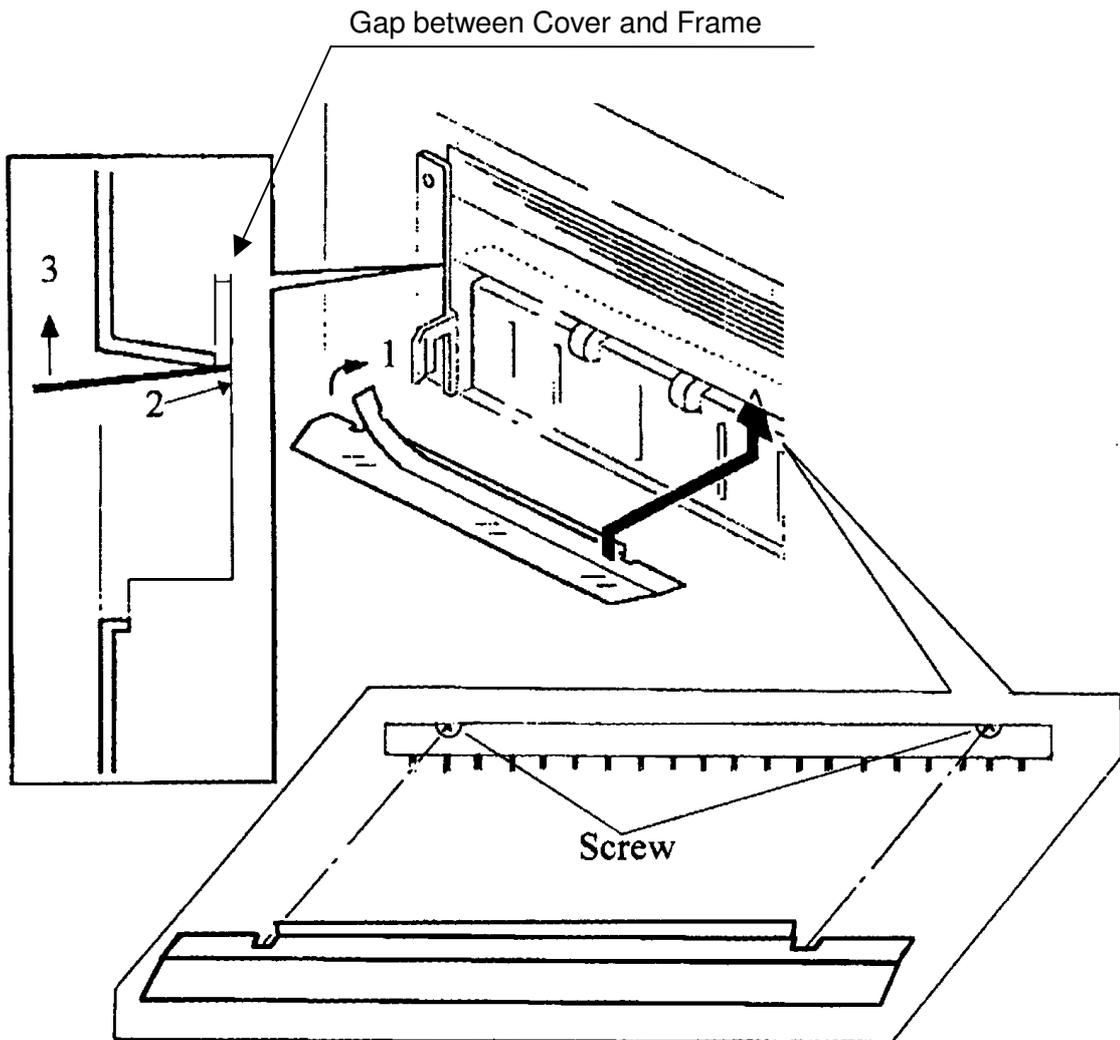
New Entrance Guide

If the Entrance Guide is not installed in the proper position, a gap may develop between the Cover and the Main Frame through which the heat and humidity generated by the paper may enter and lead to high temperature/high humidity around the lamp stabilizer.

Entrance Guide Installation Procedure

1. Peel off the tape seal for the Entrance Guide
2. Place the Entrance Guide on the Main Frame.
3. Attach the Entrance Guide to the Cover

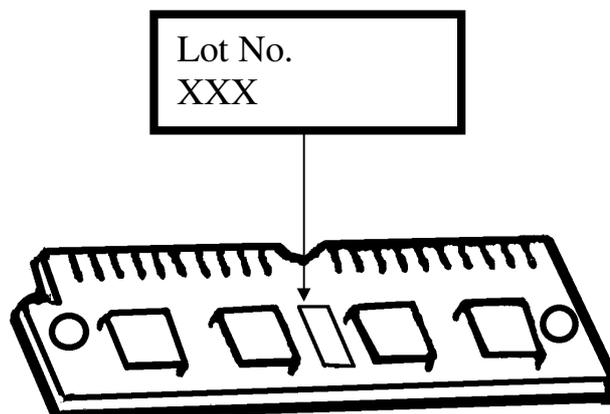
1. At installation, the PS2 board cannot be recognized.
2. New PS software cannot be reprogrammed into the PS2 board, because it is not possible to erase the programmed software before reprogramming it.

1. The program in some PS2 options was damaged due to noise on the cable between the PC and the checker in the factory which downloads the software.
2. The PS2 option uses flash ROMs from two vendors (Fujitsu and AMD). The AMD chips were used for the December production in 1997 and January production in 1998. These chips cannot be erased before programming new software.

- A. Stocked PS2 options in the warehouse
Please replace them with new ones and send back the old ones.
- B. PS2 options in the field
1. When the PS2 board cannot be recognized after installing it, please replace it with a new one.
(Note) Before replacing it, please reinstall again and confirm that it can be recognized.
 2. Please replace all boards with the lot no. of 7Zxxx and 81xxx with new ones.
The lot no. is shown on the carton or on the label on the board as shown below.

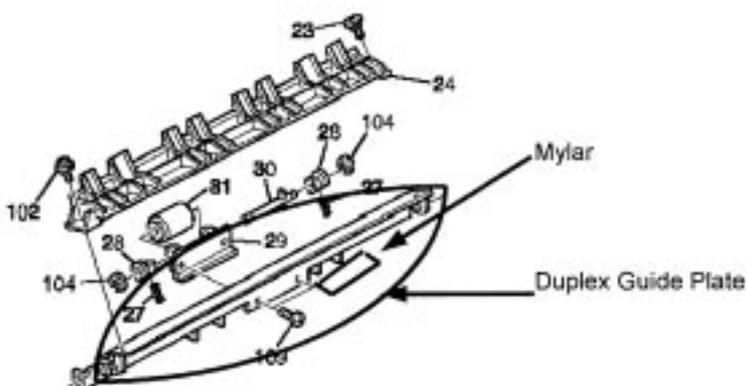
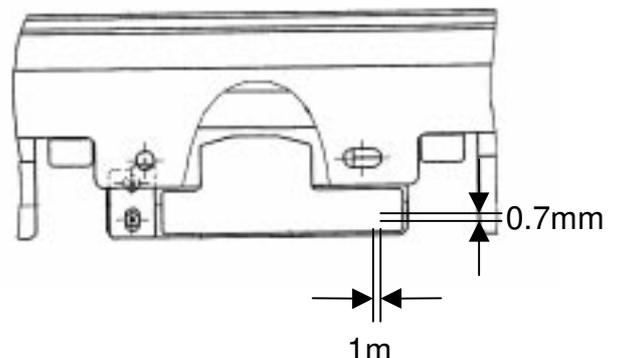
1. During paper feed from the duplex unit, the leading edge of the paper is bent or a no-feed jam occurs.
2. During stacking in the duplex unit, a stacking jam occurs.

(If the mylar is bent or out of position, the leading edge of the copy may be bent or no-feed jams may occur.)

1. Paper feed jam (leading edge bent or non-feed)
 - 1) Check to see if the duplex guide mylar is set properly. If it is bent or out of position, please replace ***the duplex guide mylar (A1344670)*** or the duplex guide plate ***(A1344662)***.

Reattaching the mylar (as shown below) is a temporary countermeasure. As a permanent countermeasure, the duplex guide plate should be replaced.

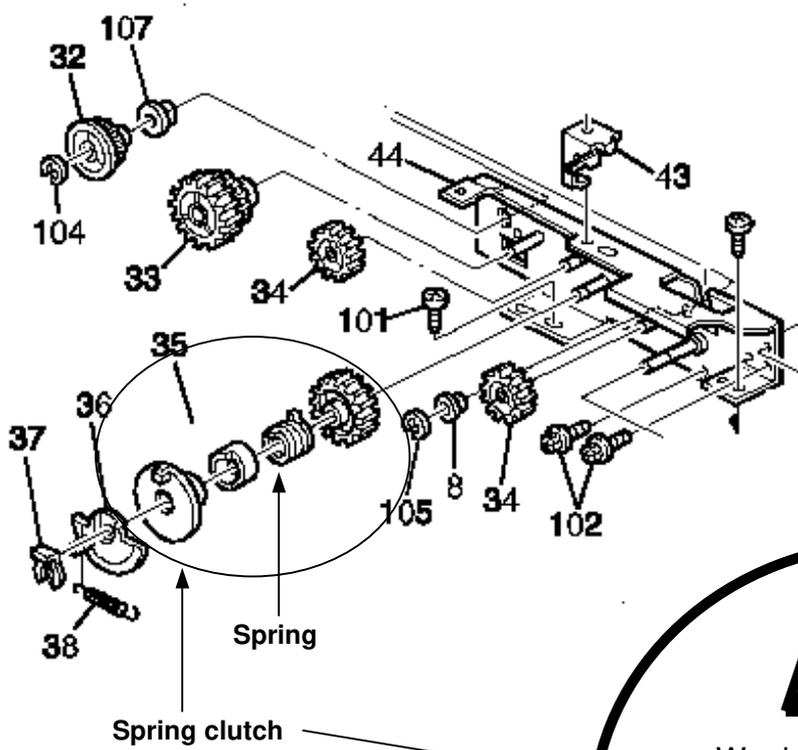
There are 3 settings for the spring. The one on the right is the strongest.

- 2) If 1) does not solve the problem, change the position of the spring in the spring clutch to increase the pressure on the bottom plate, or replace the spring clutch.
 - By adjusting the spring setting, the pressure on the bottom plate in the duplex unit increases. The stronger it is set, the more effective it is. (If the pressure on the bottom plate is insufficient, no-feed paper jams may occur.)

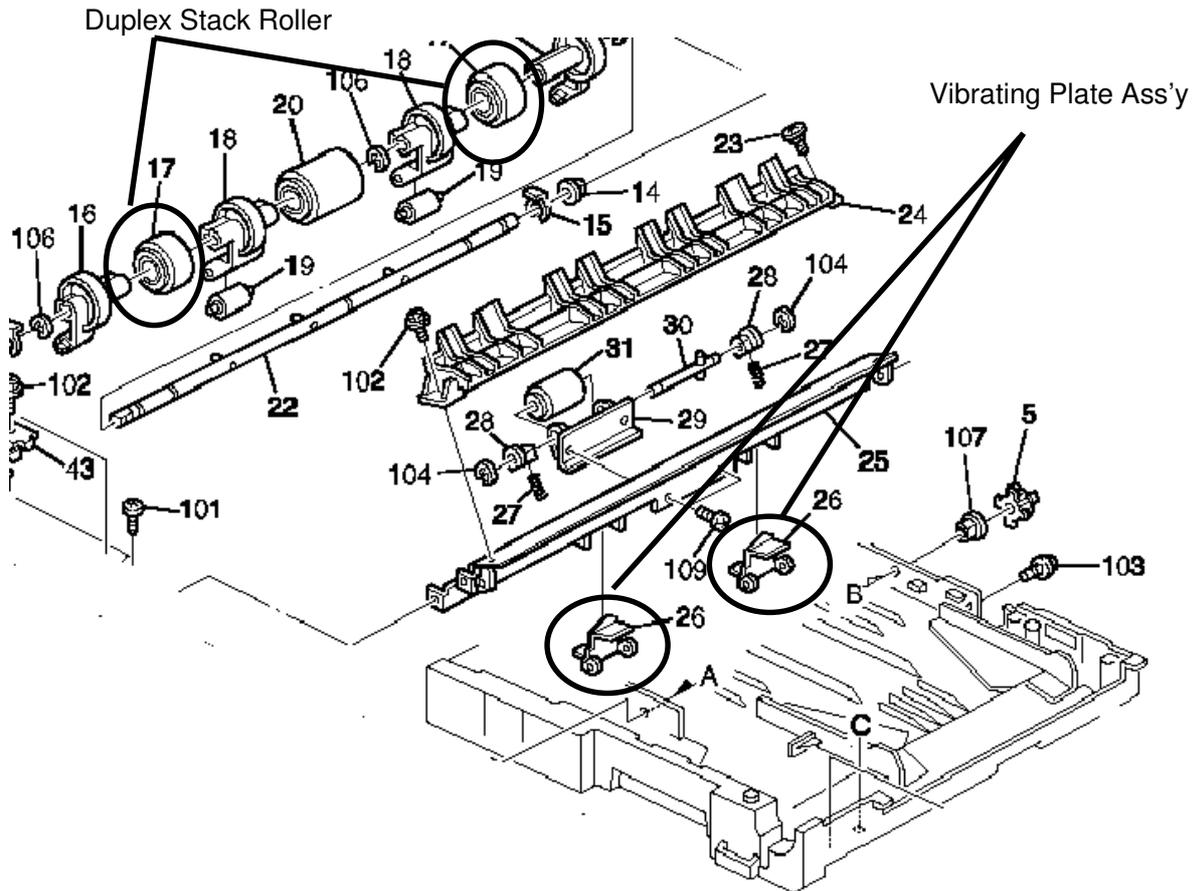
- 1) Check the condition of the mylar setting on the vibrating plate ass'y. If it is bent or damaged, replace the vibrating plate ass'y (A1544626)
 Rotate the duplex stack roller. If it makes a clicking sound, it is OK.
 (If the mylar is bent or damaged, stack jams may occur.)

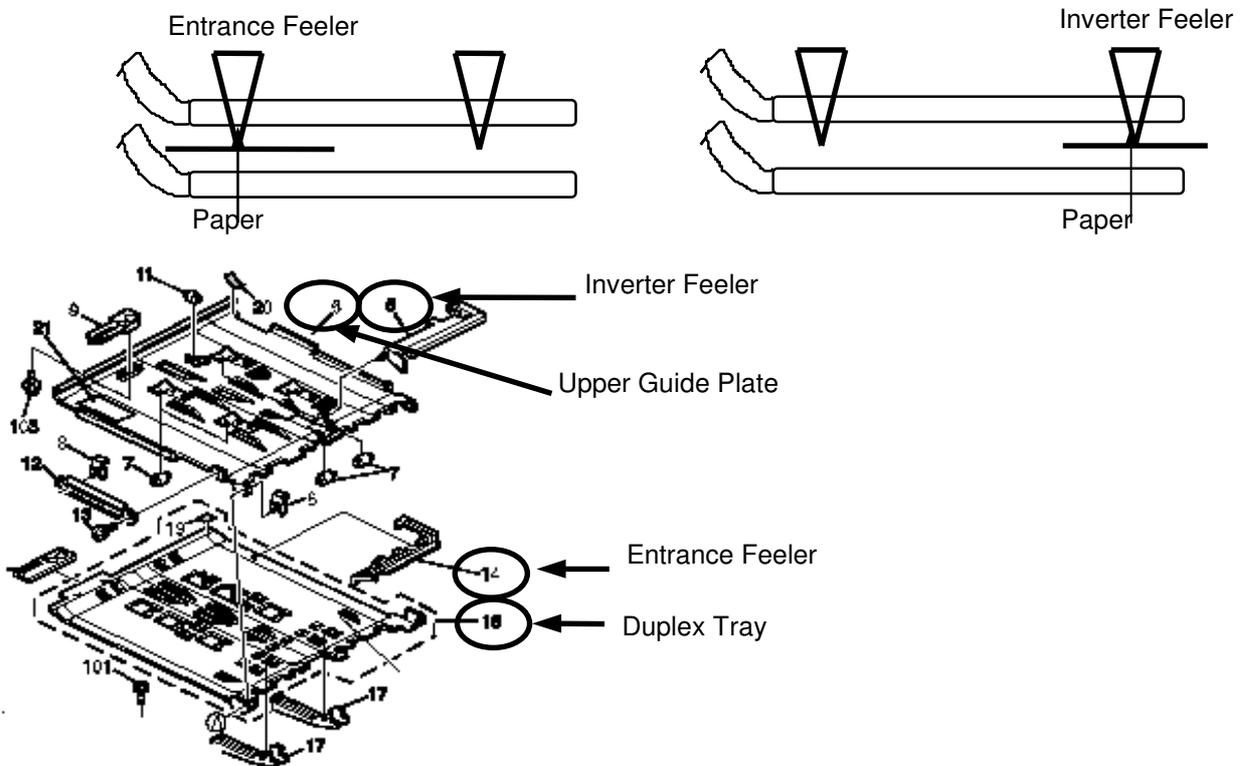
- Duplex Jam indicated = OK -

- Please inform the users that they should pull out the duplex unit all the way when removing paper when a jam occurs. If the duplex unit is only pulled out part way, this may lead to deformation of the upper guide plate and the duplex tray.

2) Check to see if the upper guide plate (A13444732) or the duplex tray are deformed. If so, replace the parts.

Check procedures: Pull out the duplex unit and put paper in between the upper guide plate and the duplex tray as shown below. Next, insert the tray and note whether or not a duplex jam is indicated. If it is, then it's OK. (This checks the inverter feeler detector and the entrance feeler detector.)
