Model: Finisher for the AD50		Date: 15-Sep-97	No: 1
Subject: New Product Information		Prepared by: S.Tomoe	
From: QAC 2nd Field Information Dept.			
Classification:	<input type="checkbox"/> Troubleshooting <input type="checkbox"/> Part information <input type="checkbox"/> Action required <input type="checkbox"/> Mechanical <input type="checkbox"/> Electrical <input checked="" type="checkbox"/> Service manual revision <input type="checkbox"/> Paper path <input type="checkbox"/> Transmit/receive <input type="checkbox"/> Retrofit information <input type="checkbox"/> Other ()

The new Finisher (SR710) is being developed as a peripheral for the AD50, which will be launched this November. This RTB clarifies the differences between the SR700 and the SR710.

Model: AD50		Date: 30-Sep-97	No: 2
Subject: Incorrect screw information		Prepared by: S.Tomoe	
From: QAC 2nd Field Information Dept.			
Classification:	<input type="checkbox"/> Troubleshooting	<input type="checkbox"/> Part information	<input type="checkbox"/> Action required
	<input type="checkbox"/> Mechanical	<input type="checkbox"/> Electrical	<input type="checkbox"/> Service manual revision
	<input type="checkbox"/> Paper path	<inp

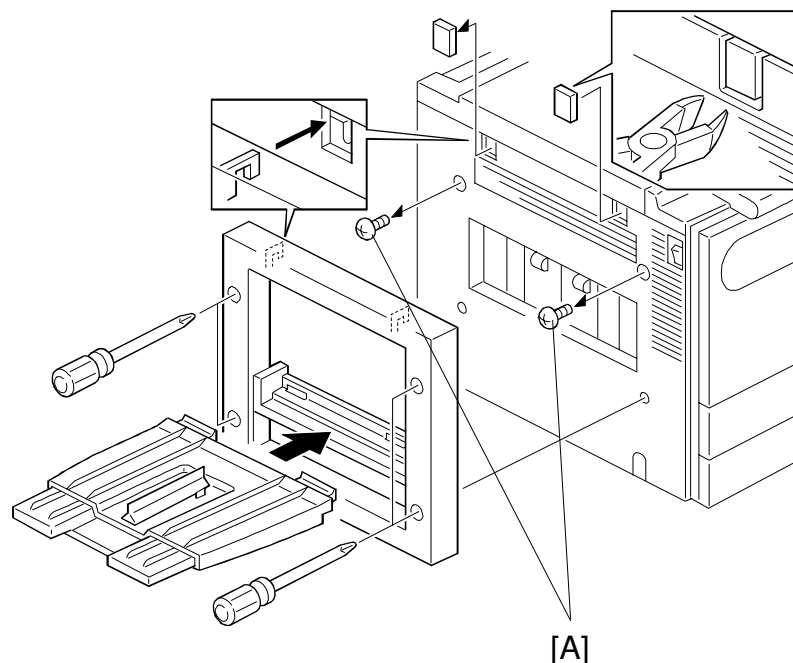
The screws [A] which are removed when the optional 500-sheet tray is installed, are truss screws. However, the September production run began incorporating knob screws. However, during the next production (around October) these screws will be reverted to truss screws.

Please note that It is not necessary for field technician to change these screws in the field.

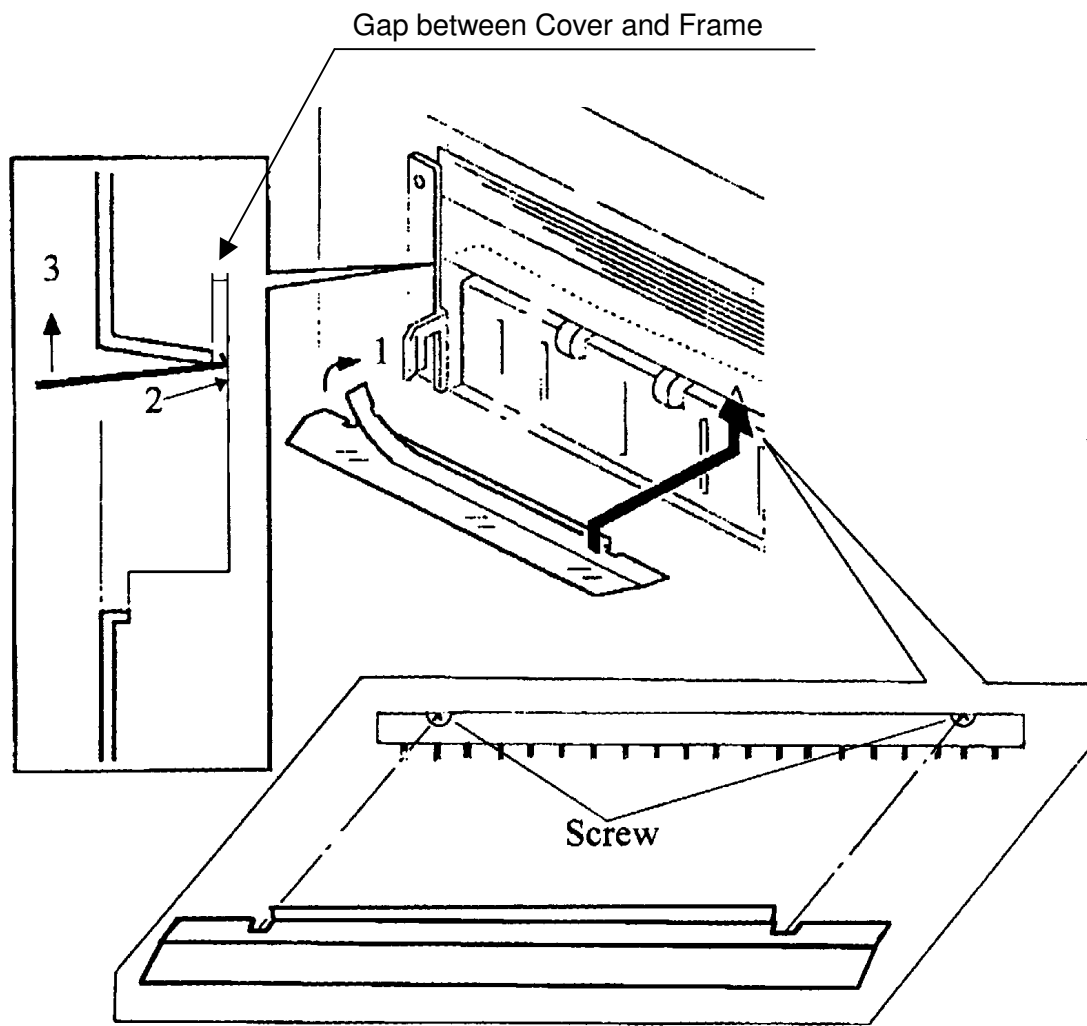
New Entrance Guide

If the Entrance Guide is not installed in the proper position, a gap may develop between the Cover and the Main Frame through which the heat and humidity generated by the paper may enter and lead to high temperature/high humidity around the lamp stabilizer. If a large amount of copies is made right after the machine is turned on, the Lamp Stabilizer will warm up very quickly and may lead to condensation. This may lead to a short circuit and cause SC101.

During the set-up of a Finisher manufactured after May 1997, please install the Entrance Guide in a manner that will prevent a gap from developing between the Cover and the Main Frame. Please refer to the attached page for this procedure.

In the event that an SC101 occurs on a Finisher manufactured before April 1997, please replace the Entrance Guide with part number A6122333.

1. Peel off the tape seal for the Entrance Guide.
2. Place the Entrance Guide on the Main Frame.
3. Attach the Entrance Guide to the Cover.

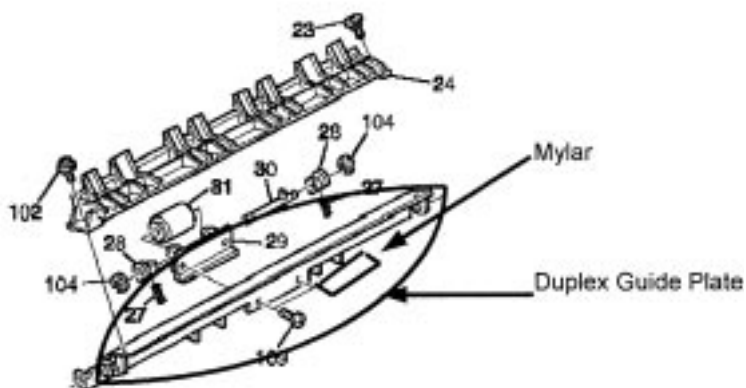
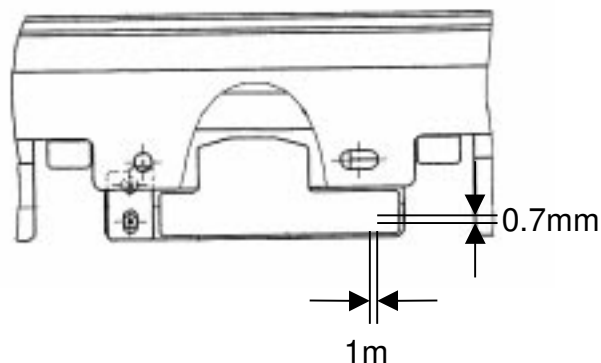
(If the mylar is bent or out of position, the leading edge of the copy may be bent or no-feed jams may occur.)

1. Paper feed jam (leading edge bent or non-feed)
 - 1) Check to see if the duplex guide mylar is set properly. If it is bent or out of position, please replace ***the duplex guide mylar (A1344670)*** or the duplex guide plate ***(A1344662)***.

Reattaching the mylar (as shown below) is a temporary countermeasure. As a permanent countermeasure, the duplex guide plate should be replaced.

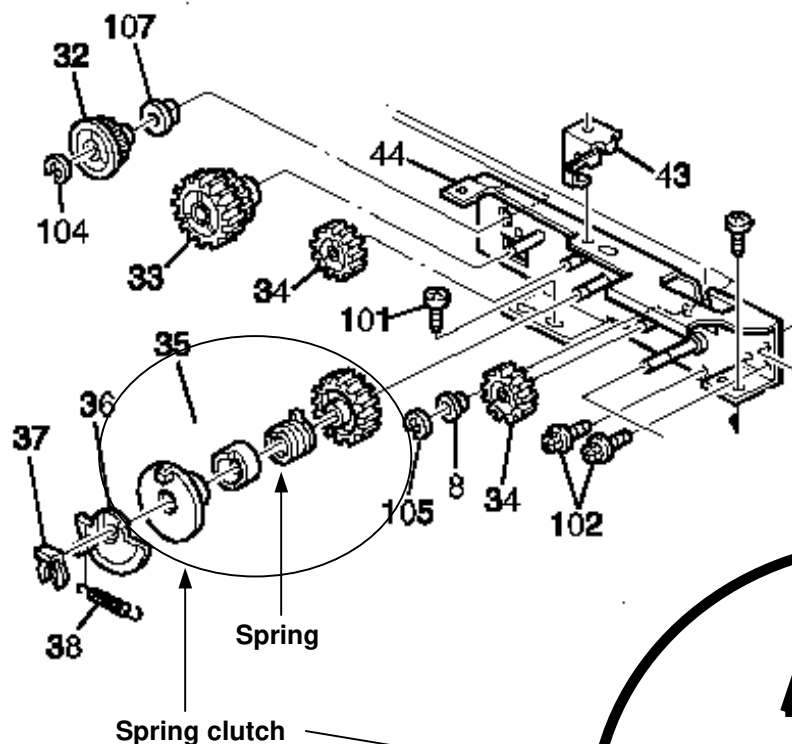
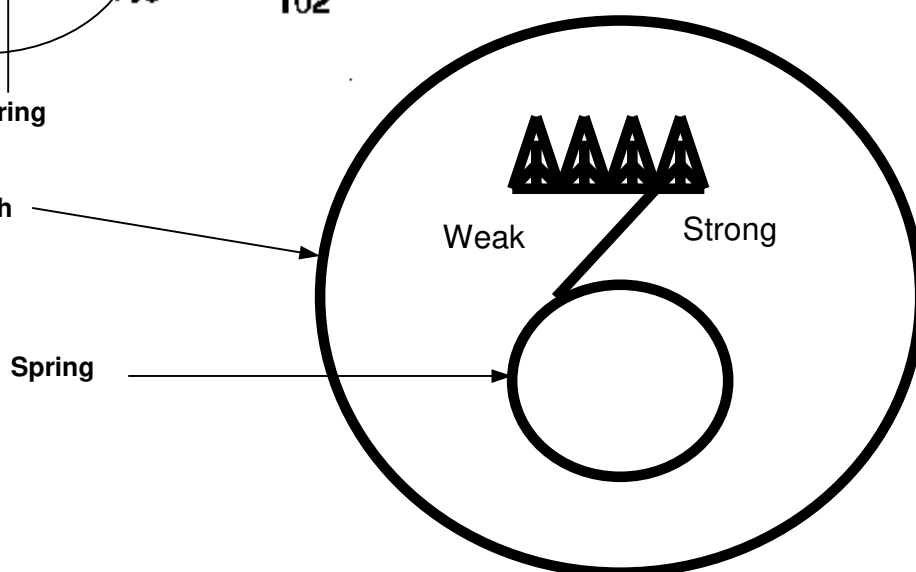
Spring clutch as viewed from the rear of the unit

- 2) If 1) does not solve the problem, change the position of the spring in the spring clutch to increase the pressure on the bottom plate, or replace the spring clutch.
 - By adjusting the spring setting, the pressure on the bottom plate in the duplex unit increases. The stronger the setting, the more effective it is.
(If the pressure on the bottom plate is insufficient, no-feed paper jams may occur.)

There are 3 settings for the spring. The one on the right is the strongest.

- 3) If 2) does not solve the problem, change the spring clutch (P/N AB040015) to a modified one (P/N AB040017). (Refer to an MB for the details of the modification.)

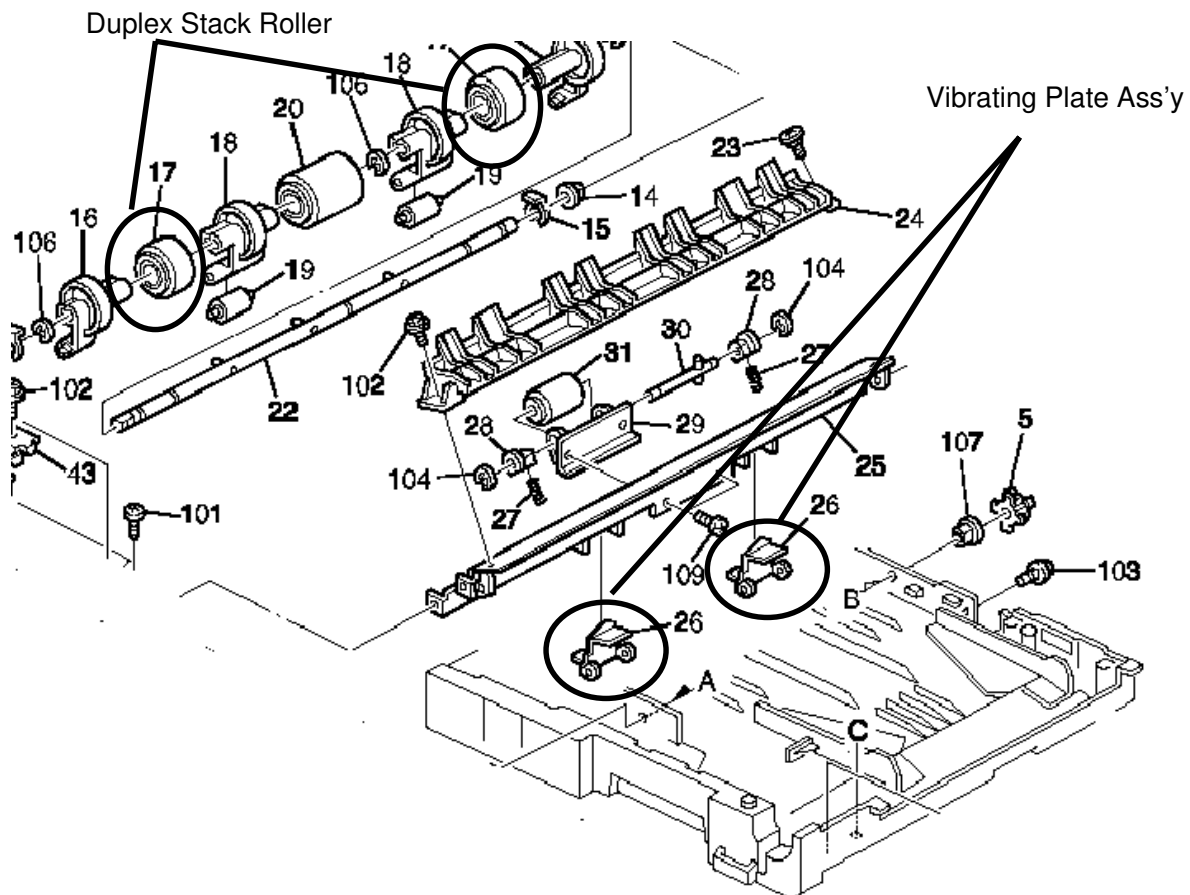
- 1) Check the condition of the mylar on the vibrating plate ass'y. If it is bent or damaged, replace the vibrating plate ass'y (A1544626)
 Rotate the duplex stack roller. If it makes a clicking sound, it is OK.
 (If the mylar is bent or damaged, stack jams may occur.)

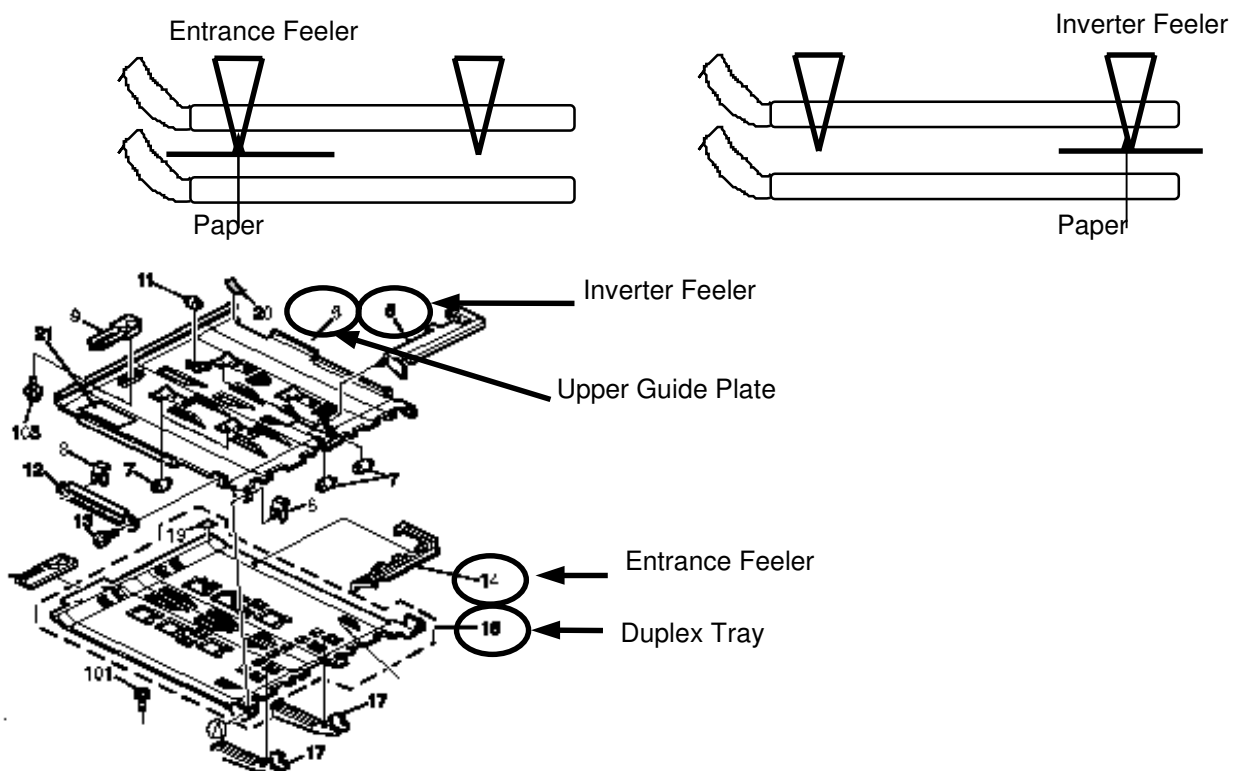
- Duplex Jam indicated = OK -

- 2) Check to see if the upper guide plate (A13444732) or the duplex tray are deformed. If so, replace the parts.

Check procedures: Pull out the duplex unit and put paper in between the upper guide plate and the duplex tray as shown below. Next, insert the tray and note whether or not duplex jam is indicated. If it is, then it's OK. (This checks the inverter feeler detector and the entrance feeler detector.)

- Please inform the users that they should pull out the duplex unit all the way when removing paper when a jam occurs. If the duplex unit is only pulled out part way, this may lead to deformation of the upper guide plate and the duplex tray.
