Model: Mojito		Date: 14-Apr-00	No.: RA293001
Subject: Software Update for Mail Box CS360		Prepared by: A. Sasaki	
From: Technical Service Dept., GTS Division			
Classification:	<input type="checkbox"/> Troubleshooting <input type="checkbox"/> Part information <input checked="" type="checkbox"/> Action required <input type="checkbox"/> Mechanical <input type="checkbox"/> Electrical <input type="checkbox"/> Service manual revision <input type="checkbox"/> Paper path <input type="checkbox"/> Transmit/receive <input type="checkbox"/> Retrofit information <input type="checkbox"/> Other ()

Model: Mojito		Date: 19-May-00	No.: RA293002
Subject: LG kit (8 1/2"x14"paper size tray Installation procedure and parts catalog		Prepared by: F. Noguchi	
From: Technical Service Dept., GTS Division			
Classification:	<input type="checkbox"/> Troubleshooting <input type="checkbox"/> Mechanical <input type="checkbox"/> Paper path <input type="checkbox"/> Other ()	<input type="checkbox"/> Part information <input type="checkbox"/> Electrical <input type="checkbox"/> Transmit/receive	<input type="checkbox"/> Action required <input checked="" type="checkbox"/> Service manual revision <input type="checkbox"

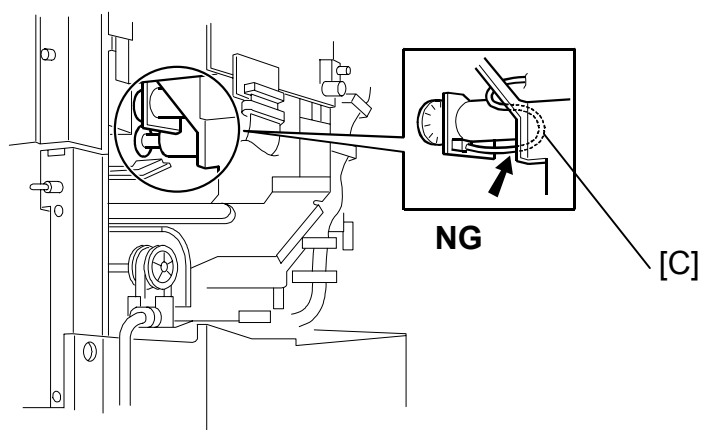
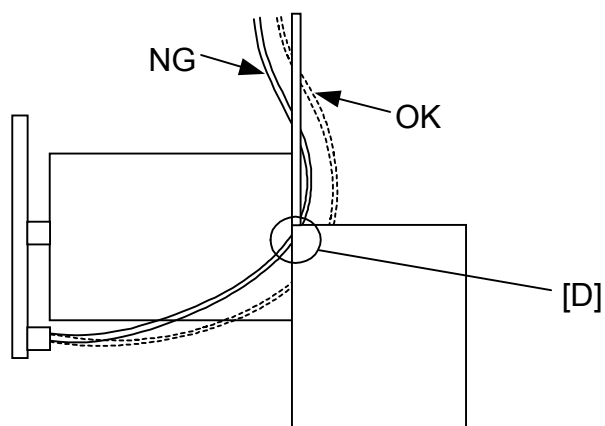
The cable of the guide plate motor is caught between the guide plate unit and frame. In the worst case, the cable covering peels off and the +24V line is shorted to ground. These two factors combine to cause the finisher board to be damaged.

3. Check to see if the cable [C] is caught.

4. If it is not caught, the finisher is Ok. If it is caught, go on to the next step.

5. If the cable is caught at area [D], go on to the next step. If not, the finisher is OK.

1. Hold up the proof tray and open the top cover [A].
2. Unhook the upper rear cover [B] and remove it (3 screws).

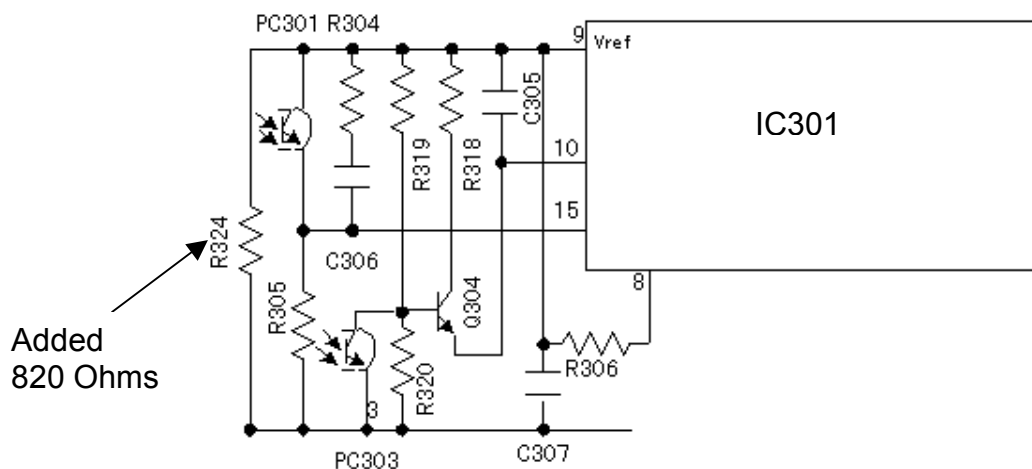
The PSUs in service parts stock have been checked and the units with defective boards have been sorted out using the IC301-9 output signatures.

An 820 Ohm (1/4w) resistor has been added to the PSU board. In order to do this, the board pattern was changed.

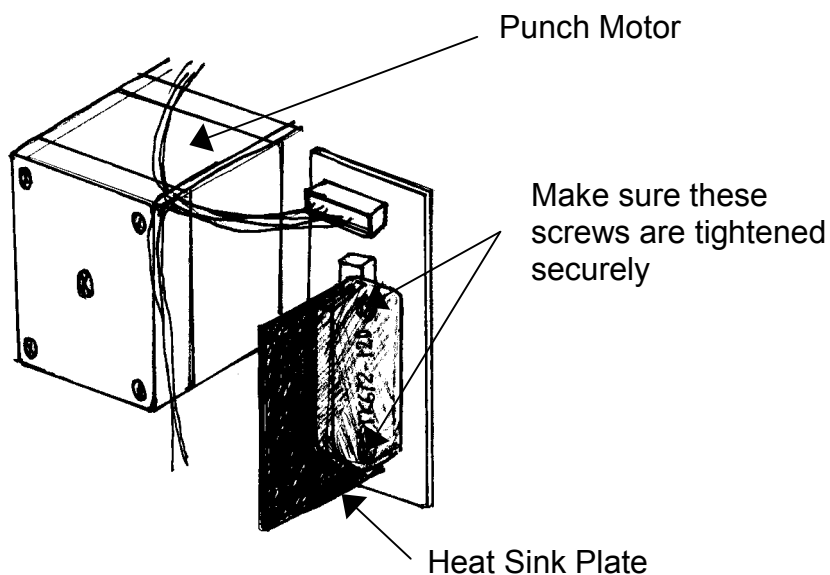
1. Electrical noise generated by the drive motor affects the initial check routine of the punch drive board firmware, such that the motor reset signal is constantly sent out. The only units on which the symptom may occur are the USA two-punch-hole and European four-punch-hole units.
2. The two screws securing the heat resistor to the IC on the punch drive board come loose. As a result, the temperature of the IC becomes too high.

3-1 Please check the two heat resistor screws when visiting the machine site and tighten them if they are loose.

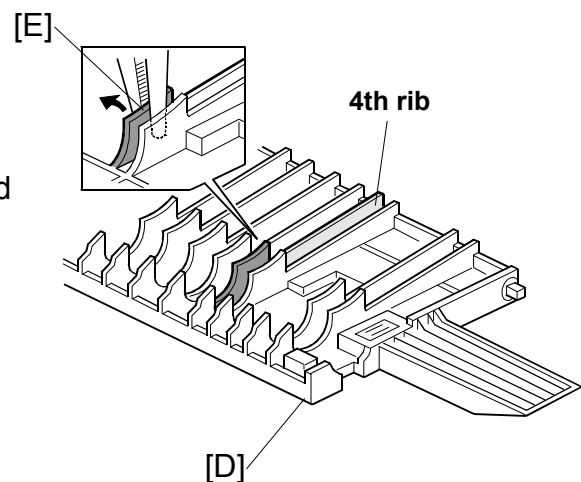
Some A2294472 upper exit guide plates contain an extra rib due to a molding error. This rib can sometimes interfere with the exit guide pawl and cause a jam.

5. Open the exit upper guide plate [D].
6. If the plate contains the extra rib shown in the illustration (4th rib from the front), bend the high end (dark shaded area) [E] toward the back at its base, breaking it off.
7. Reassemble the machine.

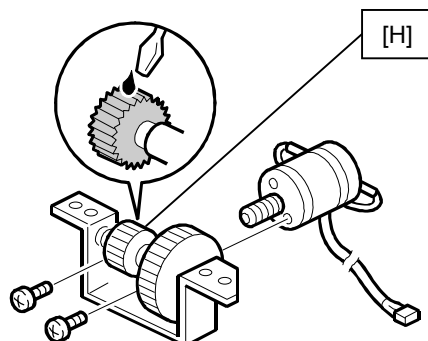
The Motor Joint Gear of the toner bottle holder is worn down, causing noise and uneven rotation.

The amount of grease applied to the gear during production was not enough to prevent premature wearing.

11. Apply the grease to the contact surface of the Motor Joint Gear [H].

Note: Please make sure to apply a liberal amount of grease to the entire contact surface of the gear.

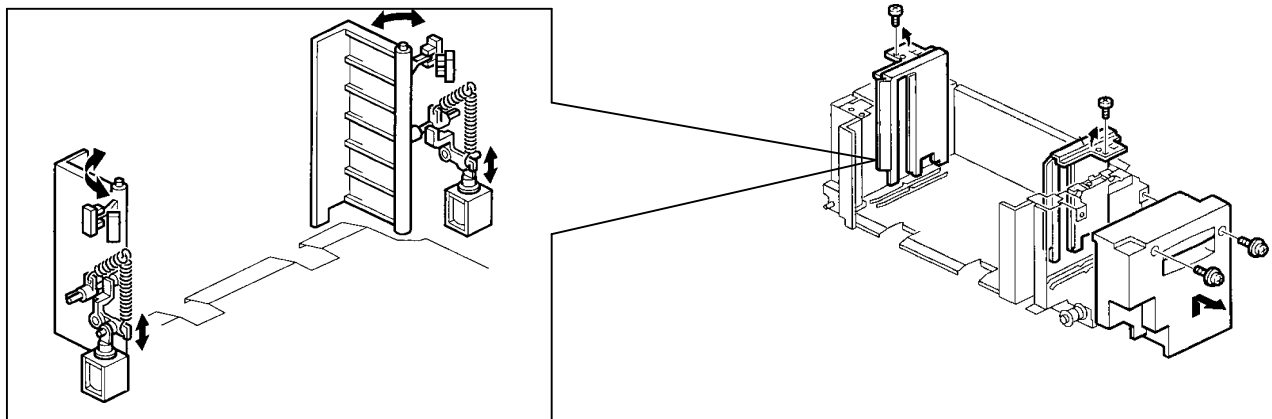
This tends to happen when the tray is forcibly closed, in which case the paper in the tray will shift to the left from this shock (causing the side fences to re-open). This can also occur if the customer loads the paper in the right tray incorrectly.

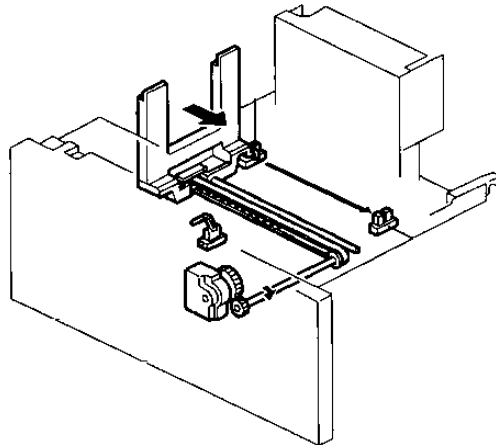
Left tray back fence is damaged

The shock of closing the left tray (or incorrect paper loading) causes the right side fences to open, which in turn causes the left back fence to move to the right (attempting to shift the paper over to the right tray). When there is paper in the right tray, the left back fence is damaged from the resulting resistance.

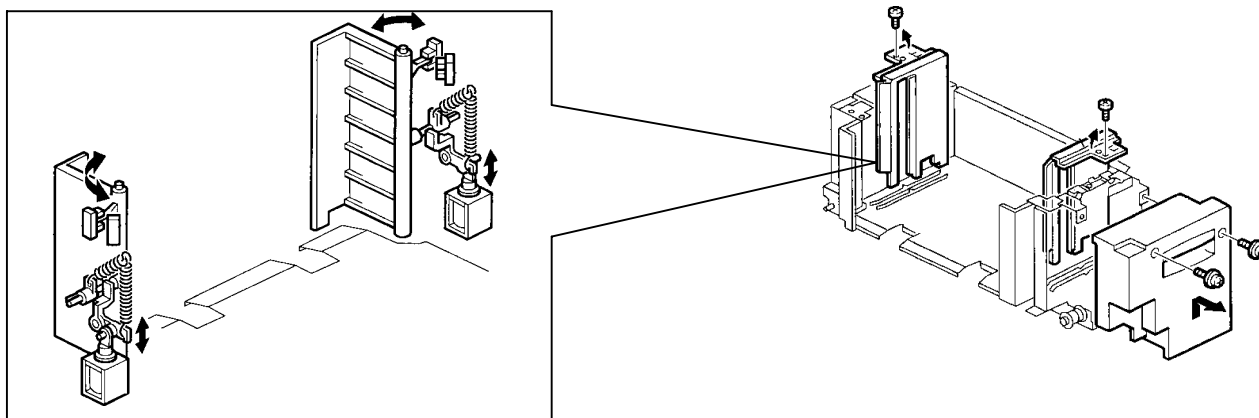
This has a tendency to happen when the tray is forcibly closed, in which case the paper in the tray will shift to the left from this shock (causing the side fences to re-open). This can also occur if the customer mis-loads the paper in the right tray.

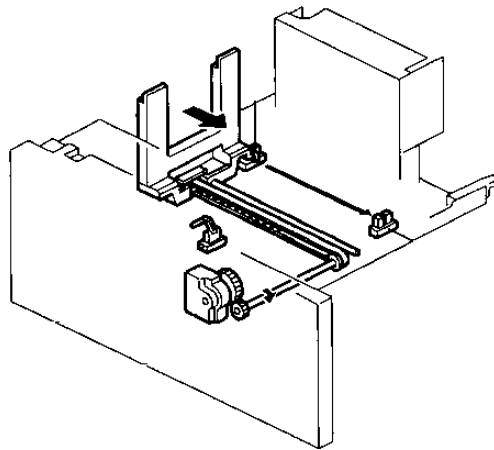
The shock of closing the left tray (or paper mis-load) causes the right side fences to open, which in turn causes the left back fence to move to the right (attempting to shift the paper over to the right tray). When there is paper in the right tray, the left back fence is damaged from the resulting resistance.

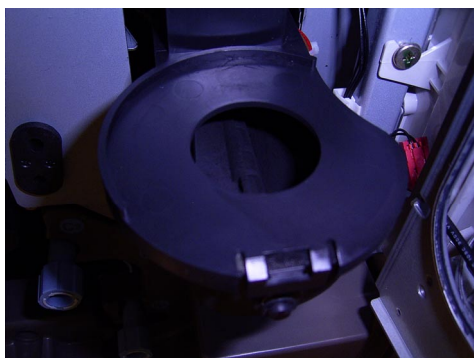
- 1) Storage: The bottle is stood upright for a long time.
- 2) Shipping: Vibration compresses the toner.

A new bottle is installed after toner end, but the toner does not fill the front of the hopper.
