Model: Mojito-C2		Date: 2-Jun-03	No.: RB098001
Subject: BICU firmware Modification History		Prepared by: F.Noguchi	
From: 2nd Tech. Support Sec. Service Support Dept.			
Classification:	<input type="checkbox"/> Troubleshooting <input type="checkbox"/> Part information <input checked="" type="checkbox"/> Action required <input type="checkbox"/> Mechanical <input type="checkbox"/> Electrical <input type="checkbox"/> Service manual revision <input type="checkbox"/> Paper path <input type="checkbox"/> Transmit/receive <input type="checkbox"/> Retrofit information <input checked="" type="checkbox"/> Other (      )

The following is for the Mojito-C2 only, and is a reissue of RTB #RA293028c since a request from the field was received to issue RTBs for the C1 and C2 separately. Mojito-C2 RTBs will contain the prefix RB098.

Subject: STEPPER MOTOR:REGISTRATION:ASS'Y		Prepared by: T.Toriumi	
From: 2nd Tech. Support Sec. Service Support Dept.			
Classification:	<input type="checkbox"/> Troubleshooting <input type="checkbox"/> Mechanical <input type="checkbox"/> Paper path <input type="checkbox"/> Other (      )	<input checked="" type="checkbox"/> Part information <input type="checkbox"/> Ele

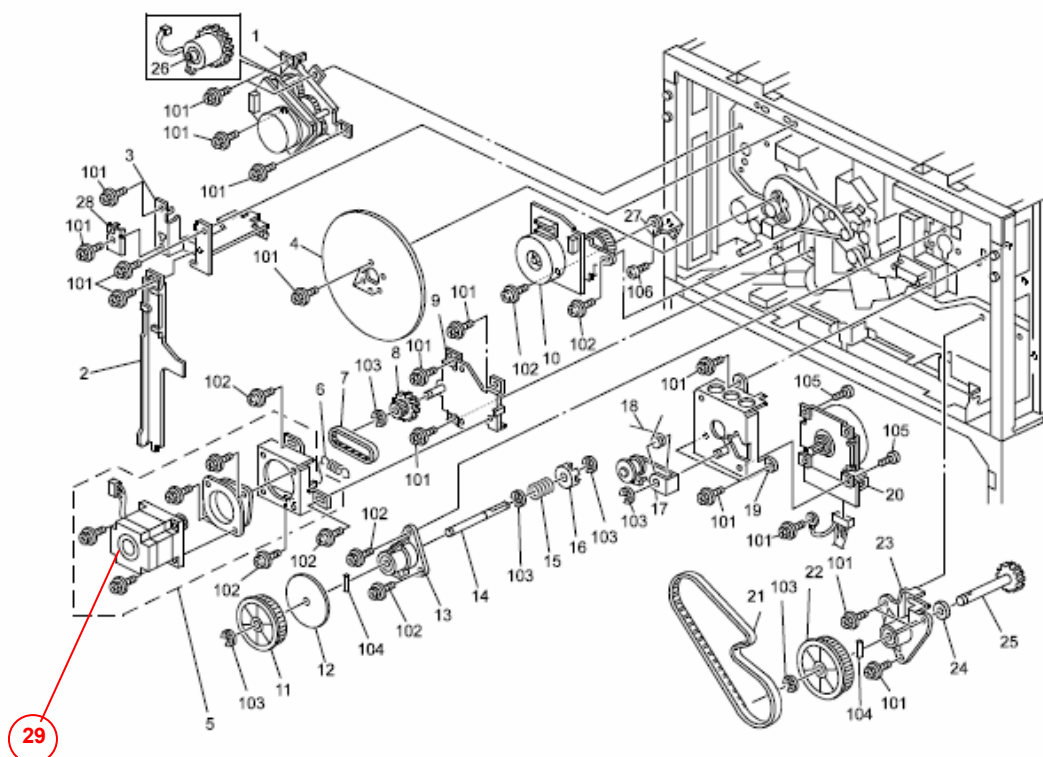
### 53.DRIVE SECTION 1 (A292/A293/B098)

**Note:** The following part (index#29) was registered as a service part.

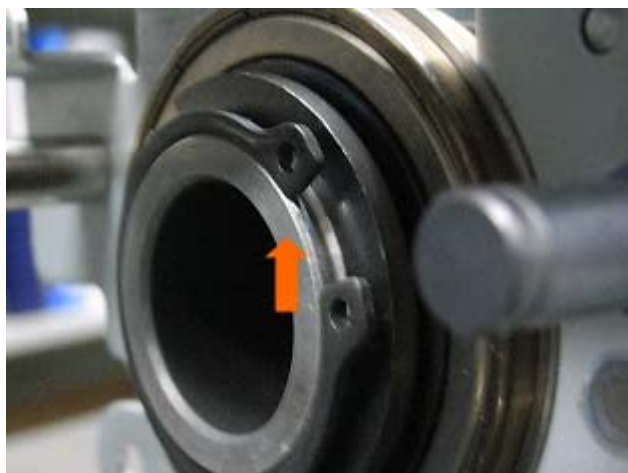
The ring stopper cannot be attached to the hot roller (AE011073) when the roller is replaced.

If the symptom occurs, and the lot number of the hot roller is in the following range, replace the roller.

Affected lot numbers: **A110510 – A310810** (May 11 and August 31)

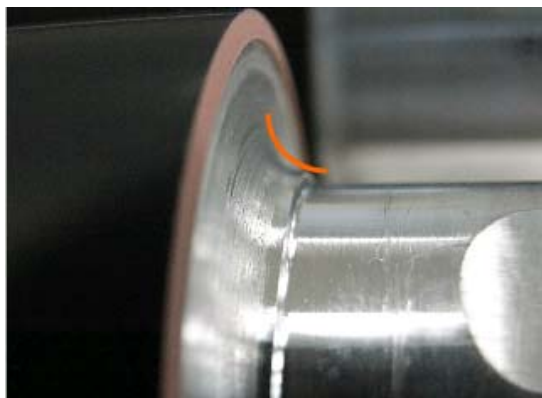
Incorrect:

The edges of the shaft section on some hot rollers in service parts stock were not ground to a 90-degree angle.

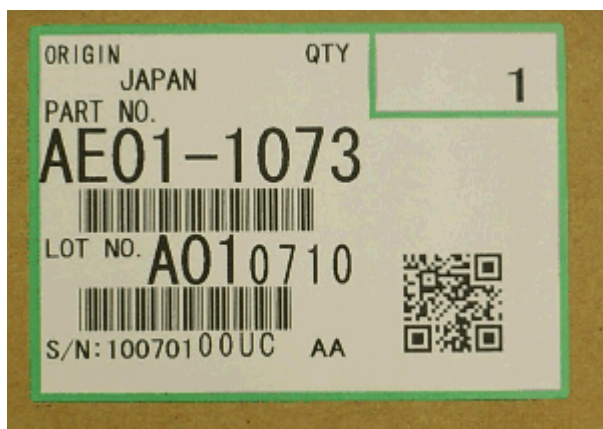
**Note:** The production date can be determined by the lot number, as shown below.

Example: Lot number “A010710” indicates that the part was produced on July 1, 2010.
