| Model: Bellini-C1 | | Date: 28-Aug-03 | No.: RA294000b |
| Subject: Troubleshooting | | Prepared by: M. Matsuda | |

This bulletin is a troubleshooting guide for Bellini-C1.

Troubleshooting Guide for Bellini-C1

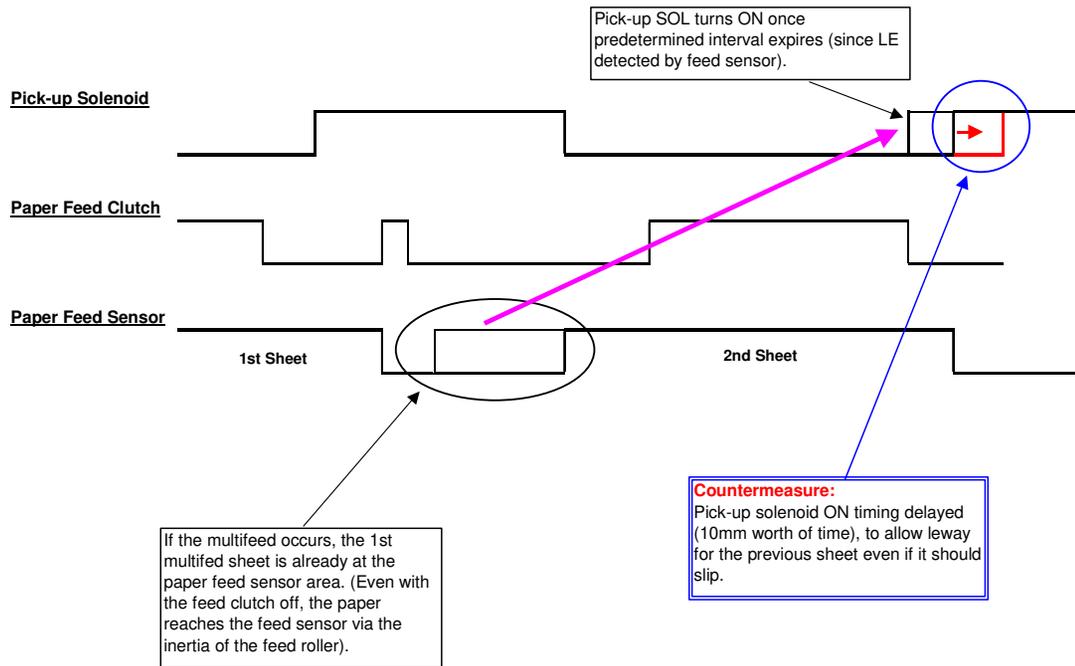
Bellini-C2 Jam Code 53 Timing Chart (LT LEF - Tray 1)

The paper sometimes slips and does not clear the paper feed sensor in time, allowing the next sheet fed to catch up with it and cause the jam.

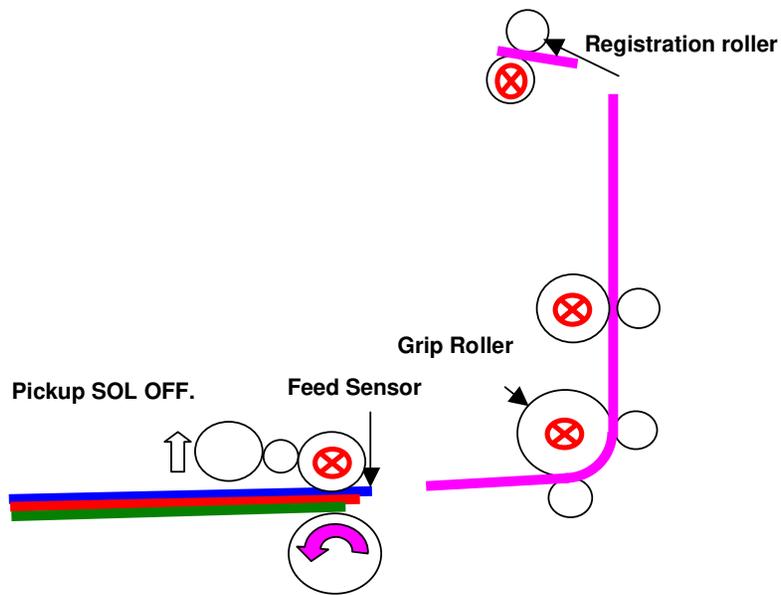
If the multifeed occurs, the 1st multifeed sheet is already at the paper feed sensor area. (Even with the feed clutch off, the paper reaches the feed sensor via the inertia of the feed roller).

With multi-feeds of 3 sheets or more, the previous sheet stops at the registration section and then the next sheet (blue) is fed to the feed sensor via the inertia of the feed roller. The paper feed sensor then turns ON, followed by the pick-up solenoid a certain number of ms later. If the paper slips at all on the way to the grip roller, it can collide with the previous sheet around the feed sensor (which detects the presence of paper and triggers jam).
Note: This symptom occurs only for LT LEF fed from Tray 1.

Countermeasure:
Pick-up solenoid ON timing delayed (10mm worth of time), to allow leway for the previous sheet even if it should slip.

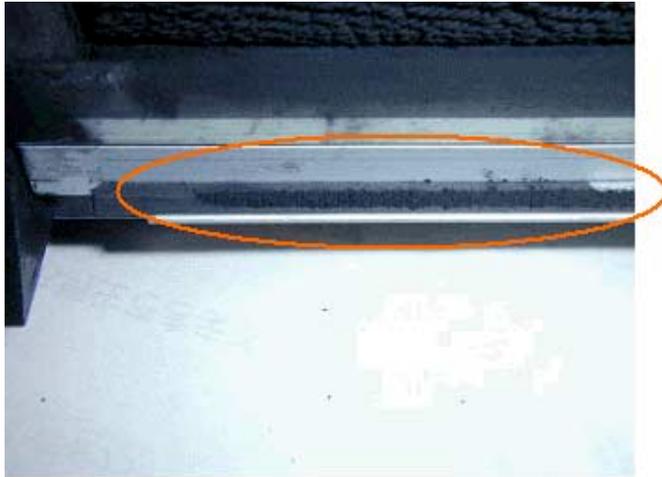
Carrier builds up on the drum unit carrier catcher as shown below, and then falls onto the transfer belt causing dirty paper stack edges (Bellini-C1c/d).

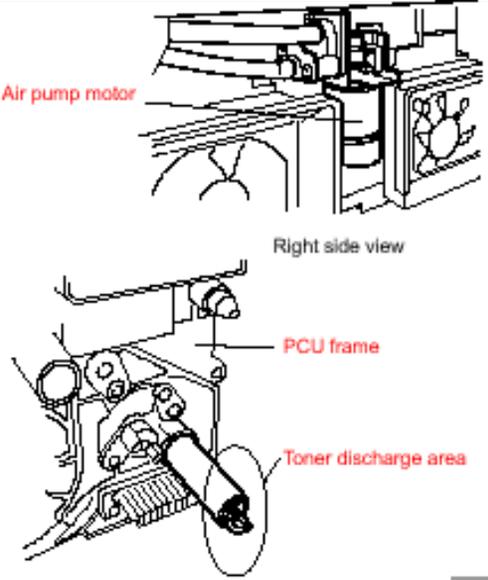
The toner transport screw (coil) has locked due to a toner blockage in the air pump motor.

| | <p>Action:</p> <ol style="list-style-type: none">1. Thoroughly clean the entire toner transport tube and transport screw (coil). If necessary, replace the parts (e.g., if the transport screw is bent).2. Replace the air pump motor. <p>Note: After performing these 2 steps, perform the following check on the toner discharge area of the PCU frame. This will further ensure the symptom does not reoccur.</p> <ul style="list-style-type: none">• Check for any deformation of the toner transport screw on the PSU (power supply unit).• Check for any toner blockages/clumping. <p>If either or both above items is YES, replace the PSU and thoroughly clean the entire toner transport path.</p> |

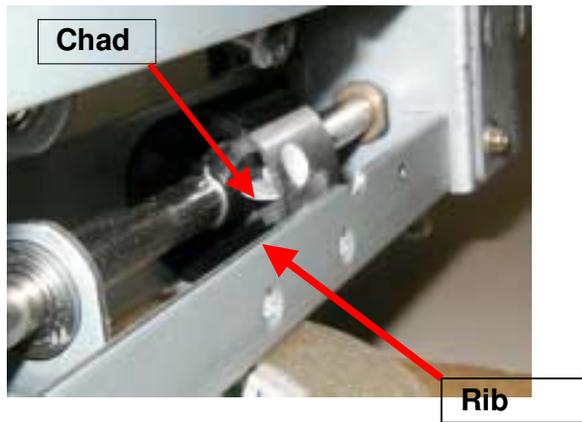
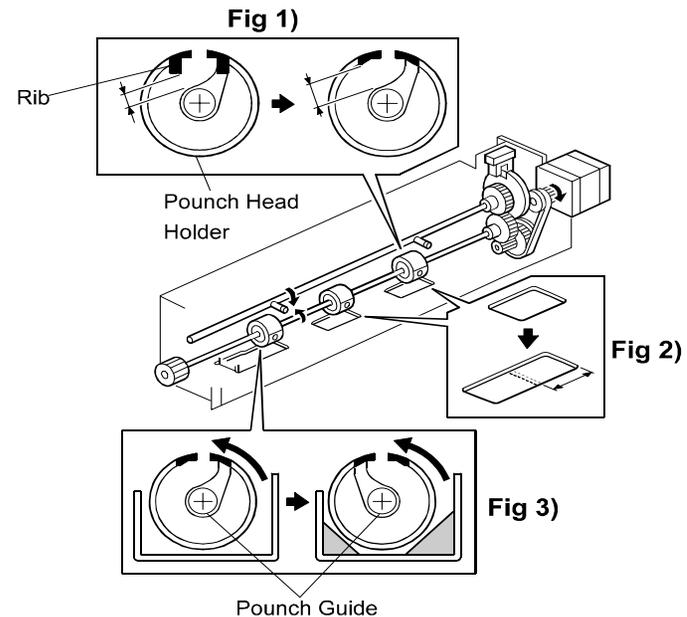
The punch waste (chads) built up in the punch unit assembly due to static electricity generated by the paper.
