Model: Cattleya 2		Date: 26-Feb-01	No.: RB023001
Subject: Main ROM upgrade for Cattleya2		Prepared by: H. Matsui	
From: Technical Services Dept., GTS Division			
Classification:	<input type="checkbox"/> Troubleshooting	<input type="checkbox"/> Part information	<input checked="" type="checkbox"/> Action required
	<input type="checkbox"/> Mechanical	<input type="checkbox"/> Electrical	<input type="checkbox"/> Service manual revision
	<input type="checkbox"/> Paper path	<input type="checkbox"/> Transmit/receive	<input type="checkbox"/> Retrofit information
	<input type="checkbox"/> Other ()

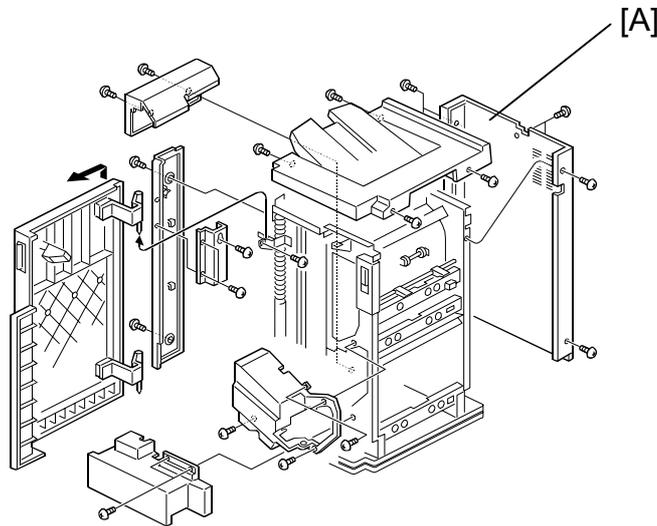
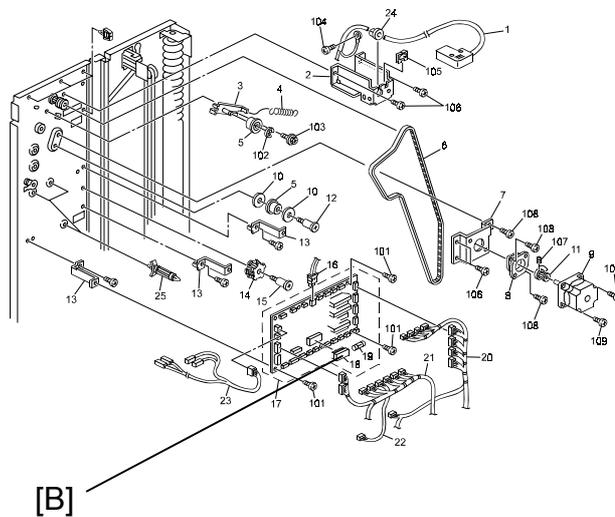
Paper jams with the sorter stapler jogging function can occur under the following conditions:

1. When ST33 (20 bin S/S) is used with Cattleya 2 (B023).
NOTE: If it is used for Cattleya 1(A257/A269), this will not occur.
2. When LT (11"X8 1/2") sideways is used when making 2 or more copies of an original.

The S/S main ROM software cannot compensate for the higher copy speed of Cattleya 2. The timing of the jogger function and paper feeding does not match that of Cattleya 2.

1. Remove the rear cover [A] (4 screws).
2. Replace the main ROM [B] with ver "G" or newer. The part number of this new main ROM is A8315111.
3. Confirm the ROM version with copier SP7-801-005. The last digit (for example G) indicates the ROM version.

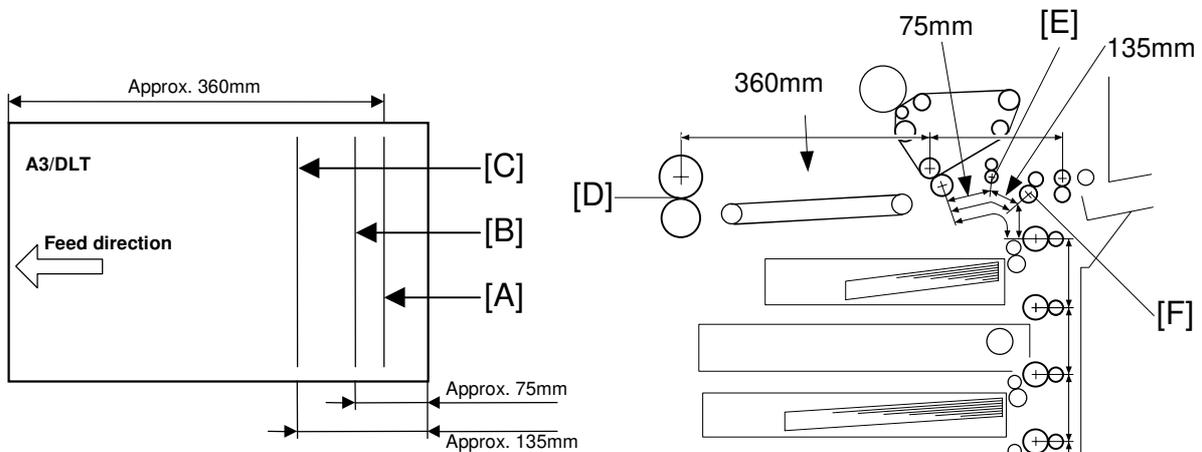
B023T023.WMF

If jitter appears in Thick or Extra Thick paper modes at the position shown in figure [A], [B] and [C], please confirm the following:

- 1) Jitter [A]: Approx. 360 mm from the leading edge
 - Possible cause: The leading edge does not enter the fusing nip [D] smoothly, and the paper impacts on some surrounding area, causing it to feel shock.

- Possible cause: The shock felt by the paper when the trailing edge leaves the registration rollers [E].
 - Try adjusting the following SP modes:
 - SP1-801-011 (Registration motor speed for thick paper)

- Cause: The shock felt by the paper when the trailing edge leaves the paper feed rollers [F].
 - Try adjusting the following SP modes:
 - SP1-801-005 (Paper feeding motor speed for thick paper)

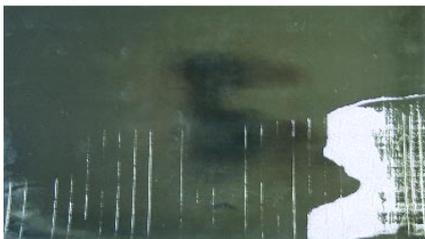
Figure: Example of the Hot offset image

3-2. With the exception of the pre-cleaning roller*, if you have the condition as shown in the table above (even if one of the parts in the table gets dirty), reduce the fusing temperature according to the following procedure described as “FINE TUNIG #1”. This is because in most of these cases are caused by the over-fusing, also known as “hot offset”.

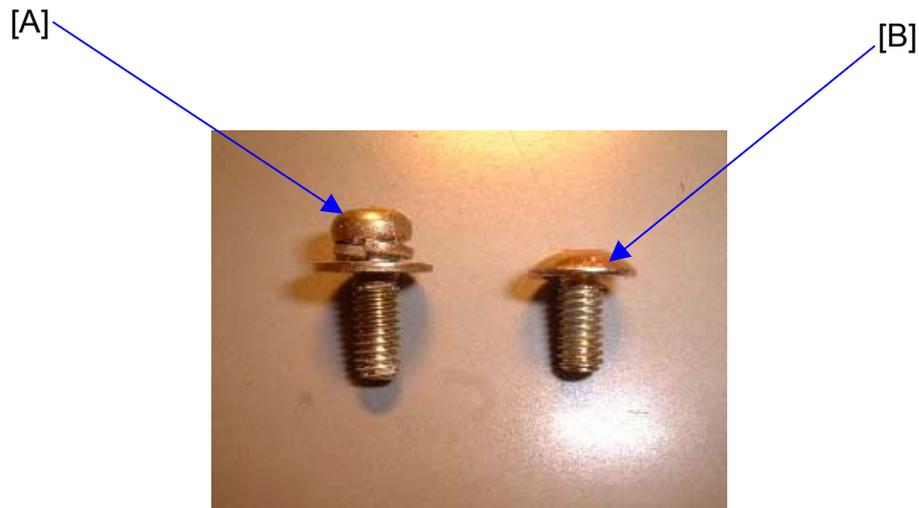
Fig-1

1. First note the difference between the old screw [A] (09544012B) and the new double-pitched screw [B] (B0231100).

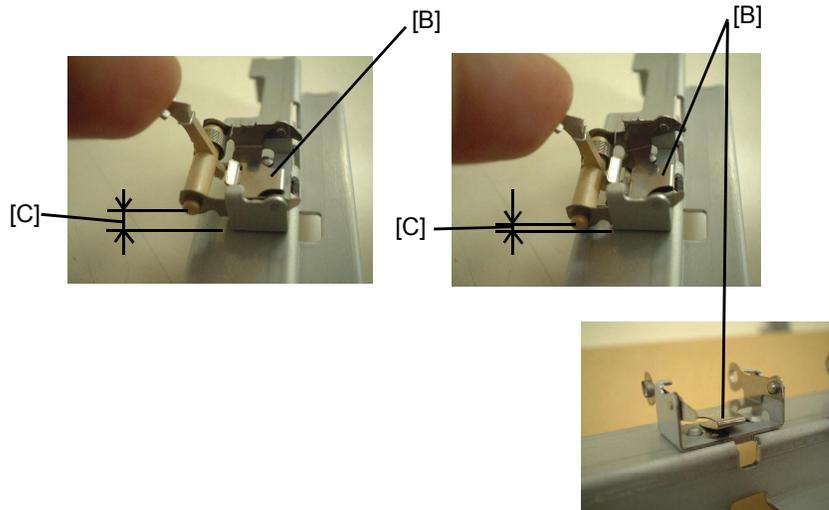
1. The stripper edge [A] has been widened, preventing damage to the hot roller from contact with this edge.
2. The stripper holder [B] has been newly designed as a plate-spring type, which allows the stripper to pull away from the roller when an accordion jam occurs. This ensures that the stripper will not damage the hot roller surface (max/min gaps shown by distance [C] below).

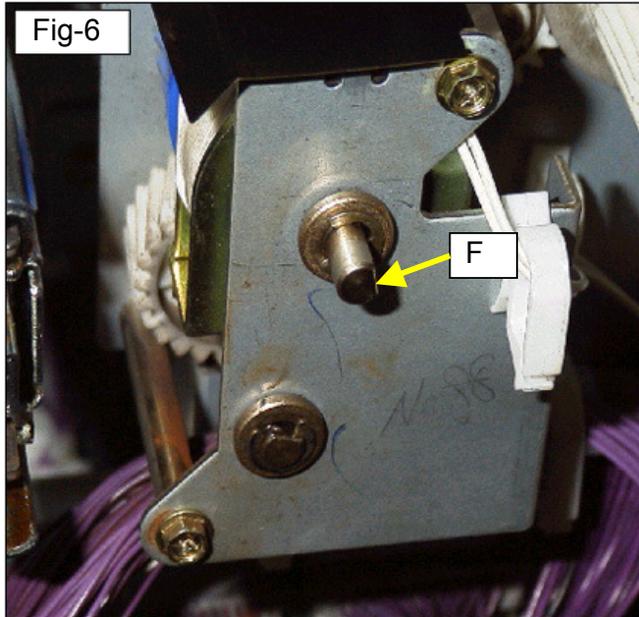
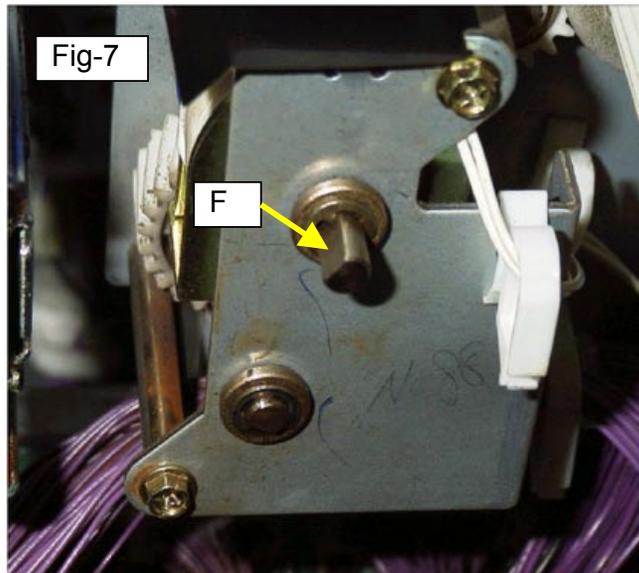
**Fig-6 and 7: Abnormal**

The flat-cut portion of the clutch shaft [F] is more than 10 degrees from horizontal.

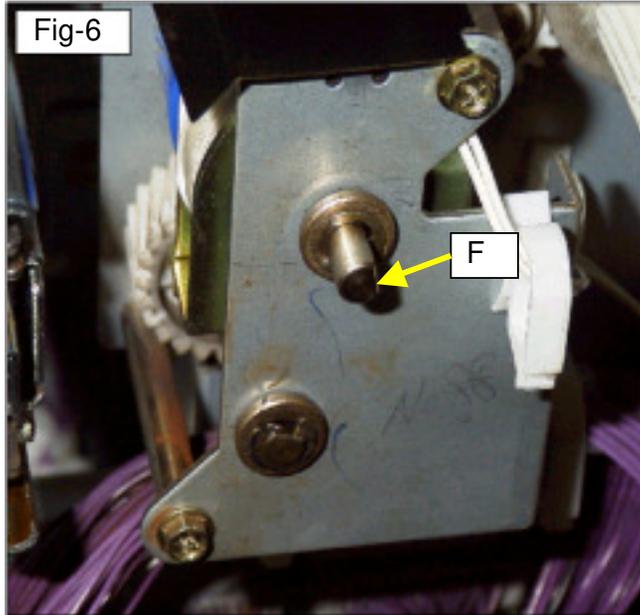
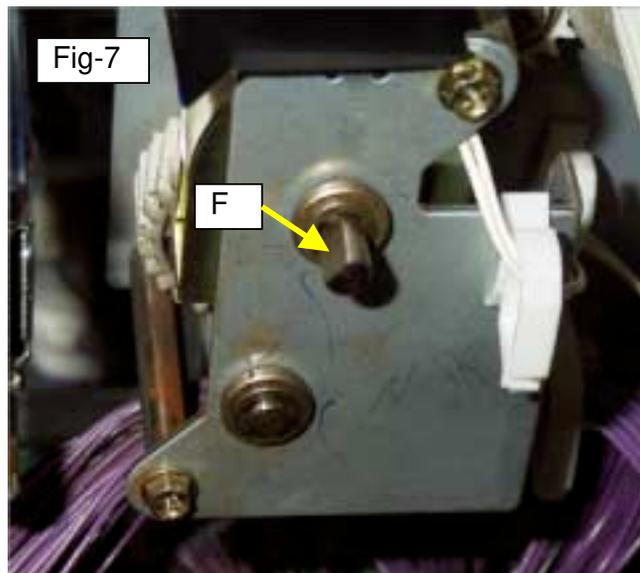
**Fig-6 and 7: Abnormal**

The flat-cut portion of the clutch shaft [F] is more than 10 degrees from horizontal.
