Model: Cattleya		Date: 15-Jun-99	No.: RA257001
Subject: Silicone Oil for the Fusing Unit		Prepared by: H. Matsui	
From: Technical Service Dept., GTS Division			
Classification:	<input type="checkbox"/> Troubleshooting <input type="checkbox"/> Mechanical <input type="checkbox"/> Paper path <input type="checkbox"/> Other (      )	<input type="checkbox"/> Part information <input type="checkbox"/> Electrical <input type="checkbox"/> Transmit/receive	<input type="checkbox"/> Action required <input checked="" type="checkbox"/> Service manual revision <input type="checkbox"/> Retrofit information

Model: Cattleya		Date: 31-Aug-99	No.: RA257004
Subject: Drum damage at installation		Prepared by: H. Matsui	
From: Technical Service Dept., GTS Division			
Classification:	<input type="checkbox"/> Troubleshooting <input checked="" type="checkbox"/> Mechanical <input type="checkbox"/> Paper path <input type="checkbox"/> Other (      )	<input type="checkbox"/> Part information <input type="checkbox"/> Electrical <input type="checkbox"/> Transmit/receive	<input type="checkbox"/> Action required <input type="checkbox"/> Service manual revision <input type="checkbox"/> Retrofit information

Model: Ca

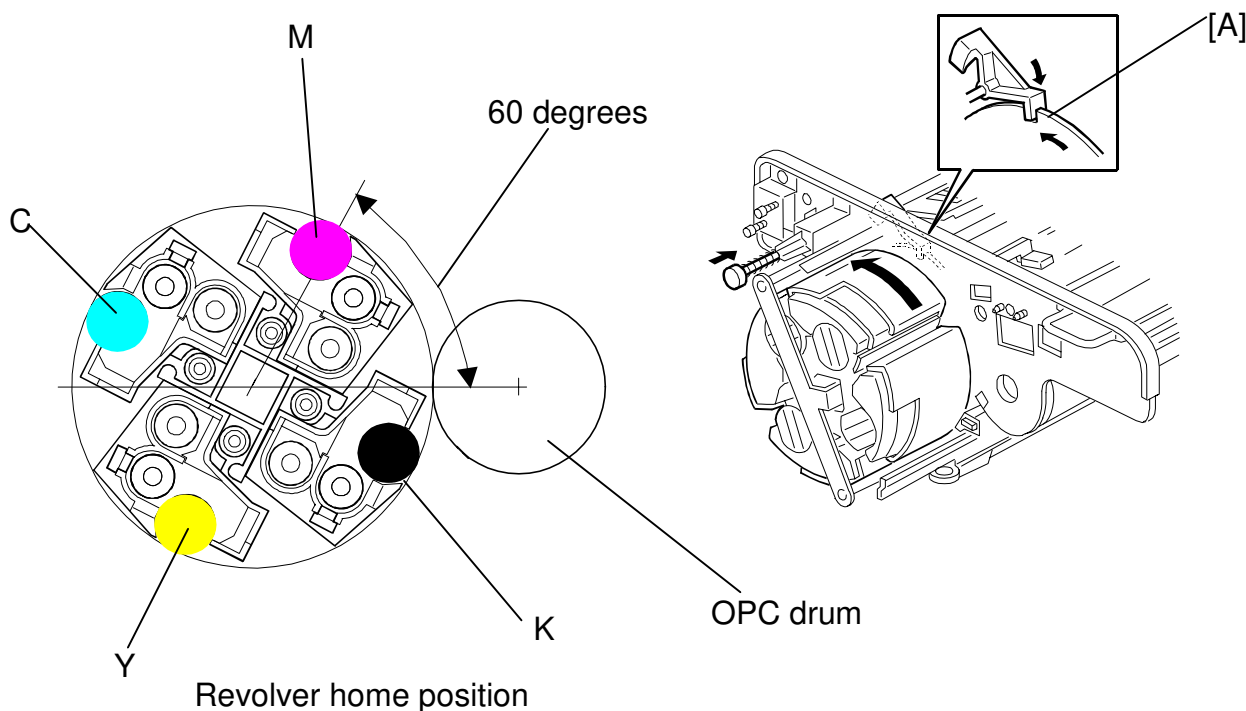
When the drum unit was set in the upper drawer unit, the development unit was placed at 90 degrees (vertical), which is the development unit removal position. Being in this position, the drum came in direct contact with the ribs of the development unit upper cover, causing the drum to be scratched or damaged.

The above problem would normally happen at the time of installation or developer replacement. To prevent the drum from being damaged, the revolver unit must be set to its home position before the drum unit is set in the upper drawer unit.

As shown in the following illustration, the magenta development roller should be positioned at an angle of 60 degrees (from horizontal). When rotating the revolver unit, you can see the cut-out [A] in the wheel, which locks the revolver unit in the home position.

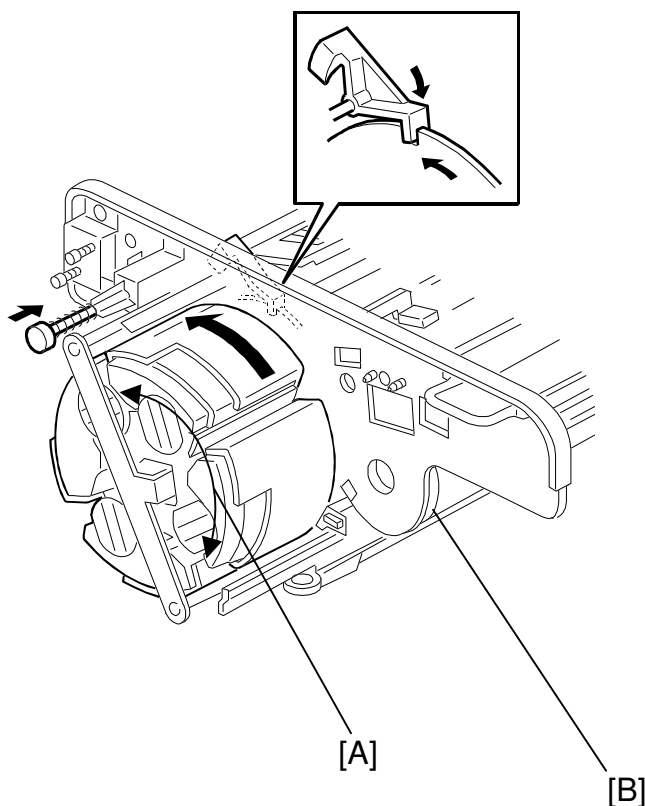
If the gears on the mainframe and revolver unit are not engaged firmly, this may result in a gap between the revolver unit frame and copier frame (thus the unit will not be properly set). This also may cause the gears to be damaged when the revolver starts rotating. To ensure that the gears are properly engaged, it is necessary to manually fit (i.e. lock) the gears together by manipulating the revolver unit back and forth (slightly) as shown in the illustration (arrow [A]). This should be done while holding the toner hoppers.

Since the vibration generated from the image transfer belt drive section is transmitted to the drum section, this vibration may interfere with drum rotation if the gears are not properly engaged. This causes banding on the image (at 1.7 mm intervals).

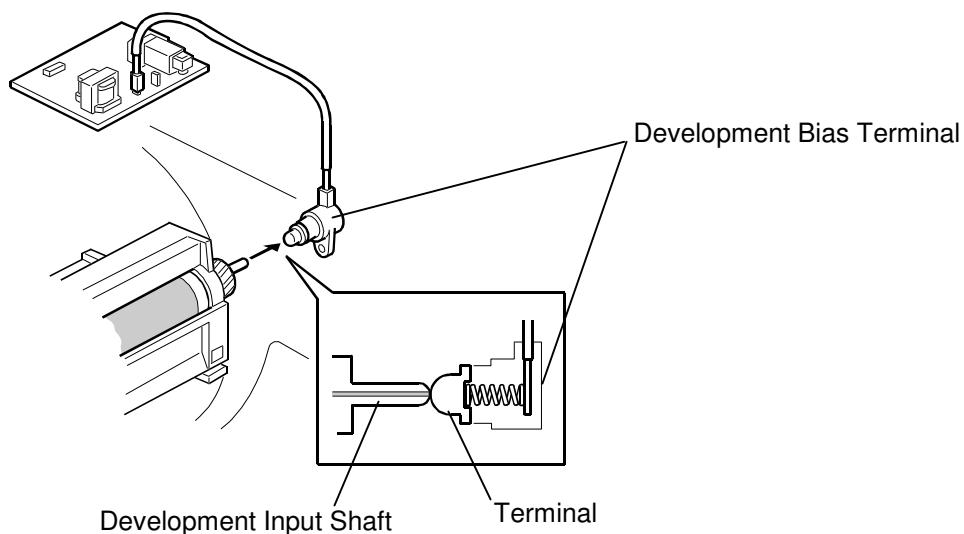
The development bias terminal is pushed against the development input shaft by a spring to ensure proper terminal contact when the development unit reaches the copying position. When the terminal does not move smoothly, poor contact of the development bias terminal results at the beginning of development of the latent image (dirty background will occur under these conditions).

When the contact between the terminal and the development input shaft is not as poor, the image becomes slightly pale (or normal if contact is good).

If the above action is not successful (this is a very rare case), replace the development bias terminal with a new one (P/N A2573298).

If the new part is not available, loosen the upper screw that secures the development bias terminal to the copier rear side frame.

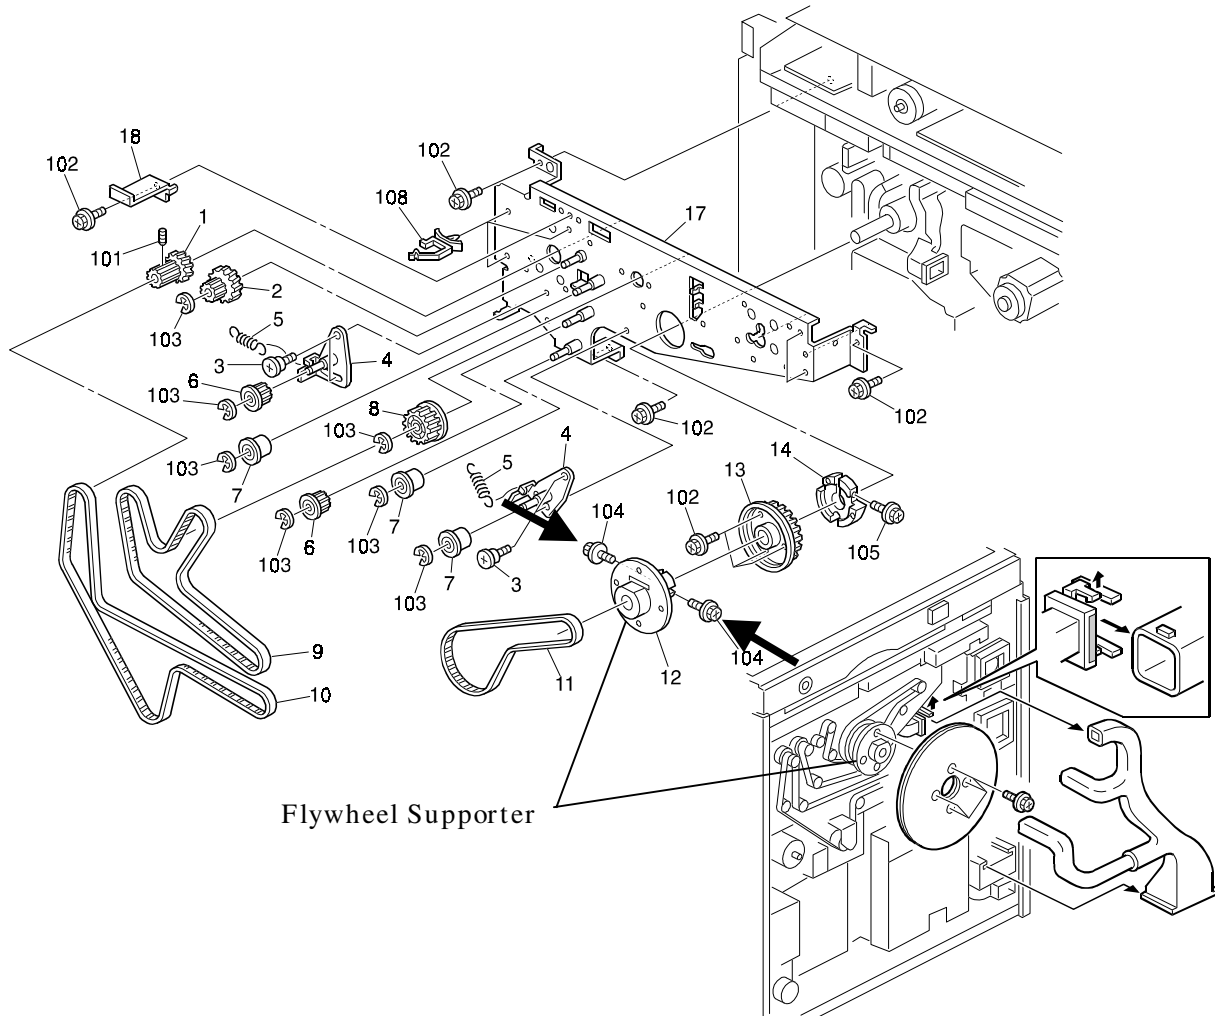
When the drum speed is slowed in thick paper/OHP mode, loose screws that fasten the flywheel supporter to the drum shaft cause the drum to stop for a very short while.

The flywheel supporter has four cut-outs for the screws. Two out of the four cut-outs have a flat surface (from May production: the cut-in serial numbers were not controlled). Make sure that the screws are positioned on these flat surfaces, especially after disassembling these areas.

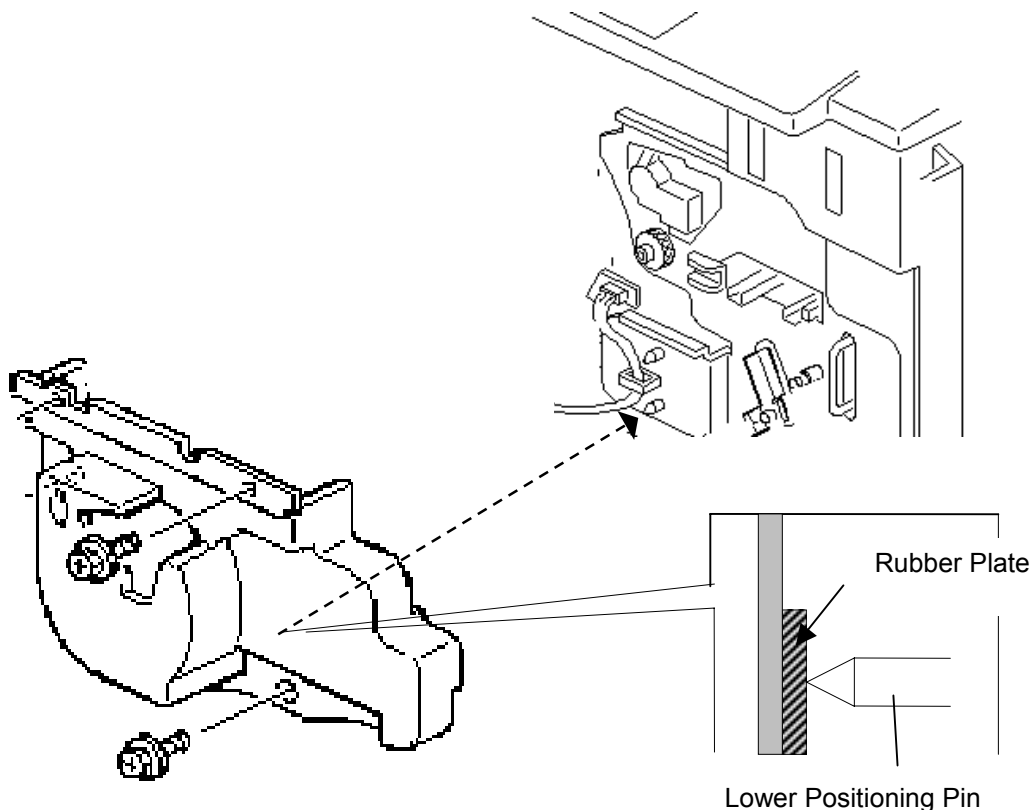
- In order to ensure the accurate setting of the image transfer belt cleaning unit, there is a rubber plate on the rear side of the revolver cover to push the lower positioning pin of the image transfer belt cleaning unit (refer to the illustration below).

- If performing tests (e.g. on machine operation) after the revolver cover has been removed, please do so after pushing the lower positioning pin and properly setting the unit.

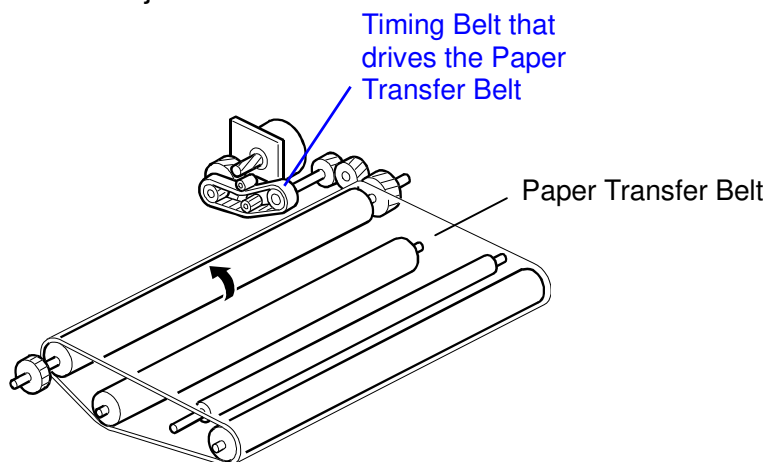
For an A4 (LT) lengthwise or A3 (DLT) copy, one jitter band is observed (at first occurrence). Later, two or three may be observed on A3 (DLT) copies.

It has been found that the tension spring for the timing belt does not have enough strength to prevent this random jitter.

Replace the tension spring with a stronger one at installation or at the next visit to the customer site.

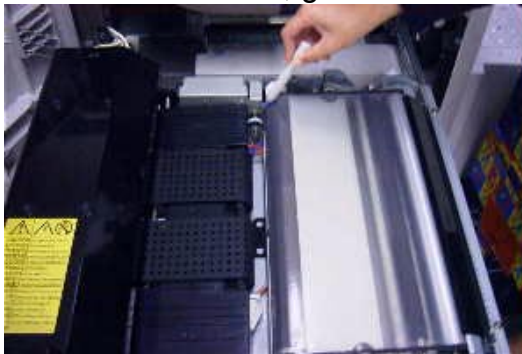
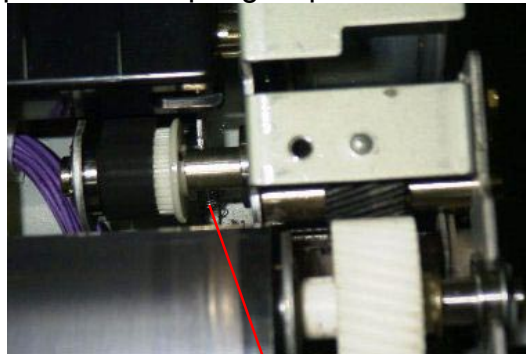
Tension Spring

3. Check the color of the tension spring of the PTB (paper transfer belt) drive belt.  
If the color is black, reassemble the machine since this will indicate that the spring is a new one.  
If the color is silver, go onto the next procedure "Spring Replacement Procedure".

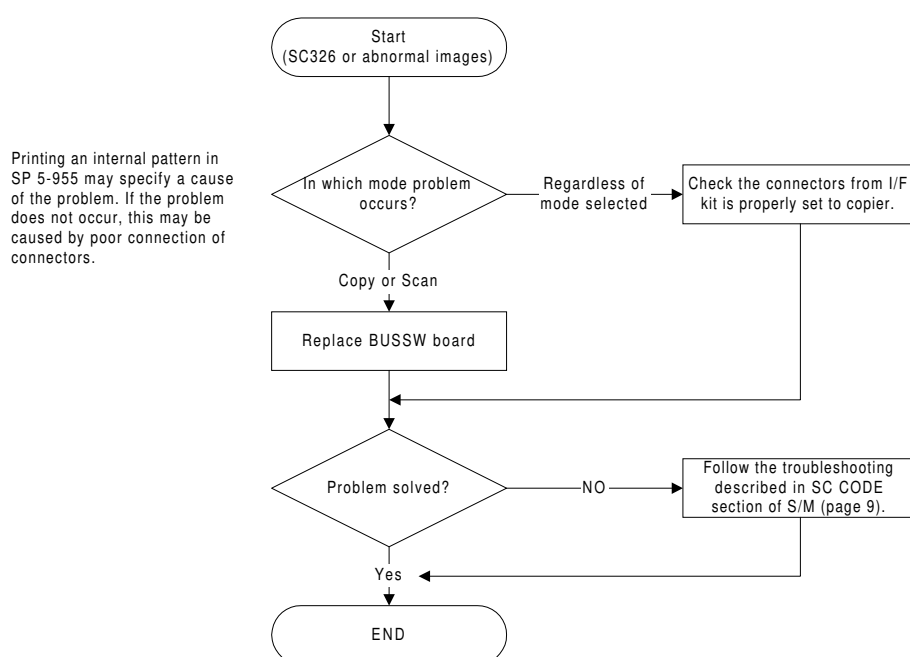
Normally, the input pins (#12 to 17) of IC18 on the BUSSW board are not used for the function of the IC18. However, due to an error in the software programmed in IC18, these pins were allocated as output pins. The resulting increase in power consumption causes the IC to heat up and malfunction.

When the IC does not renew the scanned image data due to the cause explained above, blank image or vertical lines appear on the outputs depending on the image of the first line scanned-in.

**NOTE:** If the problem is related to IC18, the replaced (old) PCB can be re-used after cutting pins #12 - 17. If occurrences still continue after cutting the pins, the problem is being caused by another PCB component.

**NOTE:** If the BUSSW board (IC18) causes the problem and the part is not available, cutting the pins (#12 - 17) of IC18 as explained in section [2] on page 5 of this RTB solves the problem.

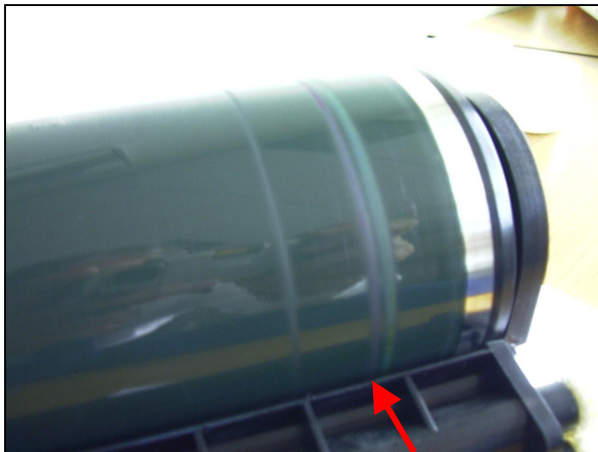
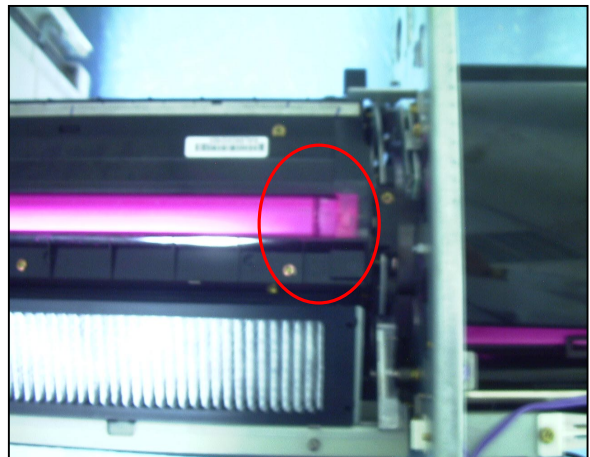
Toner bands around the development sleeve are also observed under the conditions described above. These toner bands are actually formed first and are then transferred to the drum surface.

Under these conditions, a toner band may form around the development sleeve due to heat caused by the heavier load on the developer. This is likely to occur in development units which have a relatively wide doctor gap (but still within specification) among the four development units (YMCK).

If the toner bands form on the drum surface as well, replace the drum and development unit(s) which show toner banding around the development sleeve. If the development sleeve can be cleaned completely, it is possible to re-use the development unit. Next, attach the transfer faceplate as described above.

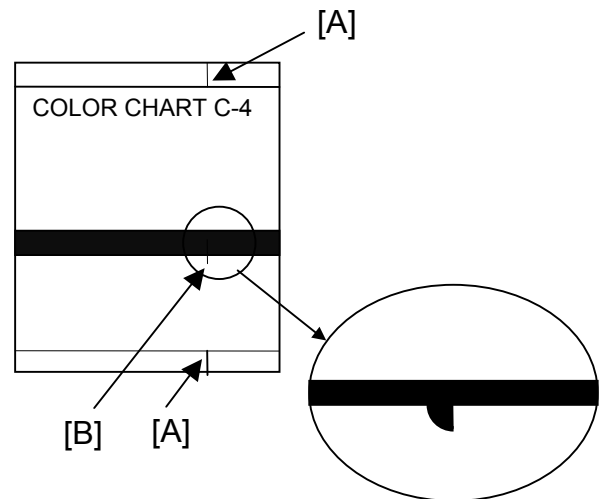
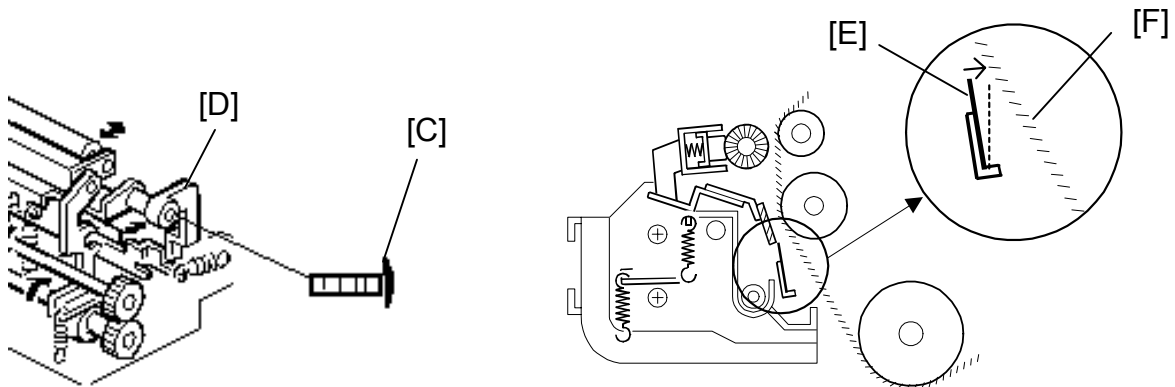
This is particularly noticeable in FC mode.

The screw [C] securing the entrance seal release lever [D] came loose and the entrance seal [E] contacted the image transfer belt [F] during the copy process. This caused the vertical lines in blank areas and the smeared images below the lower edges of solid image areas.

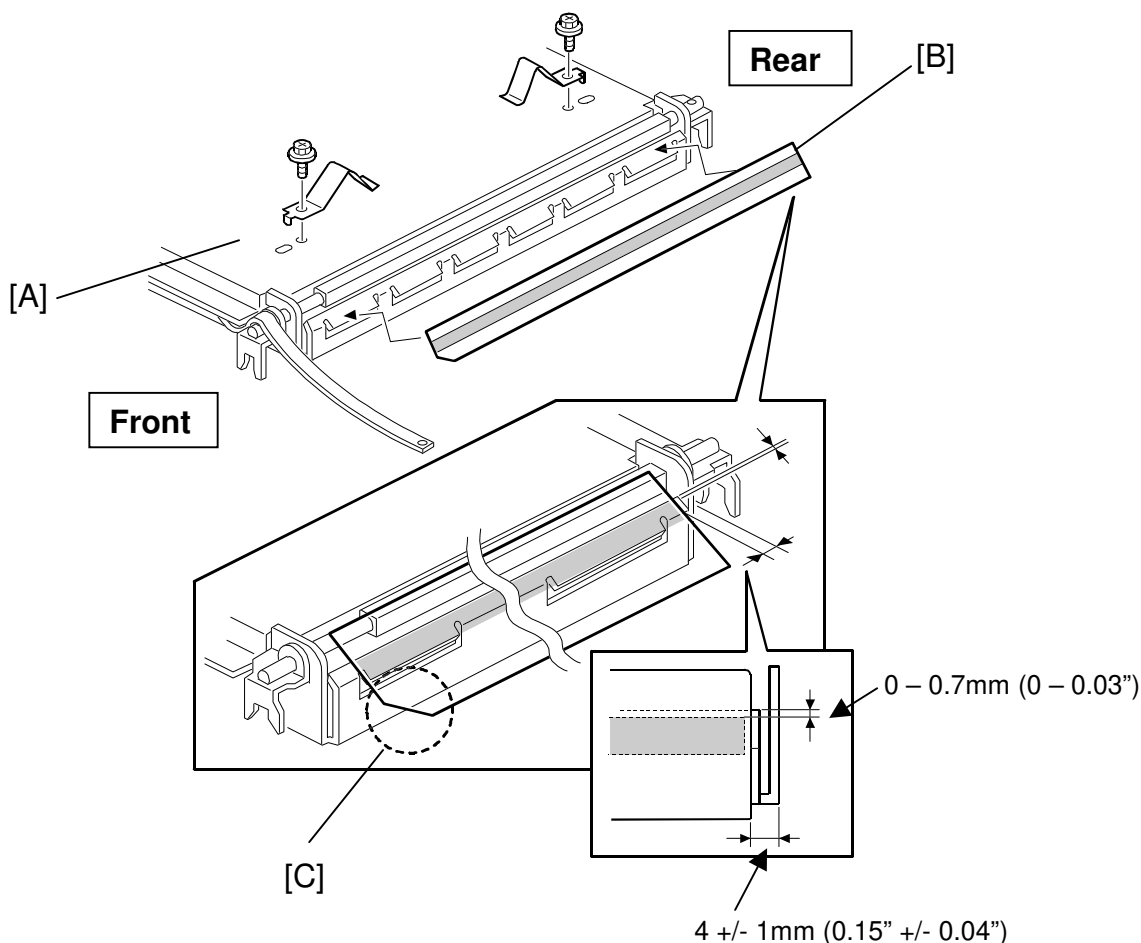
The service manual (page 3-33, LCT adapter installation) explains where the mylar [B] should be attached onto the vertical transport unit [A]. However, it was found that in the field the mylar was not properly positioned, causing paper to skew or jam.

1. Place the vertical unit [A] as shown.
  2. Attach the mylar [B] onto the vertical unit to satisfy the following conditions.
    - The cut-out [C] in the mylar must be located at the front of the unit.
    - All gaps must be within the adjustment range.
- Note:** Side-to-side positioning should be adjusted using the rear side plate (outer surface).

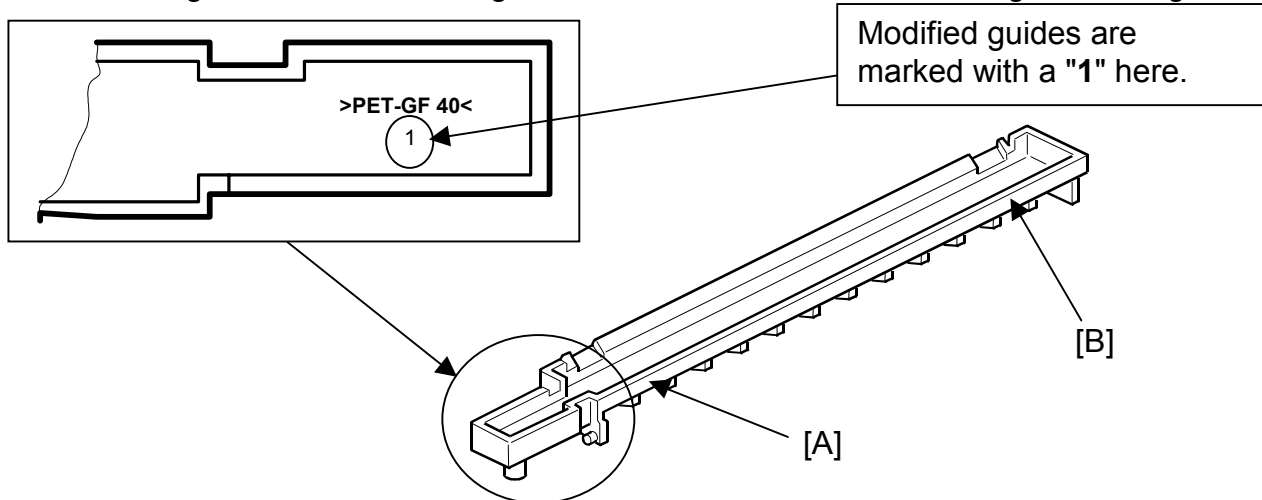
Older (pre-modification) guides have **2** burrs created by molding gates, which are located in positions [A] and [B]. Modified guides only have **1** burr, which is located at position [A].

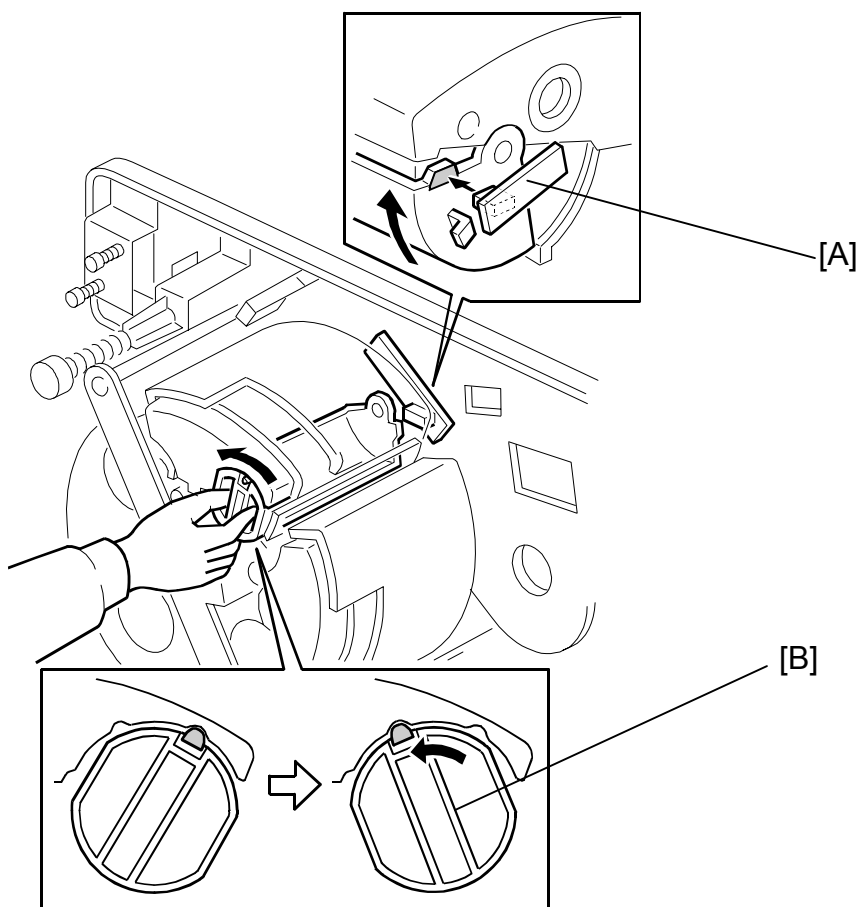
The toner cartridge set sensor [A] is not activated because the toner cartridge lever [B] is not rotated all the way.
