SUBJECT:
SOFTWARE / FIRMWARE UPDATE

MODEL: C4MF

SUBJECT: AC HARNESS MODIFICATION

SUBJECT: Inverter Misfeed

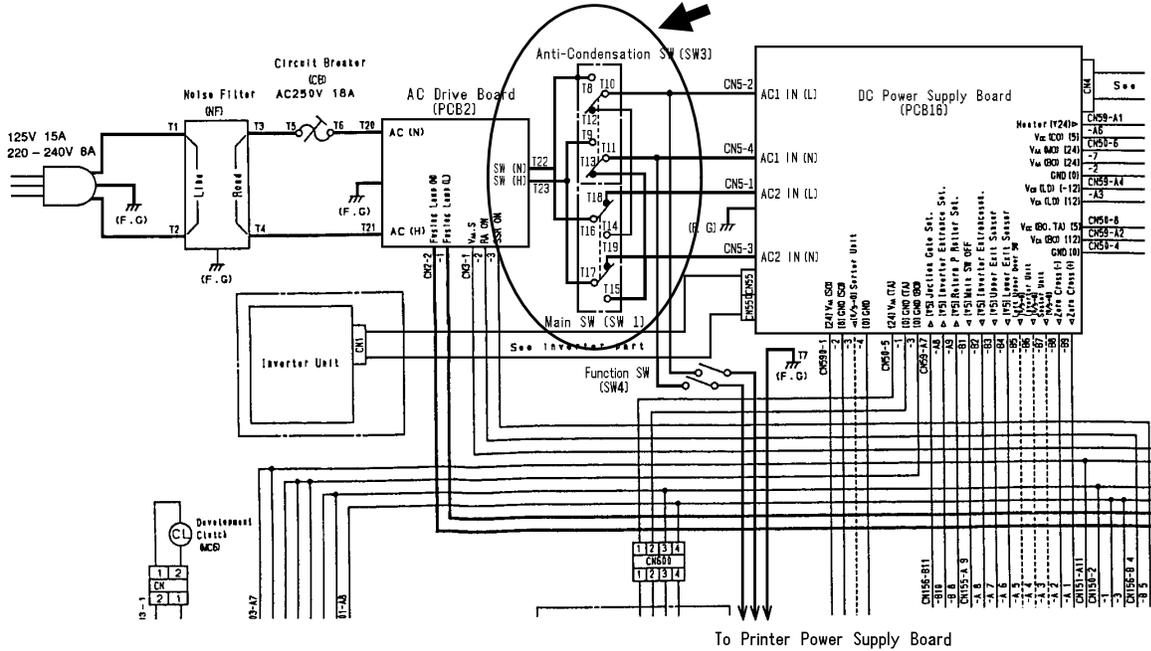
< Old circuit >

When the anti-condensation switch is turned on and the printer function is disabled, service technician or operator must turn the anti-condensation and the main switches off and on to reset the printer control board.

To eliminate the necessity of turning off and on the anti-condensation switch the ac harness (Part Number : A0995501) has been modified from July 1994 production.

The diagrams on page 2 of 2 show the point to point wiring of the old and new circuits. Please update the point to point diagram in the service manual.

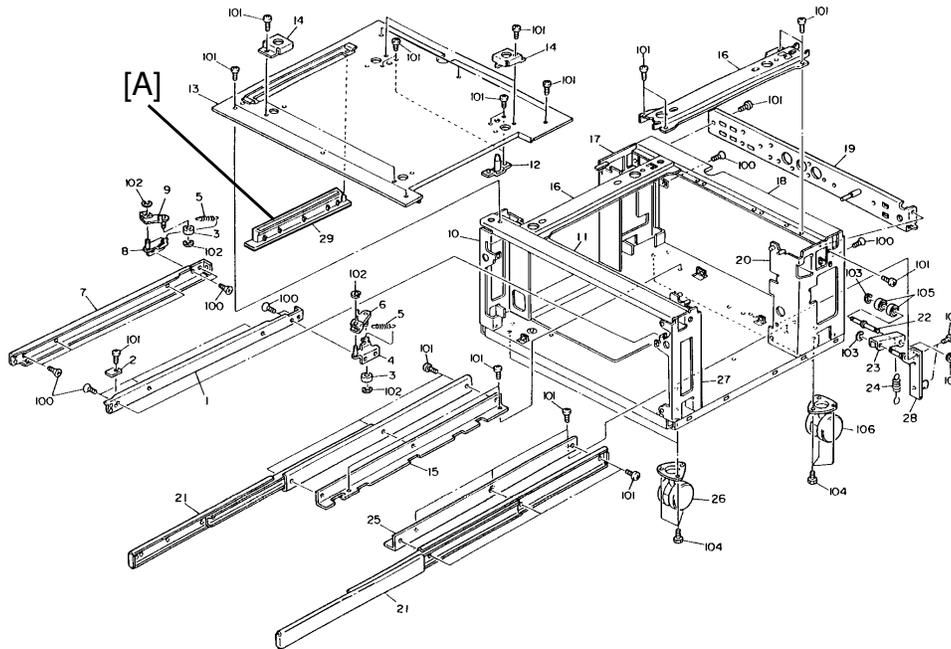
A paper misfeed occurs in the inverter unit and the Misfeed Location indicator D and E light.

The paper entrance guide [A] on the LCT / duplex unit or the LCT unit is out of position and interferes with paper movement.

1. Open the left cover on the LCT / duplex unit or the LCT.
2. Push and snap up both the front and rear of the paper entrance guide and make sure that it is positioned properly.
