Model: CMY-MF1c/d		Date: 14-Mar-19	No.: RD0AP002
Subject: Cannot log in during the daylight-saving time		Prepared by: Y.Tamaoka	
From: Overseas Field Info Sec., OP/OS PQM Dept			
Classification:	<input checked="" type="checkbox"/> Troubleshooting	<input type="checkbox"/> Part information	<input type="checkbox"/> Action required
	<input type="checkbox"/> Mechanical	<input type="checkbox"/> Electrical	<input type="checkbox"/> Service manual revision
	<input type="checkbox"/> Paper path	<input type="checkbox"/> Transmit/receive	<input type="checkbox"/> Retrofit information
	<input type="checkbox"/> Product Safety	<input type="checkbox"/> Other ()	<input type="checkbox"/> Tier 2

Model: CMY-MF1cM/dM		Date: 14-Mar-19	No.: RD0AP003
Subject: Setup procedure at the first power up		Prepared by: Y. Tamaoka	
From: Overseas Field Info Sec., OP/OS PQM Dept			
Classification:	<input checked="" type="checkbox"/> Troubleshooting	<input type="checkbox"/> Part information	<input type="checkbox"/> Action required
	<input type="checkbox"/> Mechanical	<input type="checkbox"/> Electrical	<input type="checkbox"/> Service manual revision
	<input type="checkbox"/> Paper path	<input type="checkbox"/> Transm

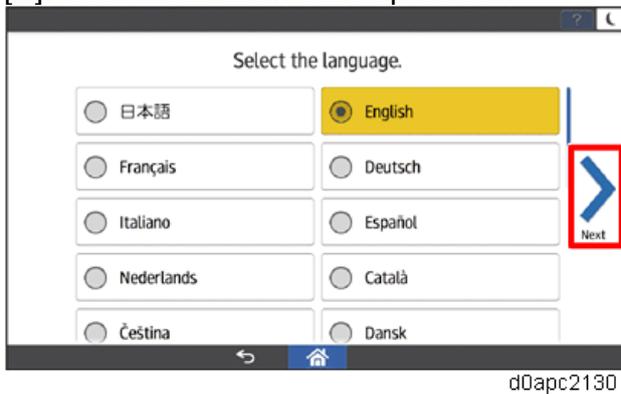
[A]: User installation start-up screen

The start-up screen for user installation [A] (instead of for service installation [B]) appears when the machine is first powered up at installation, even though the machine is a service-installed model.

The factory tool to input the initial machine settings was incorrectly programmed for service-installed models.

The initial machine settings are correct from the end of March 2019 production.

Follow the regular procedure for user installation.

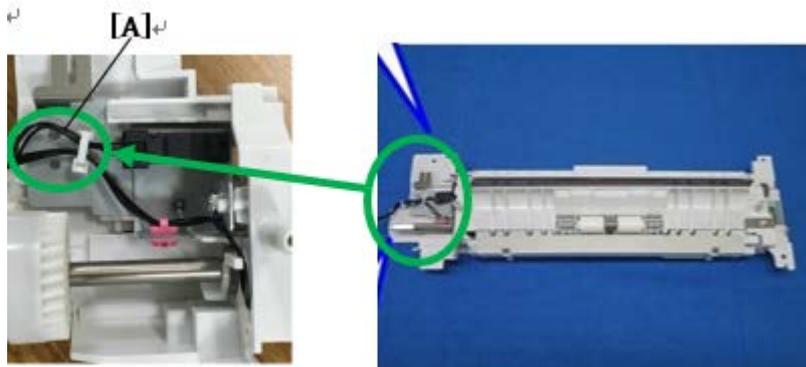
Noise occurs around Bypass feed upper cover.

Contact with the harness for Bypass Paper End Sensor [A] and clutch gear.

Replace the harness with P/N: D0A45325

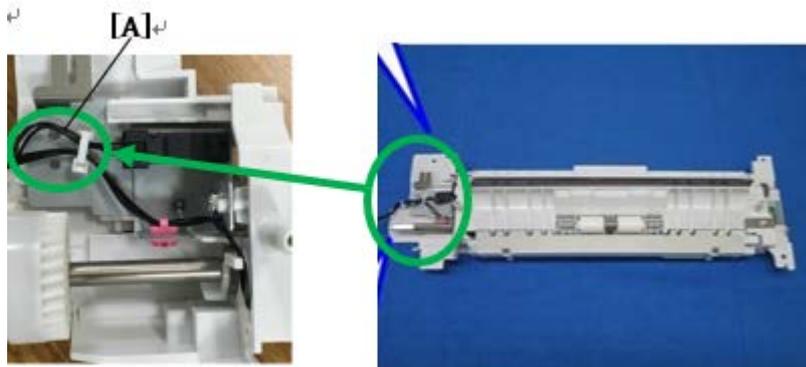
Noise occurs around Bypass feed upper cover.

Contact with the harness for Bypass Paper End Sensor [A] and clutch gear.

Replace the harness with P/N: D0A45325

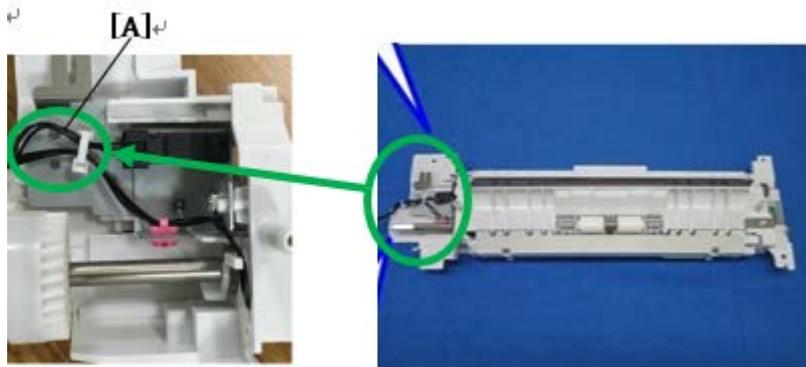
Noise occurs around Bypass feed upper cover.

Contact with the harness for Bypass Paper End Sensor [A] and clutch gear.

Replace the harness with P/N: D0A45325
