Model: Met-MF3		Date: 25-Jan-19	No.: RD0BL001
Subject: Announcement for Customer Engineer Tool		Prepared by: Y. Taniguchi	
From: Technical Support Sect., Service Strategy Dept.			
Classification:	<input type="checkbox"/> Troubleshooting <input type="checkbox"/> Mechanical <input type="checkbox"/> Paper path <input type="checkbox"/> Product Safety	<input type="checkbox"/> Part information <input type="checkbox"/> Electrical <input type="checkbox"/> Transmit/receive Other ()	Action required Service manual revision Retrofit information Tier 2 Tier 0.5

An SOP application which can support the maintenance operations is released.

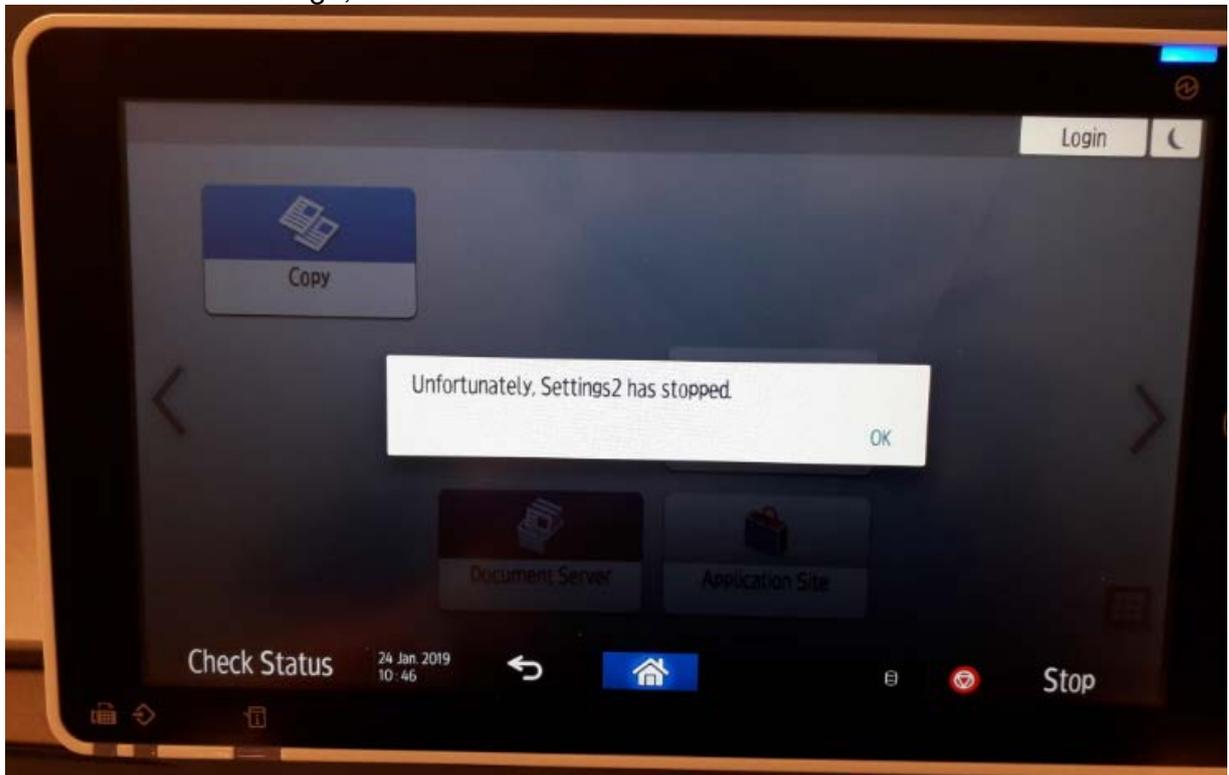
- "Unfortunately, Setting2 has stopped" error message appears at start-up and cannot be cleared, and during this time the machine is not usable.
- An error screen is displayed when the Sound Settings screen is accessed inside Installation Settings, which then closes down/crashes.

The settings file imported to the machine at the time of the shipment from the configuration center does not contain the three settings underlined below (of the total 13 sound type settings).

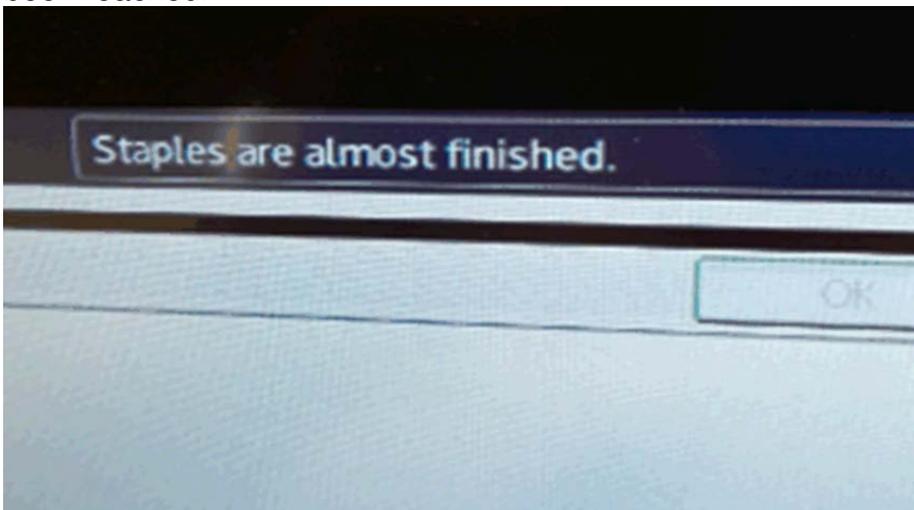
“Staples are almost finished.” is displayed in the banner shown below right after installation, even though the staple cartridge is almost full and Near End has not yet been reached.

An ORT (On-going Reliability Test) was performed on the finisher at the factory, but the factory did not return the remaining number of staples to the initial value. As a result, the remaining number counter value became lower than the Near End threshold, triggering the Near End alert to be displayed. Since a new cartridge was replaced at shipment, a discrepancy occurred between the staple remaining counters and the actual number in the staple cartridge.

1. Replace the Staple cartridge (Not just the Stapler before Staple End).
2. Set the SPs in the table above to the initial values shown.

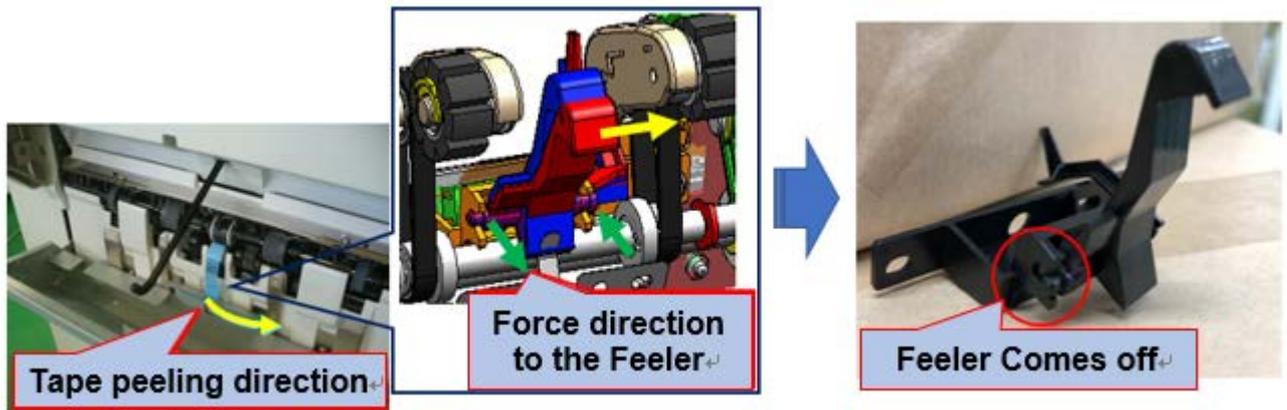
Because the force is applied in the direction in which the "Paper sensor feeler" is come off when removing the packaging tape of the "Paper sensor feeler" at the time of unpacking & installation. (Refer the Fig. 1 shown as below)

Peel the packaging tape straight up and pull out the protective member, when peeling off the packaging tape of the “Paper Sensor feeler”. (Refer the Fig. 2 shown as below)

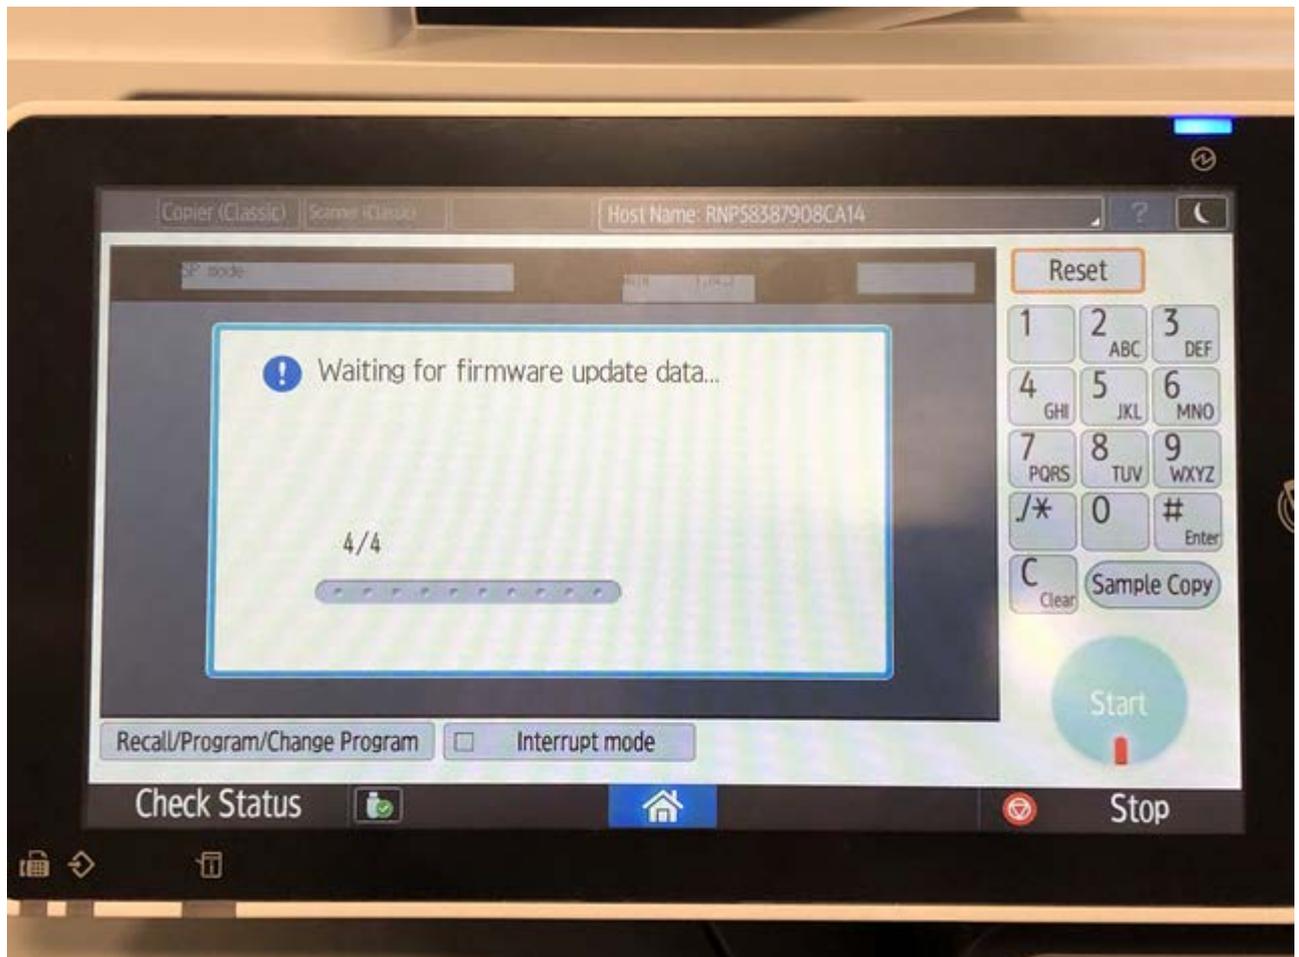
Firmware updates fail when performed from the SD/USB slot on the operation panel after recovering from energy saving mode, and the following message is displayed.

When the machine transitions to or from Energy Saver mode, the flag for the firmware upgrade start conditions is cleared.

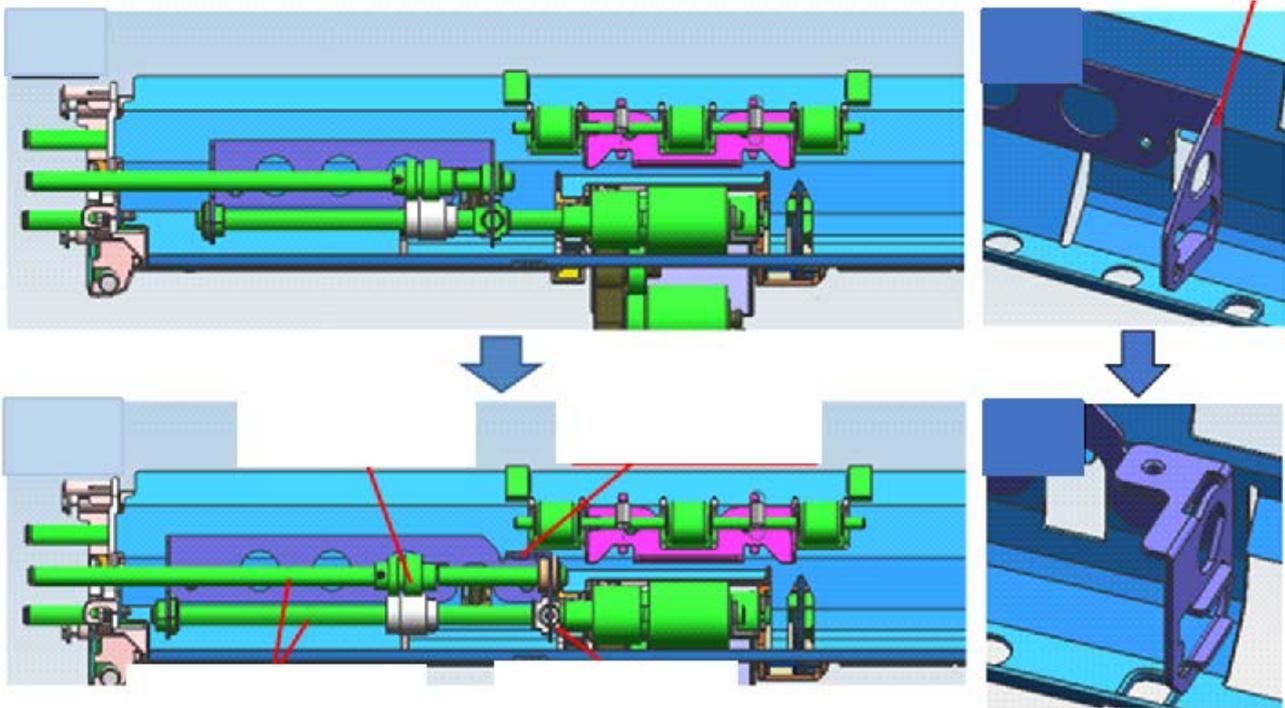
Change 4: There are no protruding parts to hold the gear. An e-ring added to stop the gear in position, and a groove added to the shaft for the e-ring.

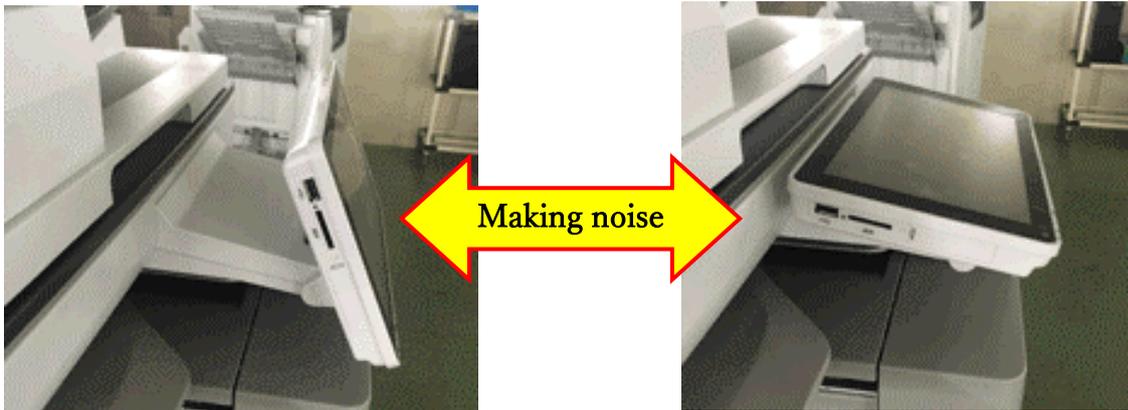
The noise occurs when the SOP tilted back down.

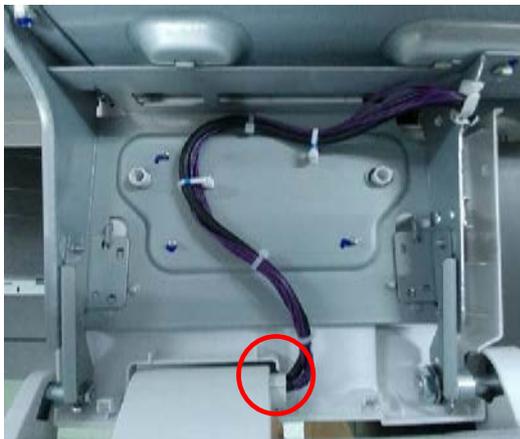
The noise is caused by the harness touching the cover (marked with the red circle).

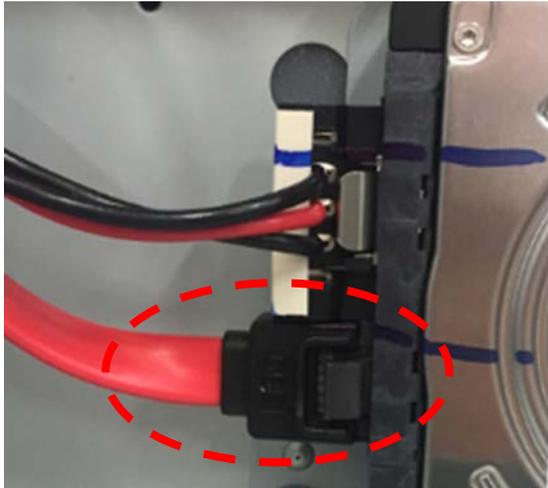
Occurrence ratio: 0.08% (=4/5,808 machines)

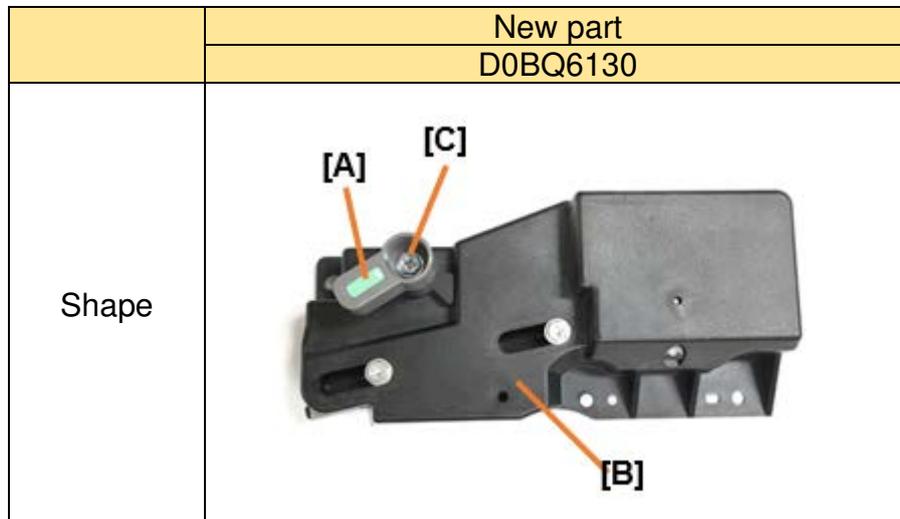
Change: The shape of the metal lever shaft has been changed slightly. The metal lever shaft is attached to the toner outlet unit[B].
