Model: Iris2/Lilac2		Date: 24-Nov-00	No.: RB017001
Subject: Relay Harness of the Fax Unit		Prepared by: N. Kaiya	
From: Technical Services Dept., GTS Division			
Classification:	<input type="checkbox"/> Troubleshooting <input type="checkbox"/> Part information <input checked="" type="checkbox"/> Action required <input type="checkbox"/> Mechanical <input type="checkbox"/> Electrical <input type="checkbox"/> Service manual revision <input type="checkbox"/> Paper path <input type="checkbox"/> Transmit/receive <input type="checkbox"/> Retrofit information <input type="checkbox"/> Other ()

Model: Iris2/Lilac2 (Controller E-310)		Date: 24-Jan-01	No.: RB017002
Subject: Important Notes when installing the E-310		Prepared by: Chisato Tsuji	
From: Technical Services Dept., GTS Division			
Classification:	<input type="checkbox"/> Troubleshooting <input type="checkbox"/> Mechanical <input type="checkbox"/> Paper path <input type="checkbox"/> Other ()	<input type="checkbox"/> Part information <input type="checkbox"/> Electrical <input type="checkbox"/> Transmit/receive	<input checked="" type="checkbox"/> Action required <input type="checkbox"/> Service manual revision <input type="checkbox"/>

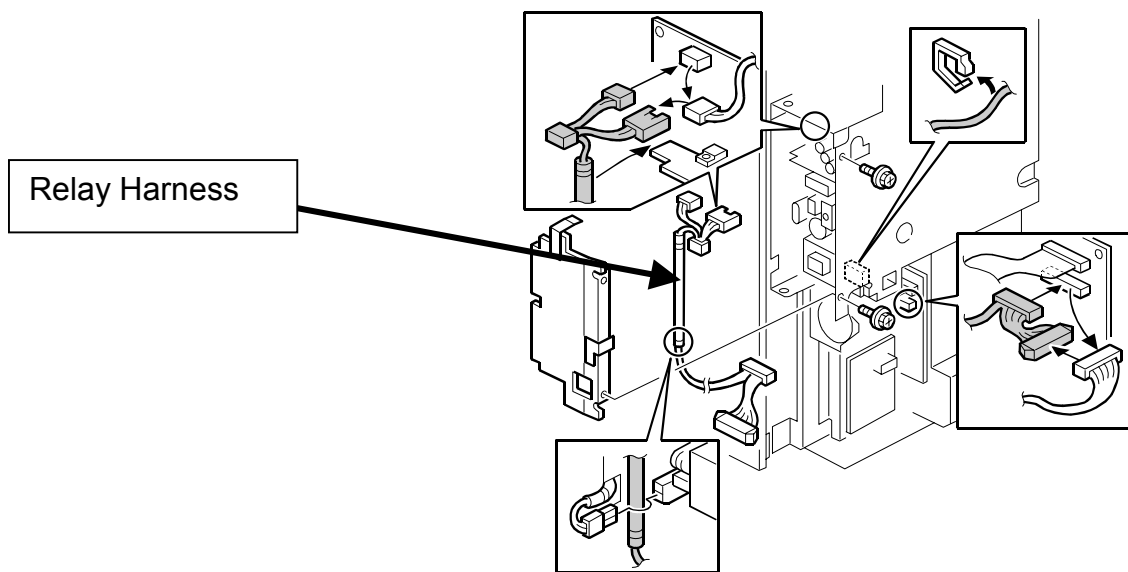
When installing the fax unit (machine code B383), it is not necessary to install the relay harness shown in the below figure.

The relay harness is packed with some of the August and September production lots of the fax unit to fix a problem with the domestic version product. The harness is not mentioned in the service manual.

The purpose of the relay harness was to stabilize +5VE power for the FCU by obtaining 5V power directly from the interface unit power supply unit. This was necessary because +5VE may drop and reset the CPU when the machine goes back to stand-by mode from energy saver mode. However, even if the CPU is reset when the machine goes back to stand-by mode from energy saver mode, no problem will appear with the overseas version products. Instead, the relay harness may cause the documents stored in the fax memory to disappear when the main switch is turned off and then on. This is because +5VE is supplied slightly after +5V when the main switch is turned on, and the battery back up to the memory is momentarily cut.

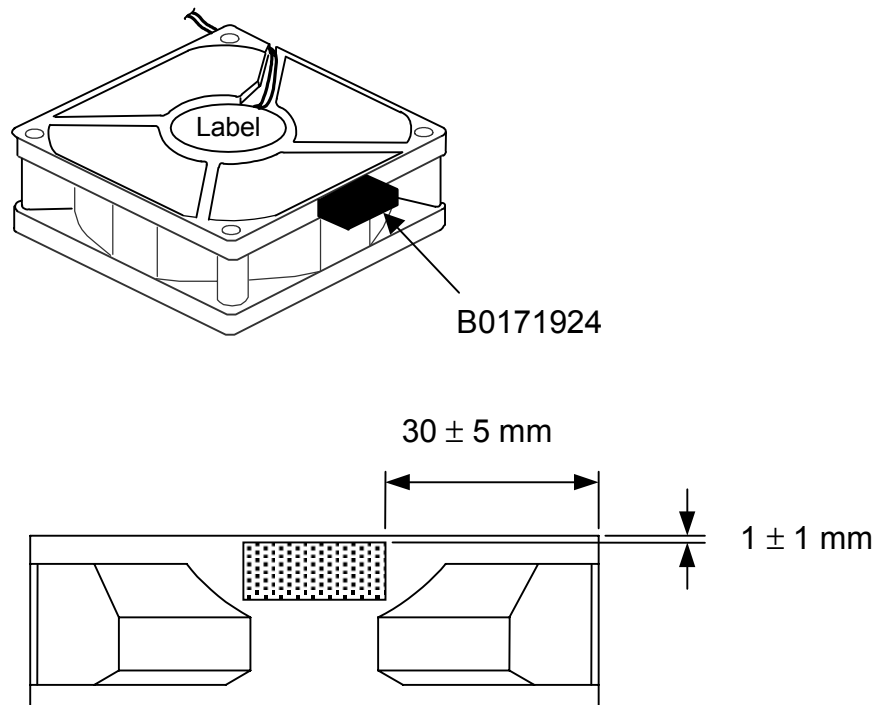
Noise can sometimes be heard from the IPU fan motor while the machine is in standby mode.

In slow speed mode, the reduced speed of the motor can sometimes cause the casing to resonate.

Attach the B0171924 damper to the IPU cooling fan as shown below.

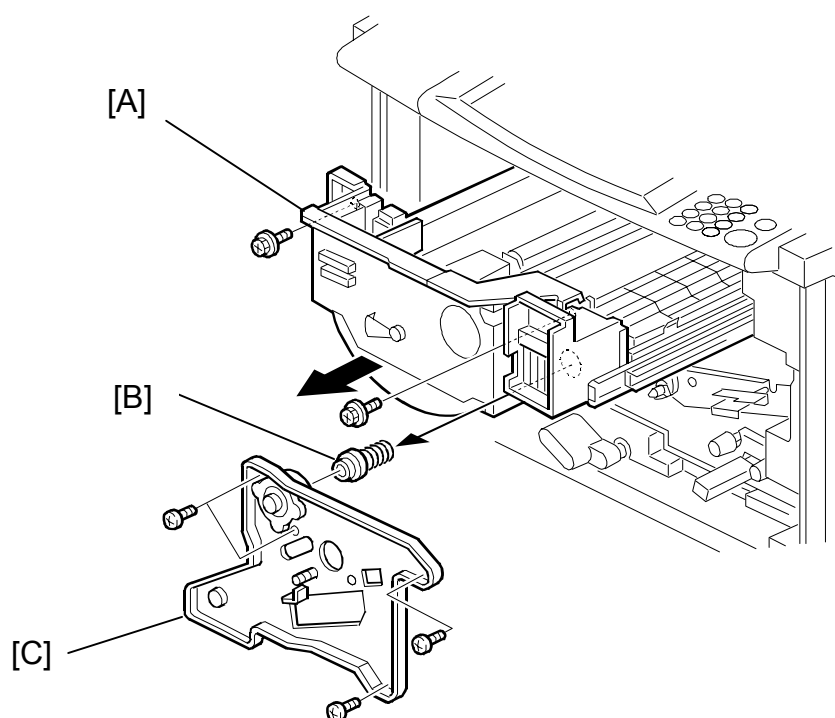
When removing the drawer unit [A], remove the spring and its holder [B] when detaching the transfer belt unit stay [C]. Otherwise, the spring and its holder can drop out when the drawer unit is pulled out. In addition, the spring and holder may spring out when the drawer unit is pushed in at unit installation.

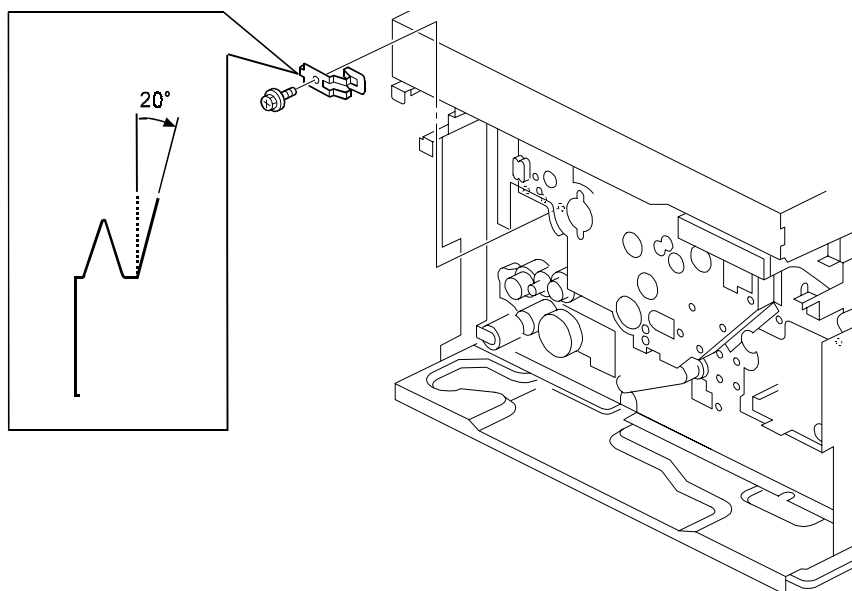
Poor contact between the grounding plate and PCC casing can cause an electrical leak and/or noise.

Bend the portion of the grounding plate shown below approximately 20° ($\pm 5^\circ$) to optimize the contact between grounding plate and PCC casing.

Note: When bending, be sure to keep the portion flat and untwisted.

The grounding plate was modified as shown above and applied to the production line from May, 2001.

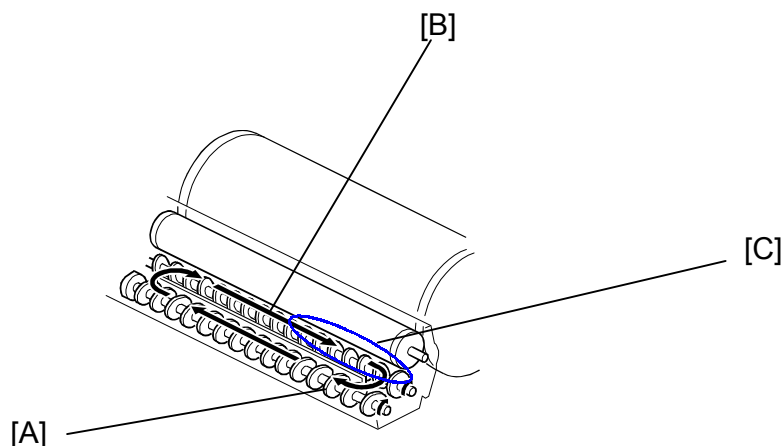
1. The toner weight percent around the area [C] inside the development unit decreases during continuous development of images containing a percent of solid image areas (copier/printer).
2. The developer's chargeability decreases prematurely.

[A]: Toner is supplied from the toner hopper around this area.

[B]: During this toner flow (non-operator side to operator side), toner is consumed for image development.
