SUBJECT: Service Manual Correction

LILY
(A172 / A199)

SUBJECT: Grease for Transfer Belt Unit and Transfer Roller Unit

Model: Lily		Date: 28-Feb-97	No: 003	1/2
Subject: Transfer Belt Tension Release Wedge			Prepared by: N. Kaiya	
From: QAC 1st Field Information Dept.			Checked by: T. Inoue <i>T. Inoue</i>	
Classification:	<input type="checkbox"/> Troubleshooting	<input type="checkbox"/> Part information	<input type="checkbox"/> Action required	
	<input type="checkbox"/> Mechanical	<input type="checkbox"/> Electrical	<input type="checkbox"/> Service manual revision	
	<input type="checkbox"/> Paper path	<input type="checkbox"/> Transmit/receive	<input type="checkbox"/> Retrofit information	
	<input type="checkbox"/> Other ()

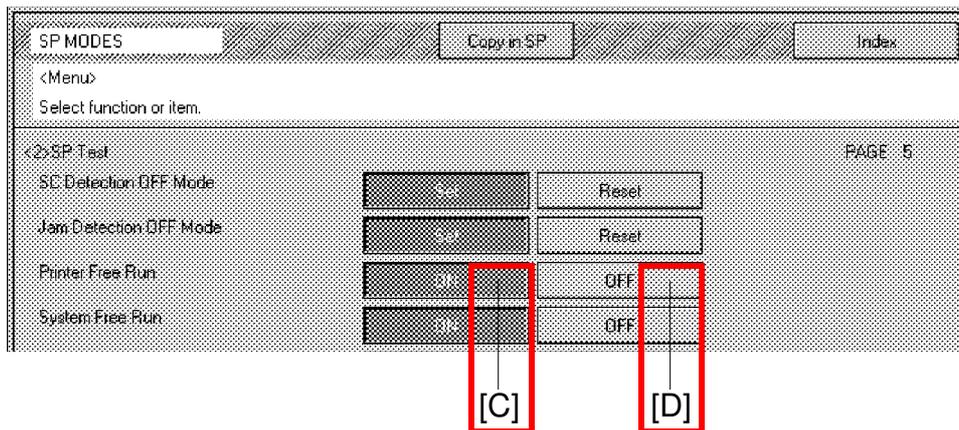
Printer Free Run must be used instead of System Free Run.

In System Free Run mode, the test pattern will not be written on the drum surface but the actual scanned image will be written. If we use the System Free Run mode in this step, a blank image (= image of white paper) will be made on the drum surface, causing too much friction between drum and drum cleaning blade.

10. Start the **Printer Free Run** by touching "ON" [C] and wait for 6 to 7 minutes.

11. Stop the **Printer Free Run** by touching "OFF" [D].

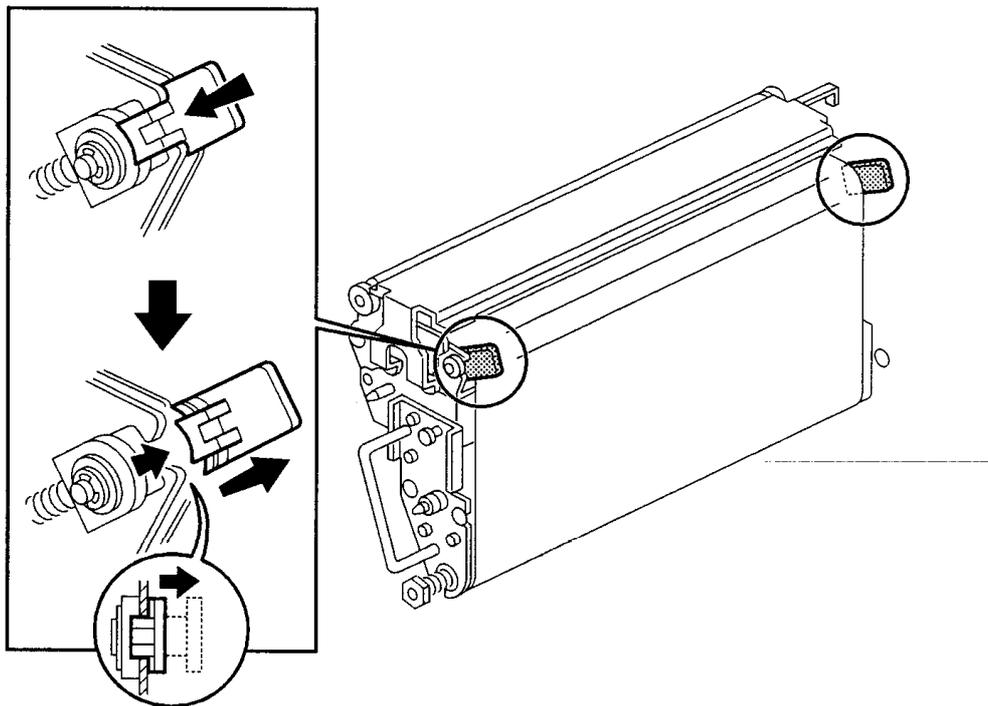
In order to release the tension of the transfer belt during transportation, the Transfer Belt Release Wedges are installed on the front and rear belt tension roller bearing holders. Please do not forget to remove the wedges when installing the machine.

To remove the wedge, push the wedge toward the bearing holder and slide it inside slightly.

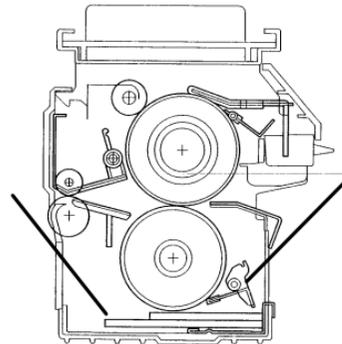
Pressure Roller
Oil Pad

A pressure roller cleaning blade and a pressure roller oil pad will be added in place of the pressure roller cleaning roller. The pressure roller cleaning roller will be removed. The pressure roller cleaning blade removes calcium carbonate on the pressure roller. It also removes excess silicone oil from the pressure roller. The silicone oil applied on the pressure roller surface prevents the pressure roller cleaning blade from making vibration noise.

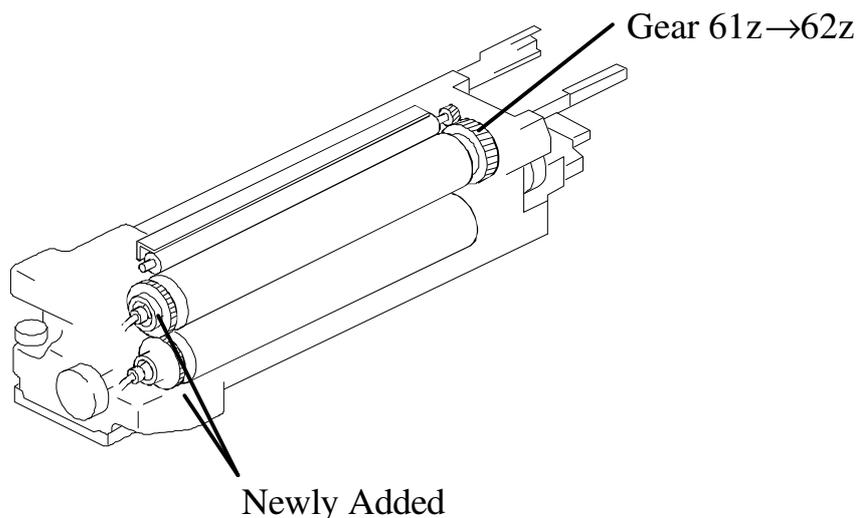
The addition of cleaning blade and oil pad applies excess load to the pressure roller which may result in copy quality problems such as muzzy image. To prevent this problem, gears are added to the front of the hot roller and pressure roller, which provide drive to the pressure roller. At the same time, the 61Z Gear has been changed to a 62Z Gear to compensate for the slight increase in the paper speed caused by providing drive to the pressure roller. To install the gears, the hot roller and the pressure roller have been modified with interchangeability x/o.

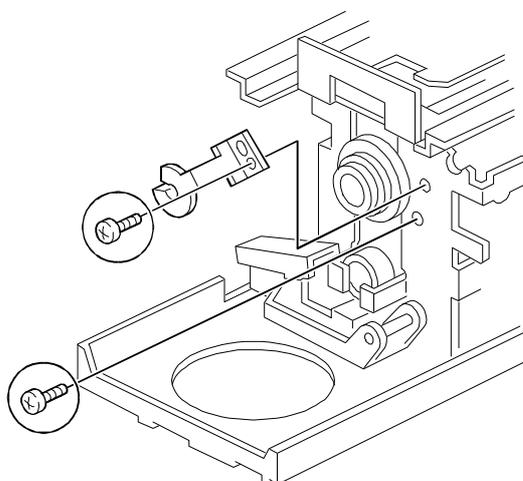
The screw holding the front fusing lamp holder has been changed to a shorter (M4 x 5) screw to prevent contact with the hot roller gear. The same screw type has been added to secure the ball bearing at the front of the hot roller. This is necessary to maintain the position of the hot roller gear and to ensure meshing with the pressure roller gear.

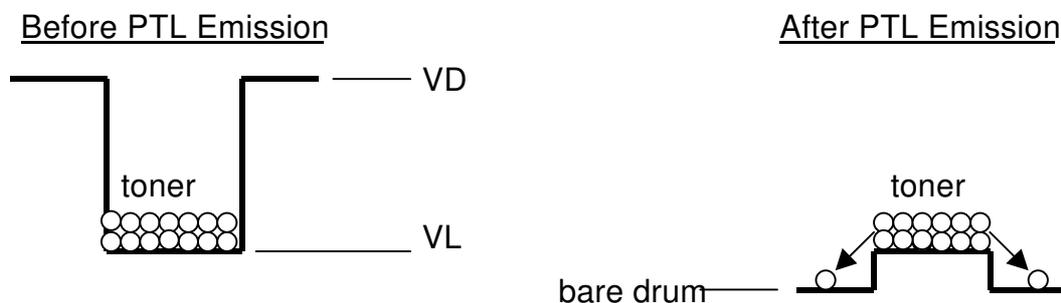
The PTL light (red light) is blocked by the cyan toner. The electrical potential of the image area does not drop, while the potential on the bare drum surface drops. As a result, some toner is attracted to the bare drum surface. See the following diagram.

(VD drops to the bare drum potential level, but VL does not drop to the same level since PTL light is blocked by cyan toner.)

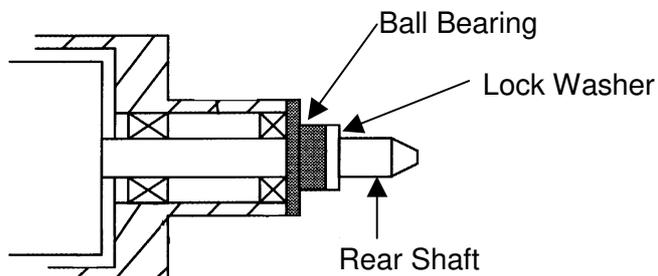
Horizontal lines (banding) occur at random pitches, most noticeably in half-tone images. Removal/reinstallation of the development unit or replacement of the development sleeve have been effective but recurrences have been reported.

Install the side sleeve shaft gear of the magenta sleeve assembly into the ball bearing (08053596) as shown below. Set the lock washer (H0014219) to secure the ball bearing.

For the field units, please add the ball bearing and the lock washer when the problem is found. Please refer to the Modification Bulletin for cut-in serial number of the modification to the production.

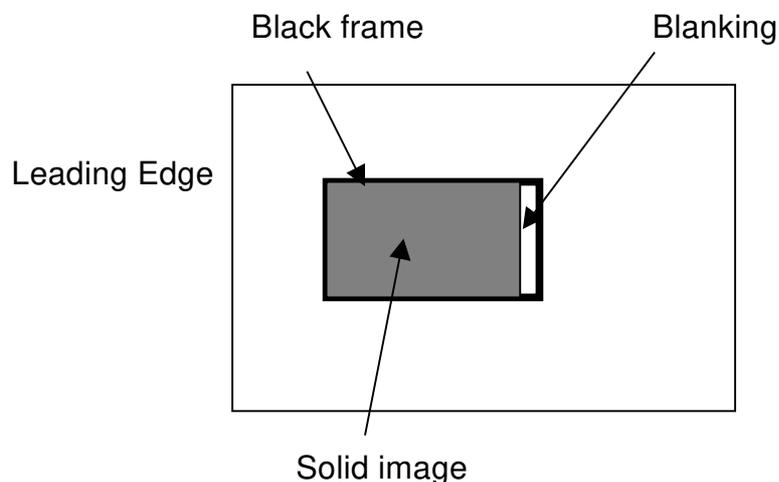
Blanking occurs at the trailing edge of a solid image area when there is a black frame. The problem does not happen with the grid pattern from the copier. The width of the blanking is about 0.1 to 0.2 mm.

In machines in which the relative speed difference between the drum and the transfer belt is quite large, the electrostatic absorption at the time of belt transfer causes partial shifting of the image. The difference in the position shift of the grid pattern and the controller image is probably a result of direct contact area difference between the drum and the belt of the toner image.

1. Adjust the tension of the transfer belt timing belt and the drum drive timing belt.
2. SP Adjustment: P. 1: Transfer Belt Speed Adjustment (Default: 0)
Increase the setting by +1~+2.
3. Check the copy quality.

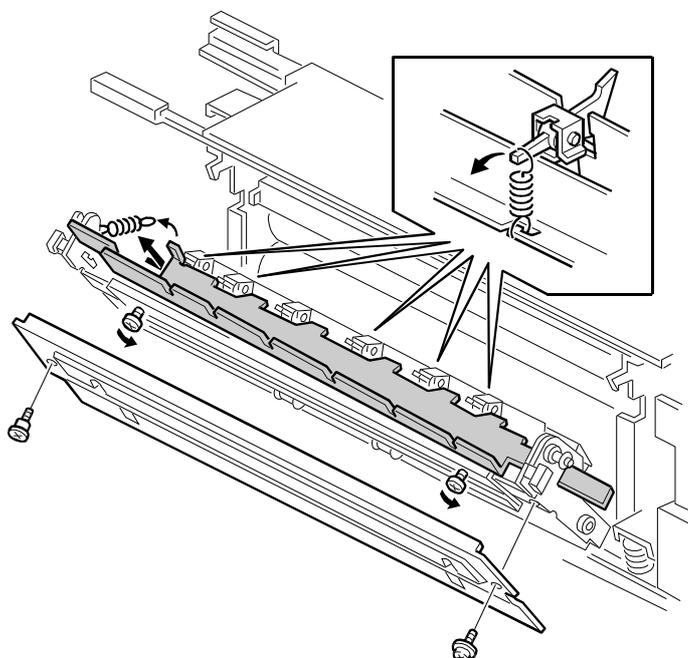
The hot roller stripper slider has been modified to prevent the stripper from being pushed too hard into the hot roller by jammed paper. The part number has been changed from A1094204 to A1724205.

When replacing the slider, loosen the two screws and remove the hot roller stripper springs as shown below. Apply some grease to the slider in the area where it contacts the front and rear frame of the paper exit unit.

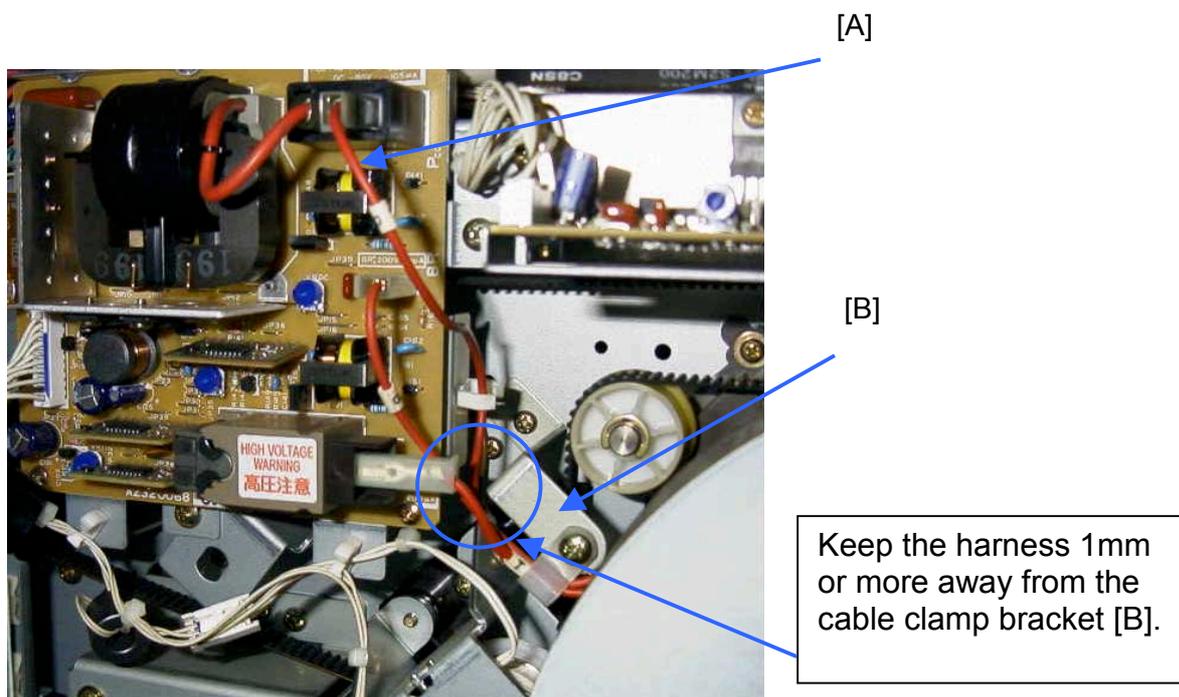
A high-voltage leak can occur if the harness [A] that runs between the power supply and PCC (pre-cleaning corona) wire touches the cable clamp bracket [B]. Although at first the leak is very minimal, over time this causes the electrical load on the harness to increase, which damages the harness and increases the leakage. The leaking point is white in many cases.

This leak can then affect the PCC, which markedly decreases the efficiency of the drum-cleaning unit. In addition, the charge applied across the drum will not be uniform, leading to density variations in the developed image that do not appear on the original.

Check to see if the PCC high-voltage harness is touching the cable clamp bracket [B]. If it is, position the harness at least 1mm away from the clamp as shown:

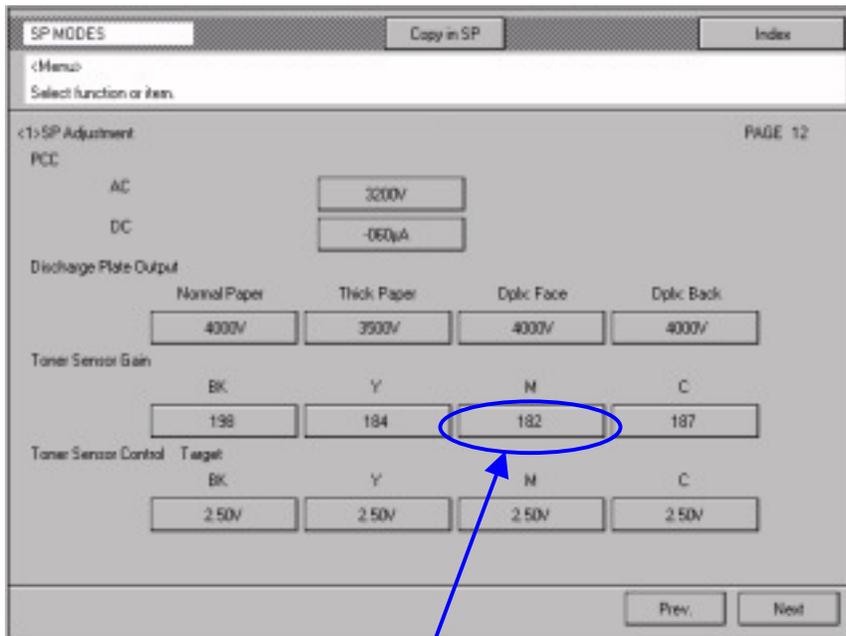
1. Never reduce the Toner Sensor Gain value more than -9. Doing so can cause side effects such as low image density.
2. Never perform this procedure for any color other than Magenta. This can also cause side effects to occur.

Decrease the *current value* by -9.
e.g. 182 → 173.

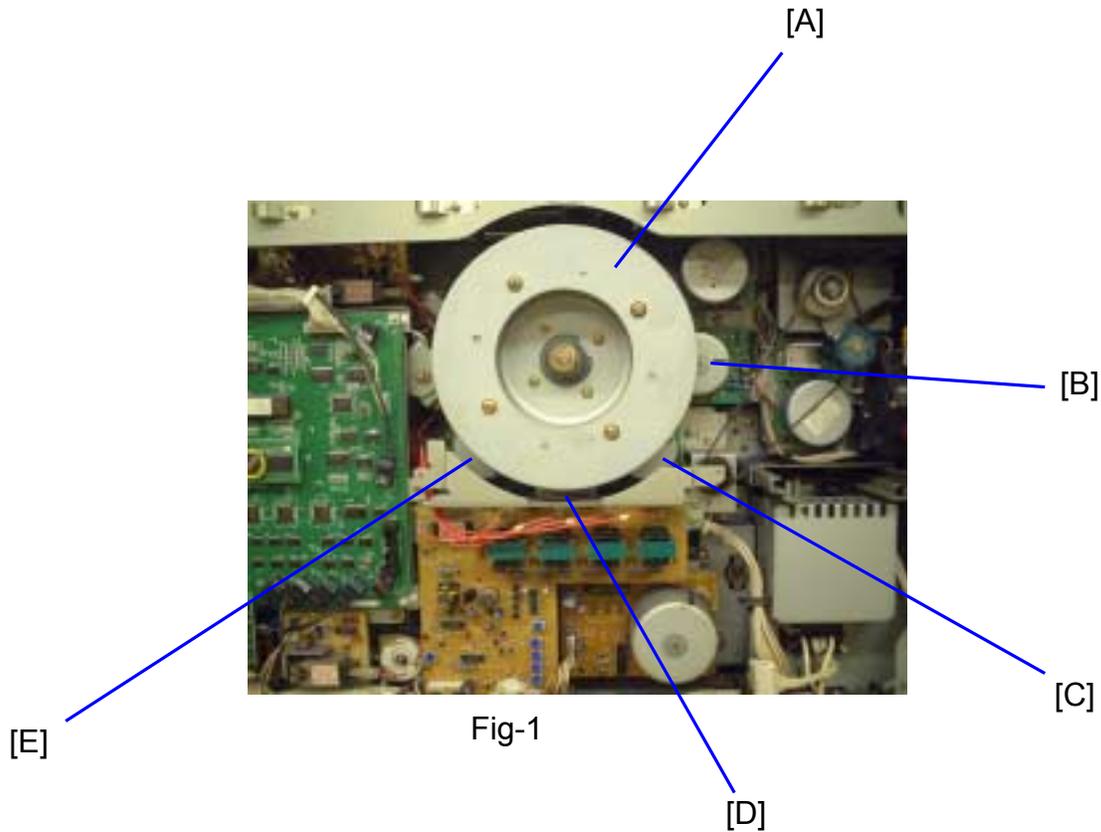
In C) above, the flywheel [A] will only continue rotating for about 5 or 6 SECONDS after the Yellow sleeve motor stops. In other words, you can determine if successful or not by the flywheel rotation time described in step C)
