Model: Bellini-C3 (Katana)	Date: 11-May-06	No.: RB234001b
----------------------------	-----------------	----------------

Subject: Controller firmware (Animation) release note for B-C3		Prepared by: T.Tadokoro	
From: PPBG QA/Service Planning Dept.			
Classification:	<input type="checkbox"/> Troubleshooting	<input type="checkbox"/> Part information	<input type="checkbox"/> Action required
	<input type="checkbox"/> Mechanical	<input type="checkbox"/> Electrical	<input type="checkbox"/> Service manual revision
	<input type="checkbox"/> Paper path	<input type="checkbox"/> Transmit/receive	<input type="checkbox"/> Retrofit information
	<input type="checkbox"/> Product Safety	<input type="checkbox"/> Other (     )

Subject: Controller firmware (Engine) release note for B-C3		Prepared by: T.Tadokoro	
From: PPBG QA/Service Planning Dept.			
Classification:	<input type="checkbox"/> Troubleshooting	<input type="checkbox"/> Part information	<input type="checkbox"/> Action required
	<input type="checkbox"/> Mechanical	<input type="checkbox"/> Electrical	<input type="checkbox"/> Service manual revision
	<input type="checkbox"/> Paper path	<input type="checkbox"/> Transmit/receive	<input type="

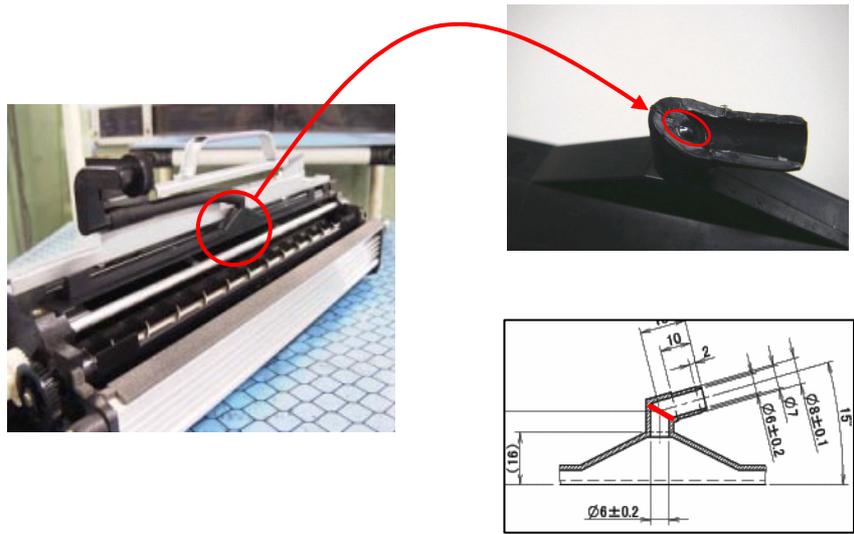
**Note:** The higher the roller (engine) speed, the higher the internal pressure. This is why, as mentioned above, the symptom occurs earlier on faster models.

1. Replace the duct unit at machine installation, or at the next service visit. To do this, use the duct unit kit: P/N **B2349902**.  
**See Page 4 below for the procedure.**

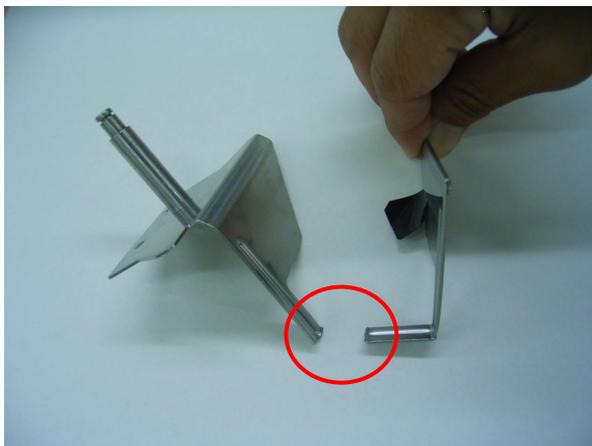
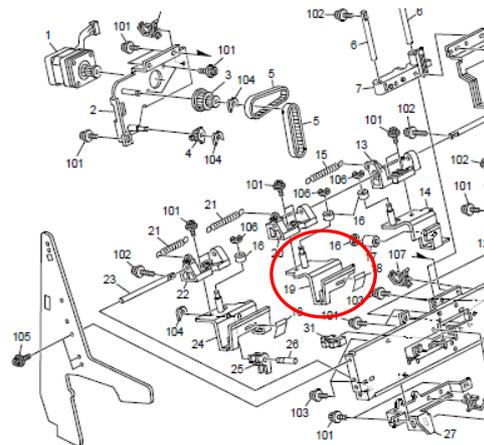
The rear fence for the SR5000 staple tray (P/N: B8304521) breaks, as shown below.

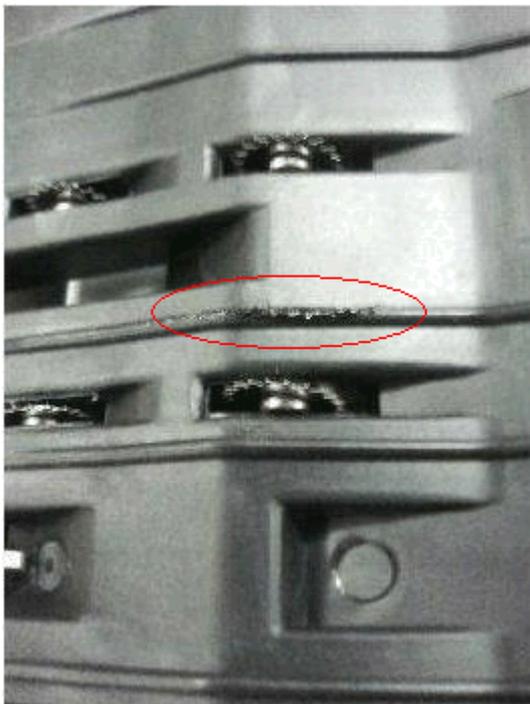
**Note:** This occurs most often when high-volume jobs are performed frequently using B4 or larger paper.
