Model: Kir-C3		Date: 25-May-06	No.: RB245001
Subject: ROM History for BICU for K-C3a Asia		Prepared by: Hiromoto Saitoh	
From: 1st Tech. Support Sec. Service Support Dept.			
Classification:	<input type="checkbox"/> Troubleshooting <input type="checkbox"/> Mechanical <input type="checkbox"/> Paper path <input type="checkbox"/> Product Safety	<input type="checkbox"/> Part information <input type="checkbox"/> Electrical <input type="checkbox"/> Transmit/receive <input checked="" type="checkbox"/> Other (      )	<input type="checkbox"/> Action required <input type="checkbox"/> Service manual revision <input type="checkbox"/> Retrofit information

Subject: ROM History for BICU for K-C3a		Prepared by: M. Saiki	
From: 1st Tech. Support Sec. Service Support Dept.			
Classification:	<input type="checkbox"/> Troubleshooting	<input type="checkbox"/> Part information	<input type="checkbox"/> Action required
	<input type="checkbox"/> Mechanical	<input type="checkbox"/> Electrical	<input type="checkbox"/> Service manual revision
	<input type="checkbox"/> Paper path	<input type="checkbox"/> Transmit/receive	<input type="checkbox"/> Retrofit information
	<input type="checkbox"/> Product Safety	<i

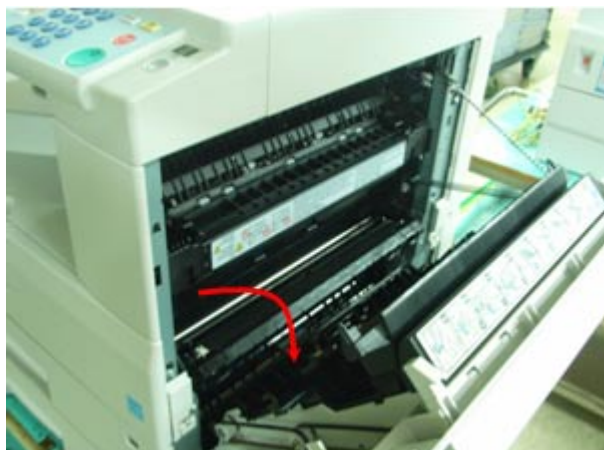
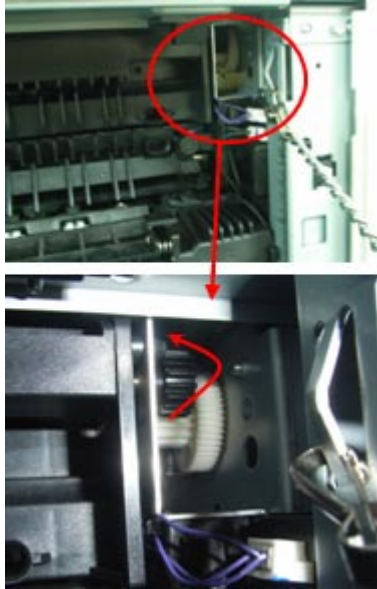
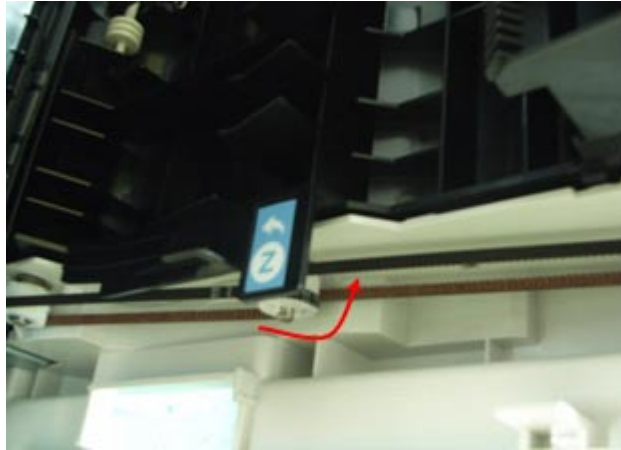
## Cause

## Action

1. Open the right door.

2. Rotate the gears until they break free of the adhesive.

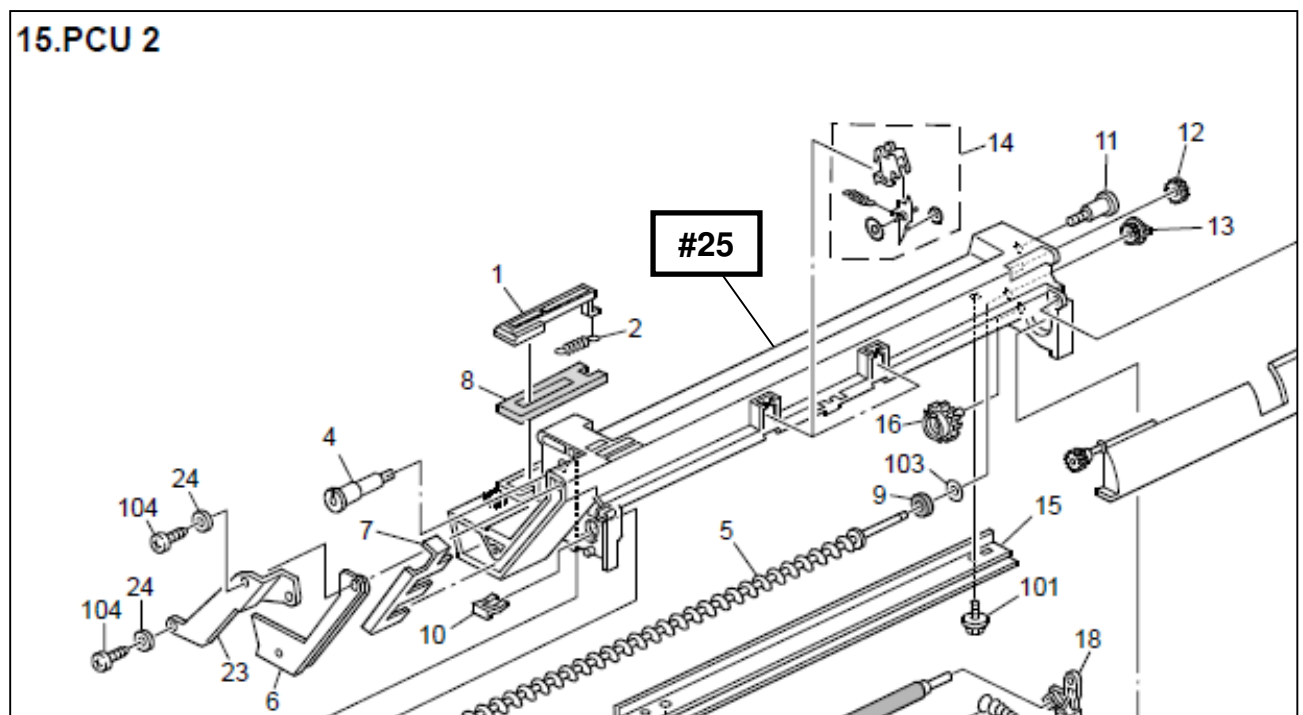
**Reason:** Correction of illustration and part number.

See the following diagram for the corrected illustration.

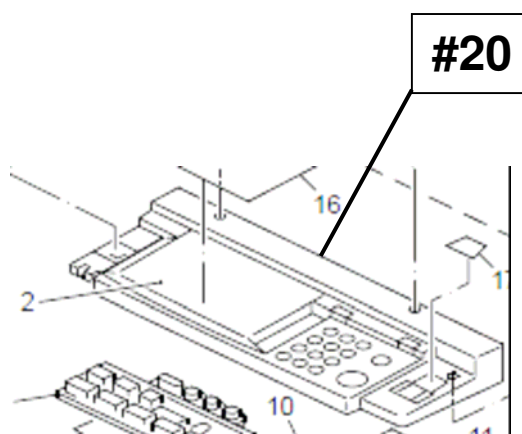
**Reason:** Correction of illustration and part number.

**See the following diagram for the corrected illustration.**

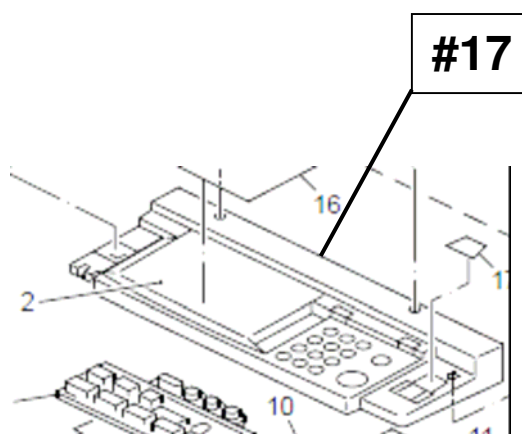
**Reason:** Correction of illustration and part number.

**See the following diagram for the corrected illustration.**

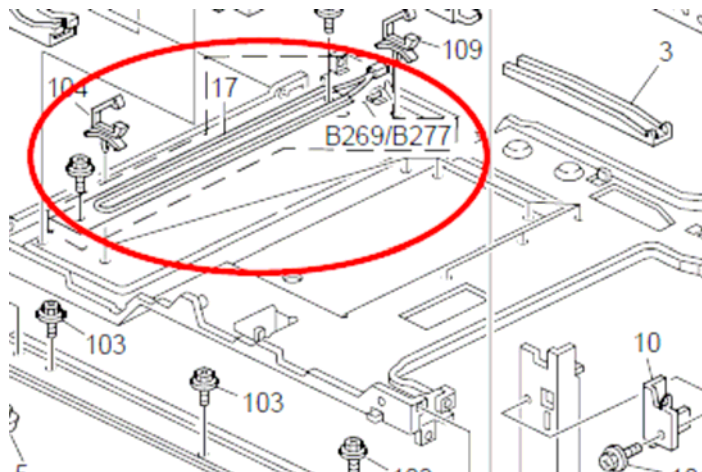
**Reason:** Redundant index (indicating the same part number as index No.15), and the illustration was incorrect.

**Parts included in the following section of the diagram (encircled in red) are deleted.**

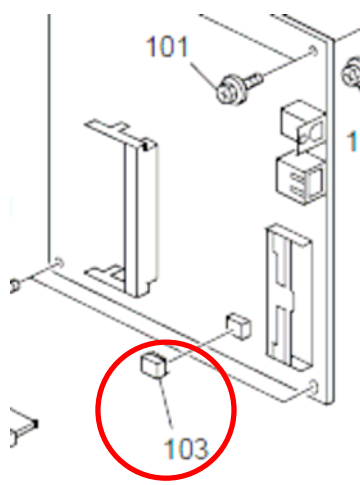
**Reason:** EEP-ROM as a new spare part cannot be used on the GDI controller board as a single replacement component because it causes network connection failure. Please replace the controller board if you need to replace the RAM.

**Part encircled in red in the following diagram is deleted.**

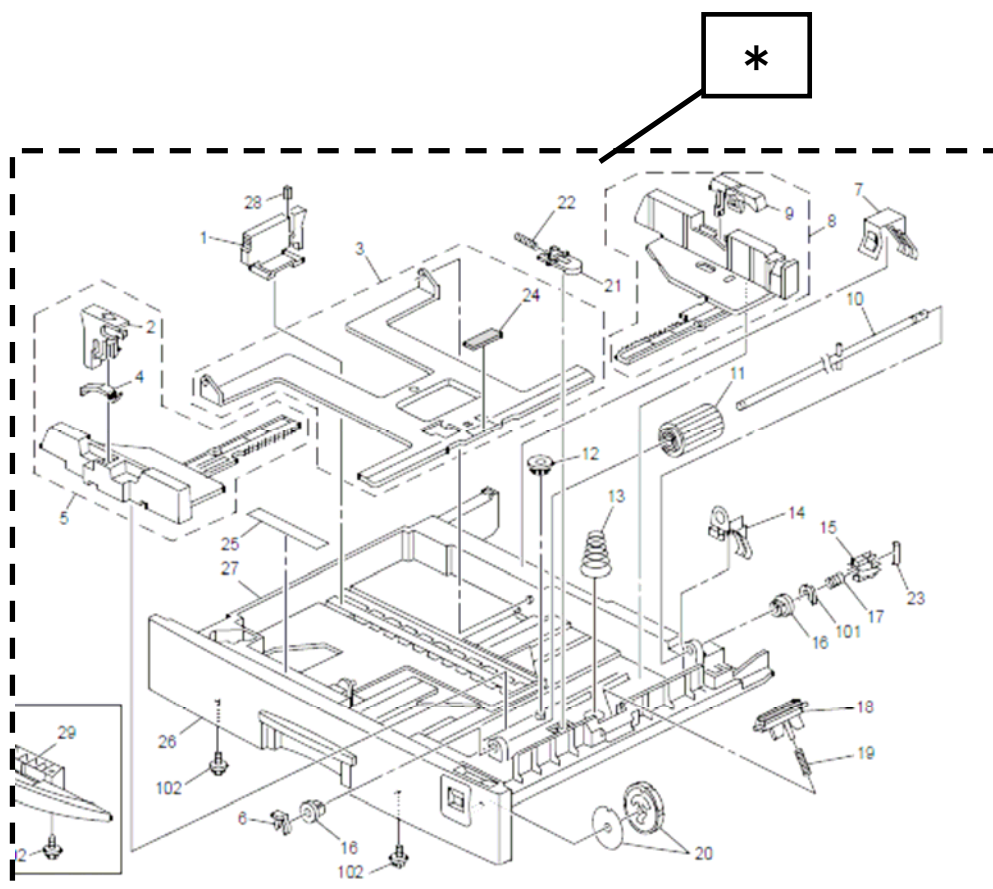
**Reason:** Correction of illustration and part number.

See the following diagram for the corrected illustration.

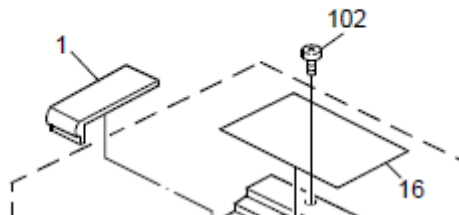
### 3.OPERATION PANEL

**Change/Reason:** The part number was missing from the parts catalog.

**See the following diagram for the corrected part.**
