Model: GW-C1		Date: 21-Apr-06	No.: RB283001b
Subject: ROM History (BICU)		Prepared by: H. Saitoh	
From: 1st Tech. Support Sec. Service Support Dept.			
Classification:	<input type="checkbox"/> Troubleshooting <input type="checkbox"/> Mechanical <input type="checkbox"/> Paper path <input type="checkbox"/> Product Safety	<input type="checkbox"/> Part information <input type="checkbox"/> Electrical <input type="checkbox"/> Transmit/receive <input type="checkbox"/> Other (     )	<input type="checkbox"/> Action required <input type="checkbox"/> Service manual revision <input checked="" type="checkbox"/> Retrofit information

Model: Model K-C3/GW-C1		Date: 15-May-07	No.: RB245023
Subject: Countermeasure for duplex printing error		Prepared by: Y.Murata	
From: 1st Tech. Support Sec. Service Support Dept.			
Classification:	<input type="checkbox"/> Troubleshooting <input type="checkbox"/> Mechanical <input type="checkbox"/> Paper path <input type="checkbox"/> Product Safety	<input type="checkbox"/> Part information <input type="checkbox"/> Electrical <input type="checkbox"/> Transmit/receive <input checked="" type="checkbox"/> Other (      )	<input type="checkbox"/> Action required <input t

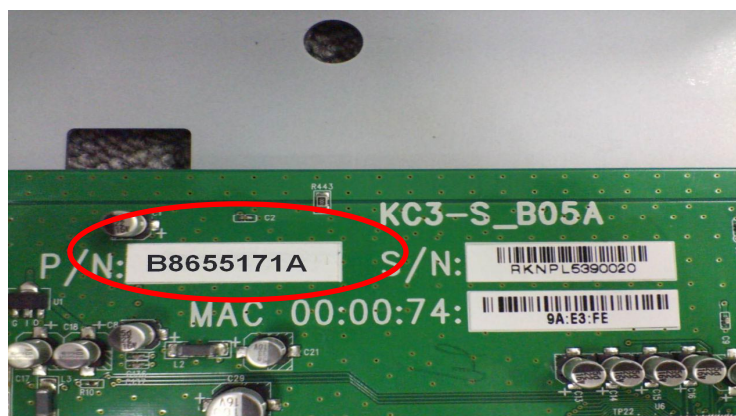
The new controller firmware is installed on controller boards from the following P/N:

**Note:** The suffix is printed on the board, as shown in the photo.

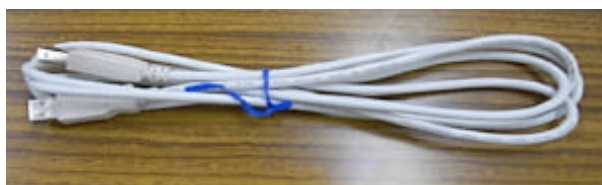
Cannot print with the GDI controller.

1. Surge voltage damages the IC chip used for the USB I/F signal.
2. The USB cable used did not meet the specification.
3. The PC or copier was not grounded properly.

1. Use the USB cables included with the Greatwall-C2, or USB cables that comply with the USB2.0 (shielded cable) standards.

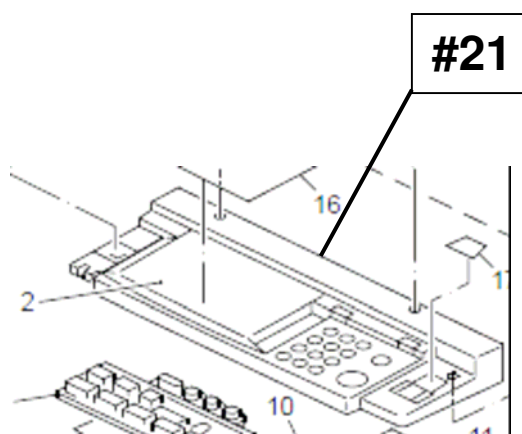
**Change:** An index in the illustration was added.

**Reason:** Correction of illustration and part number.

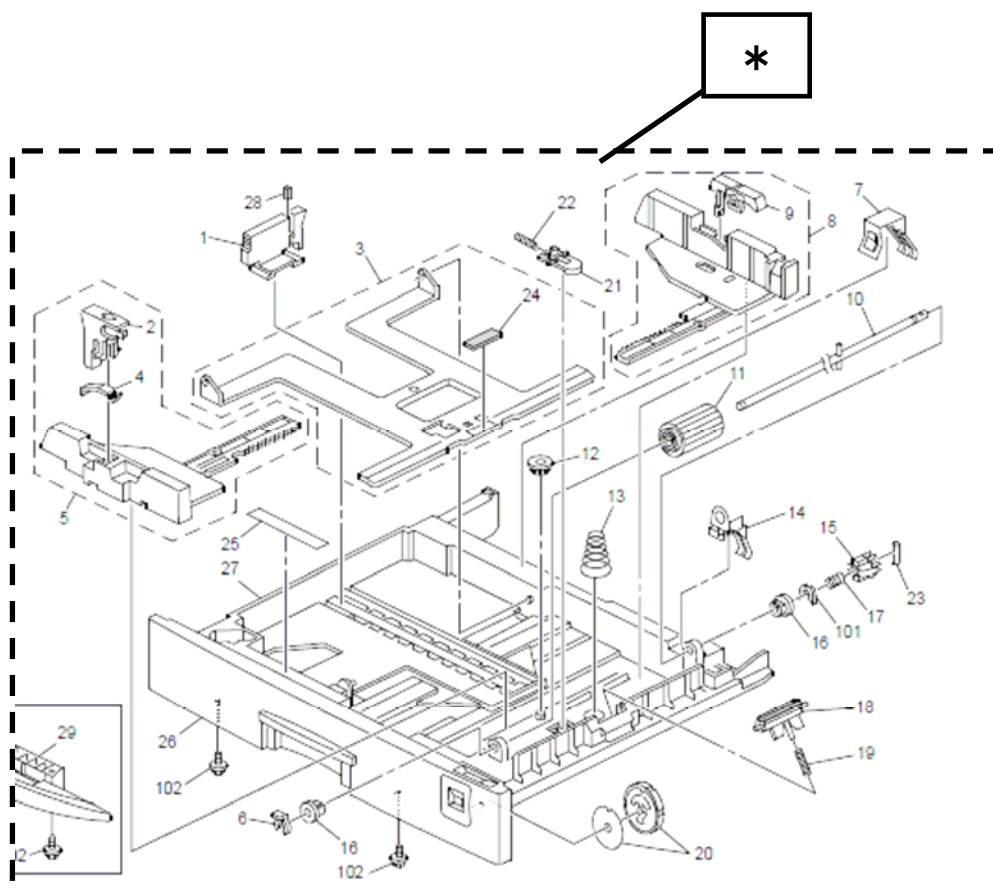
**Change:** An index in the illustration was added.

**Reason:** Correction of illustration and part number.
